Reconnaissance Report on the 31 March 2002 Earthquake on the East Coast of Taiwan

C. H. Loh,^{a)} M.EERI, K. C. Tsai,^{a)} M.EERI, L. L. Chung,^{b)} and C. H. Yeh^{b)}

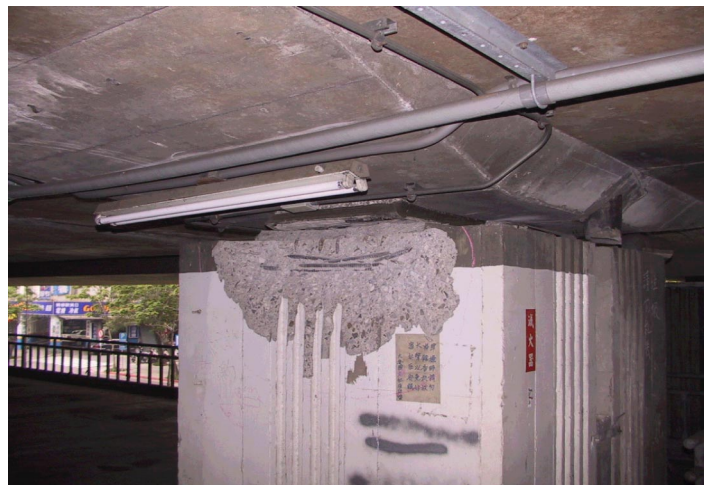
Strong motion data collected from viaducts in Taipei City were also analyzed, as shown in Figures 13 and 15. Figure 13b shows the recorded acceleration response at the center span of a viaduct (Cheng-Kuo South Expressway). The maximum acceleration at the center of the span is 482 cm/sec^2 in the vertical direction. The dominant period of that signal is 1.57 seconds. Damage of bearing in this highway viaduct was observed during this earthquake. A permanent horizontal displacement about 3 cm in the bearing had been observed, as shown in Figure 14.

Figure 14. Damage of bearing of the Chang-Kuo Viaduct in Taipei City. A 3-cm permanent displacement was observed on the bearing.

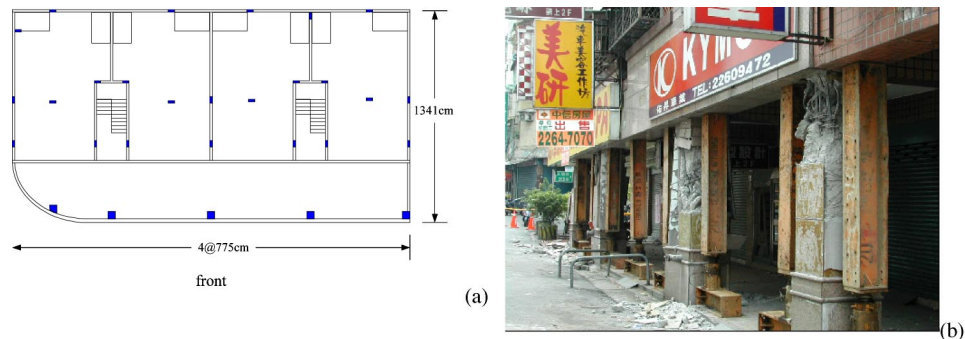
Figure 16. (a) Schematic plan of a 5-story condominium building, and (b) columns along corridor that were seriously damaged and shored with steel columns and jacks.

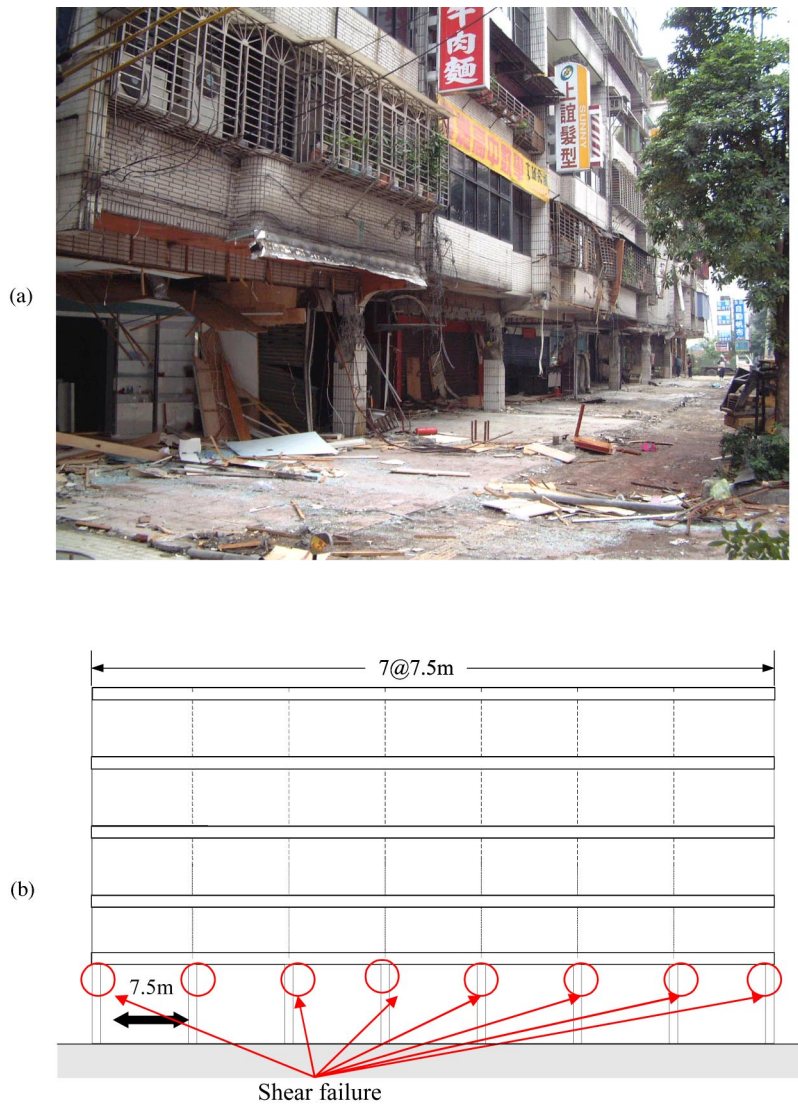
crete columns, beam and slab are then constructed by using the brick walls as part of the formwork. They are classified as reinforced-masonry buildings in Taiwan. Perpendicular to the corridor, two adjacent apartment units are partitioned with a common brick wall that is continuous in the gravity direction. However, along the corridor, there are doors and windows for entrance and natural light, and no walls are continuous in the gravity direction. Damage was observed in this type of building. Figure 16 shows the plan view of the building as well as the damage feature. Columns along corridors were seriously damaged and subsequently shored with steel columns and jacks. Similar damage features were also observed in a 5-story condominium building, as shown in Figure 17.

Figure 17. (a) Photo of a damaged 5-story building with seven units in a row, and (b) schematic diagram of the building in (a) and the damage locations of the columns along the corridor.

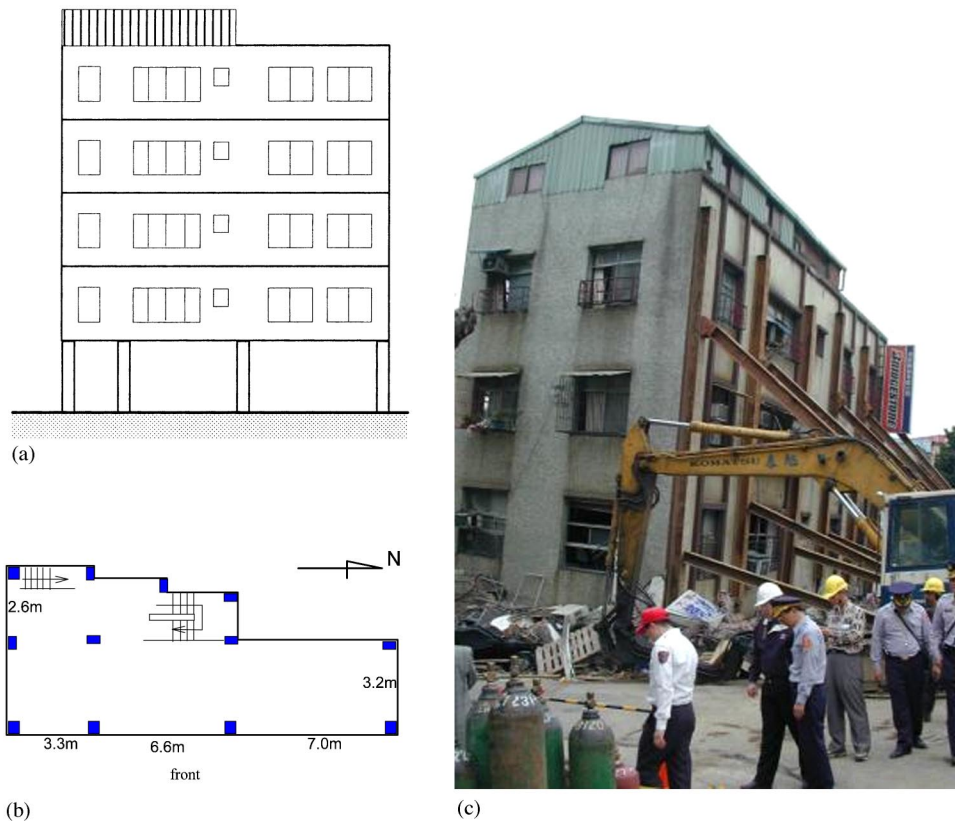
In addition to the provision of corridors, large openings for doors and windows are necessary at the street side of the buildings. Moreover, if the developers, builders, or owners provide open space for the public at the ground level, they are allowed to build more floor areas as a reward. On the other hand, the frames above the ground floor are in-filled with a brick masonry perimeter and partition walls. Thus, the bottom floor is comparatively soft and weak due to the presence of corridors, the open front, and open space. This is the case of soft first-story damage mode. The only collapsed building during the earthquake was one of the soft first-story buildings. The schematic elevation and plan views of the collapsed 5-story mixed commercial and residential building are shown in Figure 18. The basement and the first floor of the building are for commercial use and the rest of the floors are for residential use. The building was constructed between 1974 and 1975. There are a total of 12 columns. Along the long axis, a corridor is provided and the number of spans ranges from three to four. But the number of spans along the short axis just ranges from one to two spans, so that redundancy is highly inadequate. In this earthquake, the first and second floor collapsed and tilted 5 degrees toward the street side (Figure 18c).

Figure 18. Schematic elevation (a) and plan (b) views of a 5-story apartment building. The 5-story building collapsed (c) in the 31 March earthquake due to a soft first story and poor configuration of the structural system.

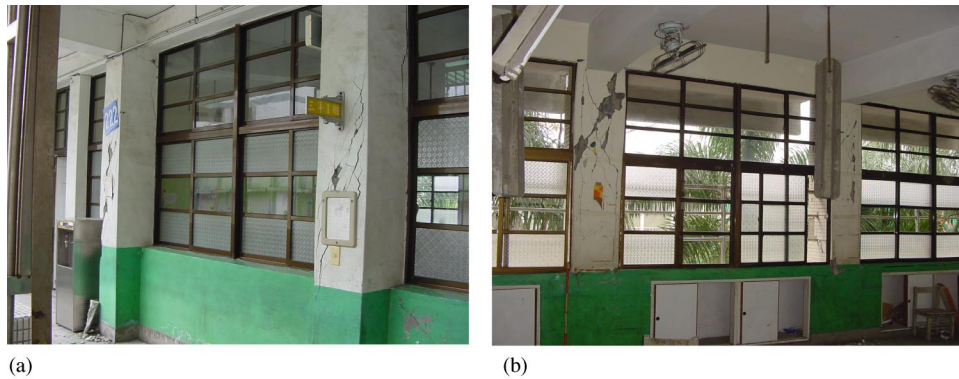
mode. Figures 21a and 21b show that the columns were damaged along the direction of the corridor. Short columns were revealed by the diagonal shear cracks.

Figure 21. (a) Columns were damaged along the direction of the corridor; and (b) diagonal shear cracks were due to the short column effect, and the lighting facility had fallen down.

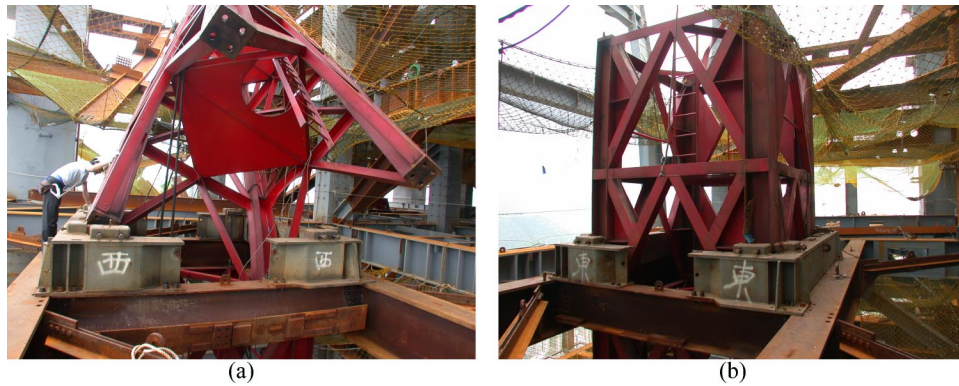
Figure 27. (a) Collapse of TC#2 at 51st floor, and (b) collapse of TC#4 above the 51st floor.

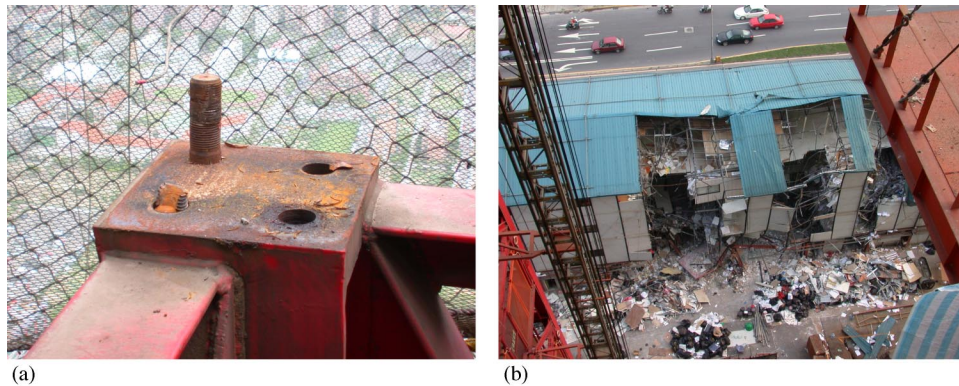
Figure 28. (a) Failure at the bolted column splice, and (b) damage at the construction site office caused by the falling counterweights.

et al. 2002) indicate that both TC#2 and TC#4 failed at the column splices where four 45-mm-diameter high-strength bolts were used at each splice (Figure 28a). Preliminary test results show that the typical failure mode of the high-tension bolt is the shearing-off of the threads, but not the tensile fracture of the bolt cross section. Test results (CEER 2002, Tsai et al. 2002a) also confirm that the shear-off failure load of the bolts is about 1250 kN. Three-dimensional analytical results (Tsai et al. 2002b, 2003) of simplified TFC building stick models incorporating the four tower cranes suggest that the peak horizontal acceleration at the 51st floor is as high as 0.8 g under the effects of simultaneous applying the two horizontal components of the TAP022 recorded accelerations. The elastic demand-to-capacity ratios of the tower crane column splices considering a tensile capacity of 5000 kN at each splice are in the range of 2.0 to 3.0. The high seismic demands imposed on the tower crane bolted splices due to a strong earthquake, significantly greater than the tower crane was designed for, appear to be the key factors responsible for the collapse of the tower crane. At the time of this writing, a stiffened and strengthened scheme has been proposed by the general contractor for the rescue Tower Crane TC#A to be used in the restoration work of the TFC construction project.
