行政院國家科學委員會專題研究計畫成果報告

The characteristics of geological environment along the New East-West cross highway (III)

計畫編號：NSC 89-2116-M-002-020

執行機構及單位名稱：台灣大學地質科學研究所

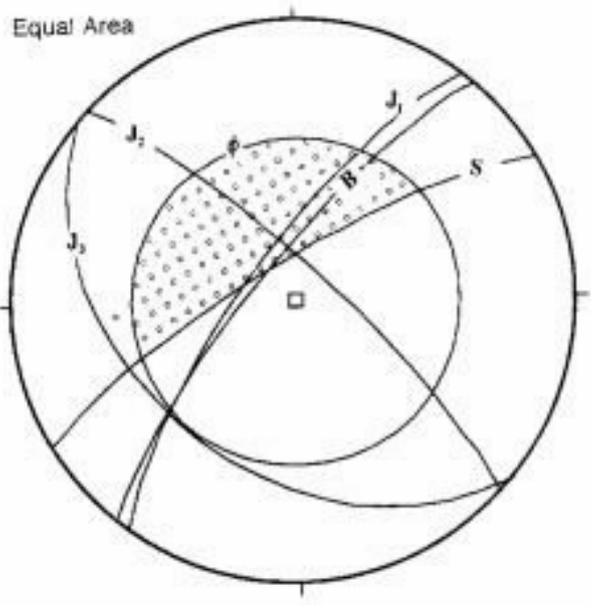
(A) No. 1 gully

Figure 2 displays the possible directions of block displacement such as the dip slope and wedge slope models on No.1 and No.3 gullies. The shadow area shows the potentially unstable slopes.

The safety factor of the outcrop at marks 1-2, 1-3 and 1-4 on both sides of No. 1 gully displays a potentially unstable state in a saturated condition. The failure model includes plane, wedge and topple failures. This result indicates a good stability under the normal dry condition. When these slopes are saturated, however, the safety factor will fall below 1.0 (Table 3), and the slope will fail.

Fig. 2 Stereonet analysis of No.1 and No.3 gullies with dotted area showing the potential unstable areas.

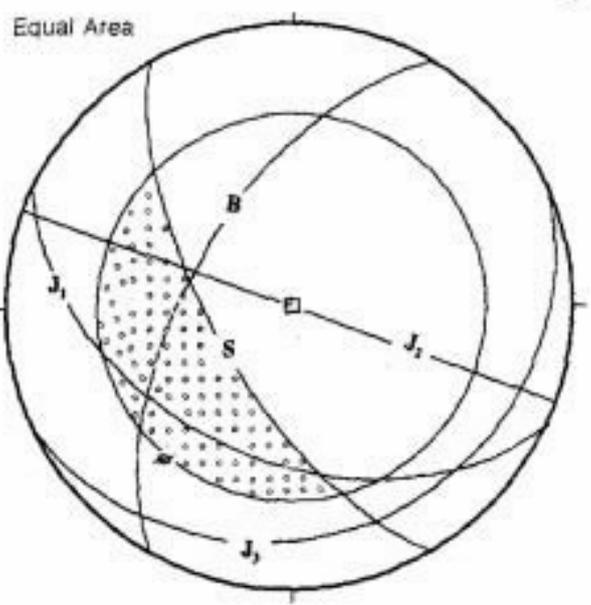
(B) No. 3 gully

The safety factor of the outcrop at marks 3-2, 3-4 and 3-5 on both sides of No.3

gully displays a potentially unstable state in the saturated condition. The failure model also includes plane, wedge and topple failure as well. This result is the same as in the former case.
