Polyethylene Failure of the Patellar Component in New Jersey Low-Contact Stress Total Knee Arthroplasties

Chun-Hsiung Huang, MD,*† Jiann-Jong Liao, PhD,† Fang-Yuan Ho, MS,‡
Chia-Yin Lin, BS,‡ Tai-Horng Young, PhD,§ and Cheng-Kung Cheng, PhD†

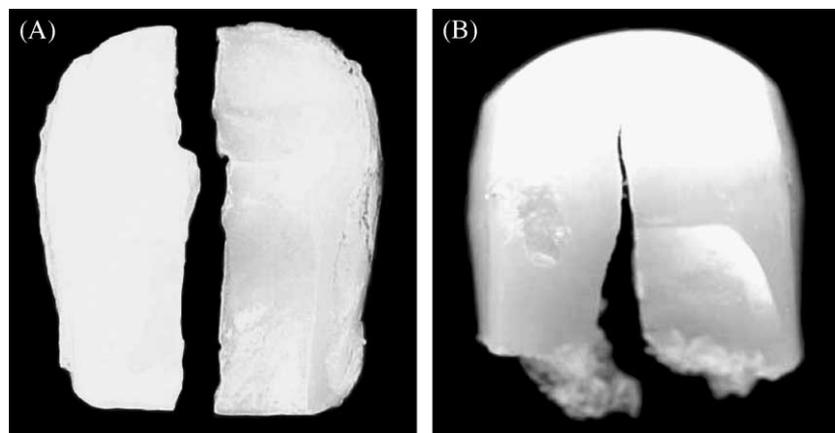
Fig. 2. Two types of polyethylene failure in group A. (A) Zip-through crack. (B) Developing crack.

transverse central line of the polyethylene. Among these 7 cases, 4 had the polyethylene portion split into 2 symmetrical parts (Fig. 2A), whereas the remaining 3 samples showed a partial split with a developing crack (Fig. 2B). The crack lines always occurred in the region where the polyethylene was thin, either beneath the metallic button or its lateral portion. The thicker region of the medial portion seemed to be able to arrest the crack

propagation starting from the thin region in the cases of a partial split.

When a large subluxation of the patellar component occurred, the pinnacle of the polyethylene, especially at the thinnest part beneath the metallic button, became the only point that had contact with the femoral condyle. The polyethylene would then experience a highly concentrated load on its thinnest part and begin to crack and/or tear. The crack could then propagate toward either the medial or lateral side or both.

The split rupture of group A came with 2 conditions. First, the crack split the polyethylene into 2 symmetrical parts (Fig. 2A). Second, the crack went through the longer, thinner flange but was arrested in the shorter, thicker one (Fig. 2B). The scanning electron microscope photograph in Fig. 6 shows the thinnest point of crack initiation with patterns of striations (to the right of the center) indicating fatigue crack advancement.

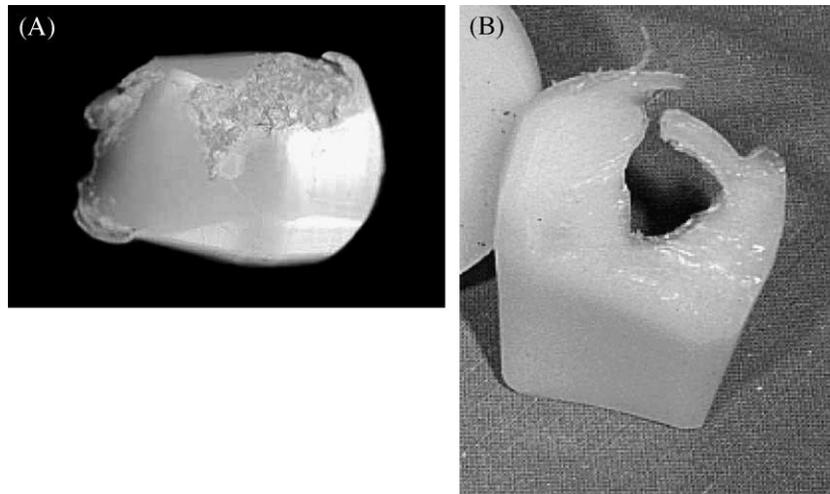
Fig. 3. (A) Peripheral wear seen in group B. (B) A worn-through polyethylene in the medial portion.

There were 21 cases (65.63%) showing wear around peripheral regions (Fig. 3A). Wear patterns ranged from slight scratch to severe wear, which may be accompanied with color change, and were identified by visual inspection. Regardless of the degree of wear, most polyethylene components showed a similar wear location, visible at the periphery but occasionally extending to the patellar ridge. Among these 21 cases, 1

showed polyethylene worn-through on the medial side (Fig. 3B).

If the patellar component is tilted, it will make contact with the femoral condyle on one of its flange. The flange will then take up the majority of the load, leading to the peripheral wear as illustrated by group B. Fig. 7 shows the severe delamination seen around the flange.

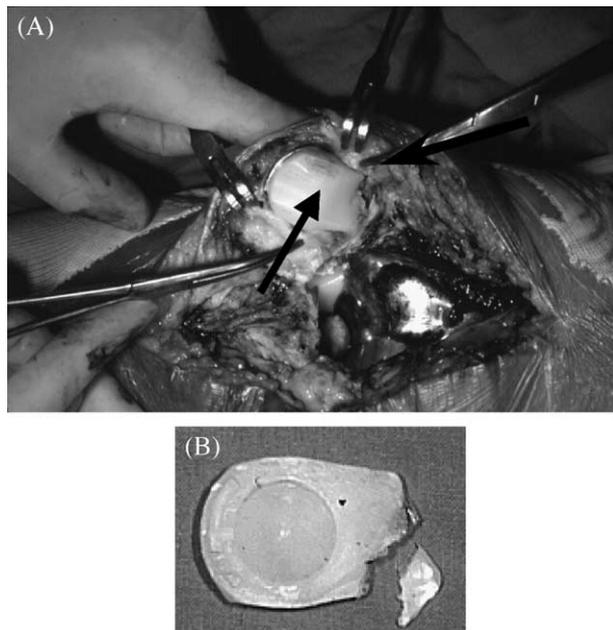
Fig. 4. (A) Bony ingrowth over the corner of the metal plate was found during surgery. (B) Breakage of the cantilevering edge.

This type of failure involved 4 cases (12.5%) of fragmentary breakages mostly in the lateral portion. During the revision, bony ingrowths over the corner of the metal plate were noted (Fig. 4A). We believe the bone ingrowth impinged on the polyethylene rotation. The cause of such breakage was the stress riser in the polyethylene sustaining the load as a cantilever beam when rotated out of the metal-back buttress (Fig. 4B).

Another advantage of the LCS design is its rotating mobility, which adjusts the patellar tracking and reduces the shear stress at the bone/implant interface. When the patellar components experienced a large tilt and displacement (group C), the range of the rotating mechanism might become limited. This may cause bony ingrowths at the corner of the metallic baseplate. When rotation was blocked by the bony ingrowths, the polyethylene extended beyond the metal buttress and behaved as a cantilever beam, leading to cantilevering breakage.

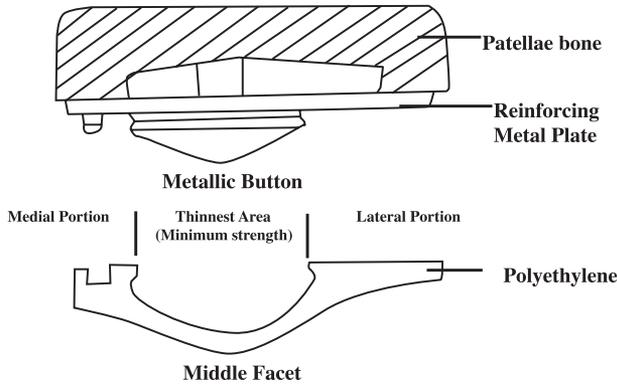
Fig. 5. Variation of the thickness on the cross section of the polyethylene component.

congruency and, thus, uneven stress distribution. Both group A and B demonstrated such a problem. Because the patellar component fitted to a shaft of the metallic button settling in the metal baseplate, the thickness of the polyethylene was uneven (Fig. 5). The area beneath the button had the minimum thickness, meaning the minimum strength.

Low-contact stress patellar components are well designed with a lower rate of failure as compared with other competitive designs. For here, the authors would like to offer the following recommendation based on our clinical findings: the patellar component can be modified to have a flatter metallic button to increase the focal thickness of polyethylene and a dome-shaped polyethylene to reduce the concentration of stress on the pinnacle should subluxation or tilting of the patellar occurs. The authors would also like to point out that surgical technique, although not felt to be a factor in this study, plays an important role

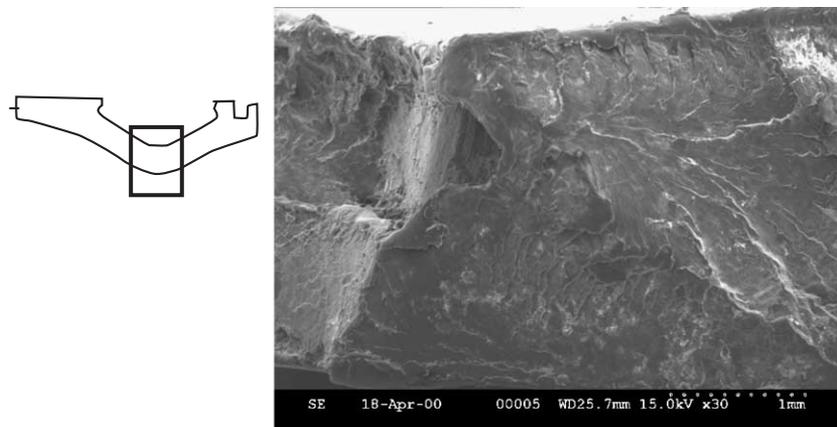
Fig. 6. The SEM photograph of a specimen from group A showing a zip-through split. The section with the thinnest area shows an obvious river pattern which is considered as the crack initiating point.

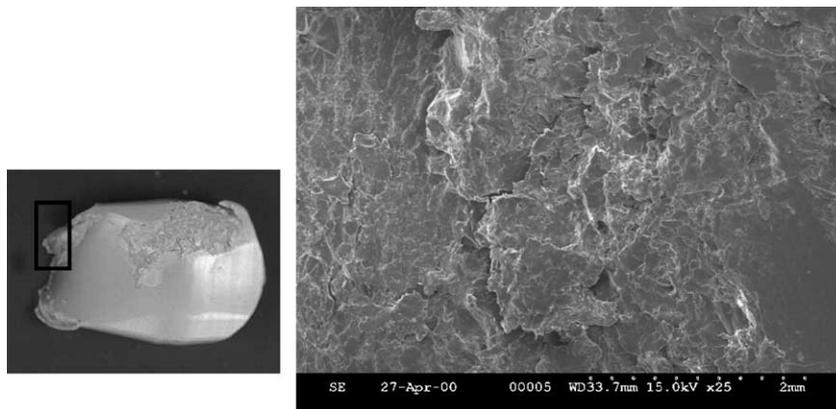
Fig. 7. A large area of delamination on the articulating surface of a patellar component in group B.
