DAMAGE TO HYDRAULIC FACILITIES FROM THE CHI-CHI (TAIWAN) EARTHQUAKE

Key Words: Chi-Chi (Taiwan) Earthquake, earthquake disaster, hydraulic facility, dam damage, inundation map.

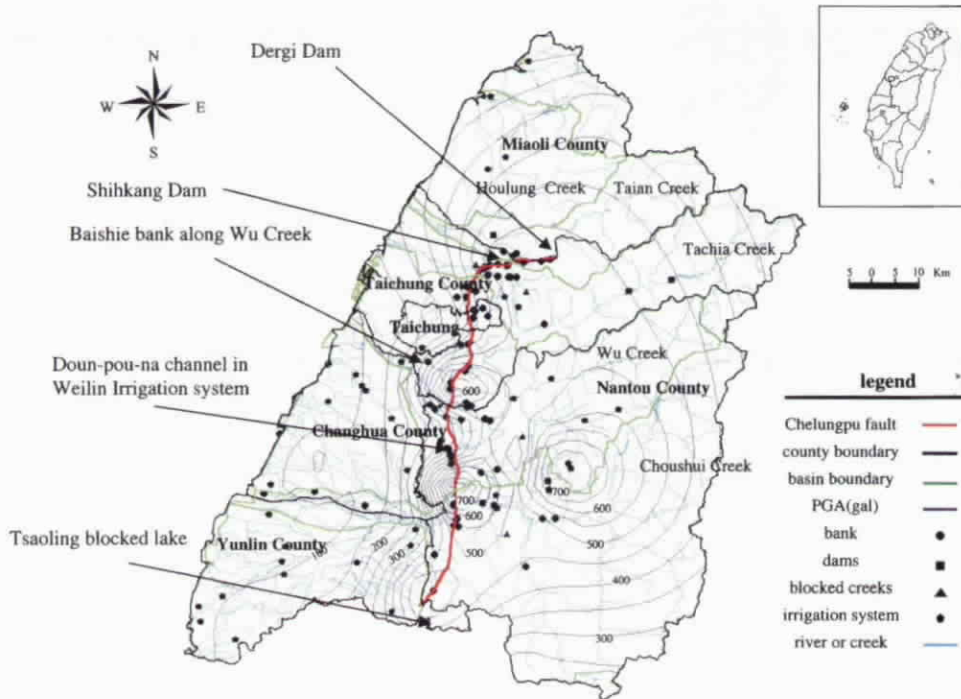
Fig. 1 Relationship between the Chelungpu fault and the locations of the damaged hydraulic facilities

Ground motion in the Chi-Chi (Taiwan) Earthquake may be characterized as high accelerations, large velocity pulses, and permanent tectonic displacement. The nature of ground motion is related to the direction and mechanics of the fault rupture as well as the path of the seismic wave to the site. Fig. 1 shows the relationship between the Chelungpu fault and the locations of the damaged hydraulic facilities in the counties of Miaoli, Taichung, Changhua, Yunlin, and Nantou. It clearly points out that the damaged locations were concentrated along the Chelungpu fault. Recorded peak horizontal accelerations typically ranged between 0.4g to 0.8g in the

regions that suffered significant hydraulic facilities damage. Some riverbanks along Tachia Creek, Choshui Creek, and Wu Creek were cracked. Shihkang Dam was severely damaged. Landslide materials blocked five different creeks and formed new lakes. The irrigation systems of west-central Taiwan were also seriously damaged.

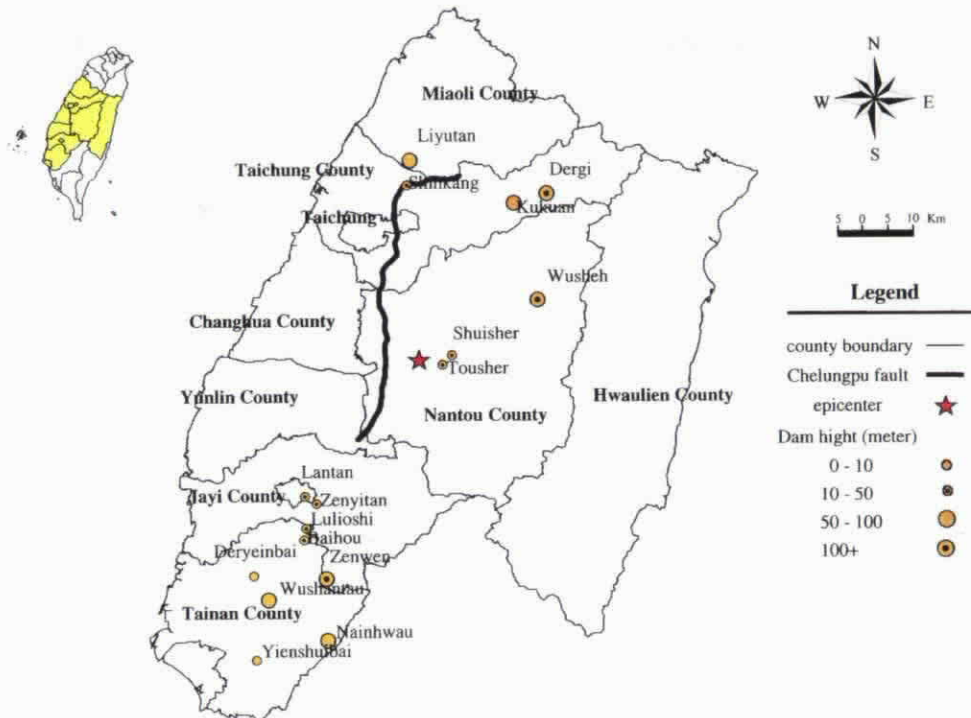
Fig. 2 Locations of dams in west-central Taiwan

Totally there are 16 dams located within the area affected by the Chi-Chi (Taiwan) Earthquake. In order to show the spatial distribution of the 16 dams, their locations are shown in Fig. 2. The basic data and computed peak ground acceleration a_{PGA} are summarized in Table 1 for each dam. In addition, the damage to each dam caused by the Chi-Chi (Taiwan) Earthquake is also indicated in the last column of Table 1. It should be mentioned that the shortest rupture distance for each dam is cautiously determined and thus its peak ground acceleration a_{PGA} can be calculated by using Eq. (1) with the use of $M=7.3$ which is the local magnitude for the Chi-Chi (Taiwan) Earthquake. As an example, the shortest rupture distance for the Shuisher dam from its site to the Chelungpu fault is determined to be 13.9 km, hence the value of a_{PGA} for this dam is found to be 0.35 g after substituting $R=13.9$ km and $M=7.3$ into Eq. (1). Employing the same procedure, the values of a_{PGA} for all the 16 dams can be determined as listed in Table 1.

It can be found that the peak ground accelerations for the Shihkang dam, Liyutan dam, Kukuan dam, Tousher dam, Shuisher dam, Lantan dam, Zenyitan dam, and Dergi dam are larger than their maximum credible earthquakes, and thus damage occurred, except for the Lantan dam and Zenyitan dam. On the other hand, it also can be observed that for all the other dams their peak ground accelerations are less than or equal to their maximum credible earthquakes and hence no damage occurred. Even though

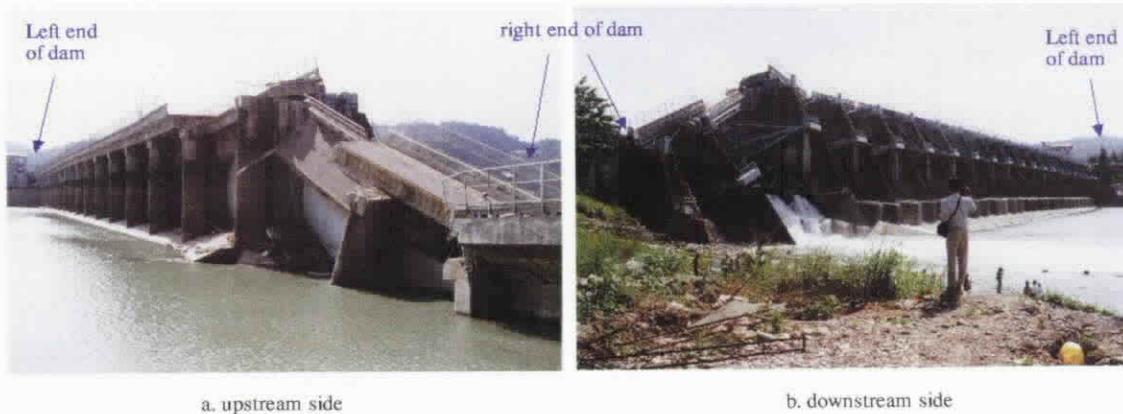
Fig. 3 Damage to Shihkang Dam

1. Shihkang Dam

The most serious damage occurred at Shihkang Dam, a 25-meter-high dam located on a river channel of great capacity (Tachia Creek) and administered by Taichung County. The structure is a relatively low diversion dam. Shihkang Dam is located near the Chelungpu fault and about 40 kilometers from the epicenter as shown in Fig. 2. During the earthquake, the reservoir was 30 percent full with a volume of 0.5 million cubic meters, and the water surface was 5.2 meters below the crest.

Peak horizontal accelerations on the abutments were ranged from 0.6g at the foot of the dam to 0.9g on the sidewall near the crest. Damage visible at the site was consistent with the strong shaking indicated by the strong ground motion and the rupture of the Chelungpu fault. The sluice gate on the left end of the dam and six of eighteen spillway gates are still operational. Fig. 3 shows the four gates at the right end of the dam were severely damaged and cannot be easily repaired. In addition, the crest elevations of all the sluice gates and spillway gates should be surveyed and new rating curves should be computed. The design and construction of a new replacement structure at an alternative site would take years to complete. However, this structure provides vital

water supply benefits to Taichung City. The restoration of Shihkang Dam must be done within a reasonable time.

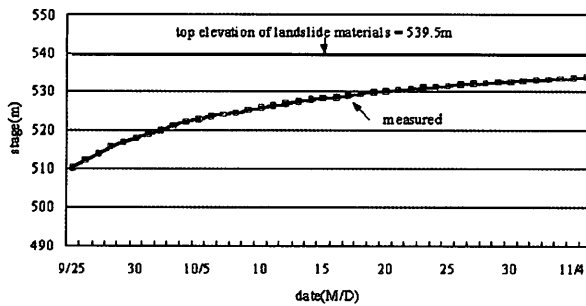
Fig. 4 Measured water stage of Tsaoling lake

An upstream impoundment of water above the streambed elevation of approximately 509 meters, was formed below the village of Tsaoling. Fig. 4 shows

the measured water surface level of the blocked lake. It was 534 meters on November 7, 48 days after the earthquake. The digital terrain model and geographic information systems were employed to calculate the storage curve of the blocked lake. The computed result is shown in Fig. 5. It represents an estimate volume of about 34.8 million cubic meters, for an average baseflow of less than 5 cubic meters per second. The minimum crest of the landslide materials at the impoundment is measured to be at elevation 540 meters, with a total storage capacity of 43 million cubic meters.

A temporary spillway was constructed by the Water Conservancy Bureau (WCB) for an emergency use to avoid the flow overtopping. Significant improvements have already been made by the WCB to the current channel by flattening the actual slope over the last 1 kilometer and adding larger rock-fill at the downstream toe. These would serve to reduce channel flow velocities during overtopping, provide an additional buttress for the slope, mitigate potential piping concerns by loading and filtering the exit point, and reduce potential surface erosion.

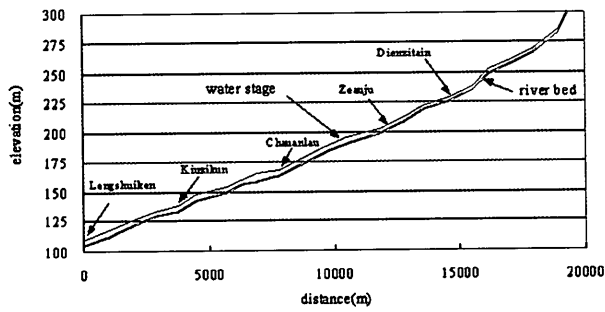
Fig. 6 Simulated water stages of Chinshui Creek

Fig. 6 shows the simulated results of the water stage of Chinshui Creek under the conditions of collapse of landslide material with a full storage of water and the design storm with a rainfall of 600 mm in 24 hours. Fig. 7 maps out the inundation zone that covers 14 villages in the downstream lowland of Chinshui Creek, such as Lengshuiken, Tauziyen, Chentain, Kiuzikun, Dershien, Futain, Liyui, Chauanlau, Paijaishen, Linan, Moogautain, Zeauju, Tuntau, and Dienzitain, where there are more than 20 thousand people. The inundation map can show areas of potential flooding. It also helps local authorities to adopt emergency procedures for the

evacuation and security of populated areas below the new blocked lake. It is suggested that the inundation mapping for different scenarios of landslide material failure must be calculated and duly provided to the authorities concerned in proposing strategies for flood hazard mitigation plans.
