International Journal of Remote Sensing

Side-scan sonographs of steep slopes in the Wushieh Reservoir

Operators tow side-scan sonar transducers at the optimum height from the bottom to produce better quality side-scan sonographs. This can be done only if the bottom is moderately flat. Sonographs with maximum tonal intensity are easily produced on steep slopes e.g. valley banks. Strong signatures are recorded over all ranges due to the poor geometry of sonographs produced without acoustic shadows. In order to create clear scanned images of a steep slope using a side-scan sonar, rotation of the towed fish or tilting the transducer face to the dipping slope surface is suggested. Cases conducted on the shore of the Wushieh Reservoir, Taiwan, in which the bank slopes varied from 10° to 45° are discussed in this work. In general, the angle of the scanned slope determines the degree of towed fish rotation angle. The rotation angle is set at a smaller angle than the slope, giving stronger returns from the lower slope. In contrast, if the rotation angle is set at a larger angle a null return outside the insonified area in the lower slope is produced. A sub-aqueous landslide was observed i

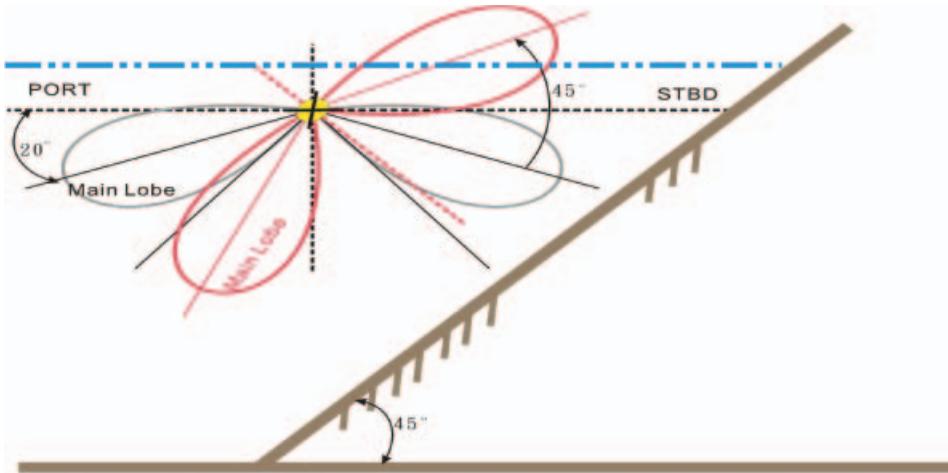
Figure 1. Power directivity diagram of the vertical sonar beams transmitted from towed fish. The yellow solid circle represents the location of the towed fish. The main beam lobes are denoted by grey lines. The side lobes are not shown for clarity. The blue dashed line denotes the water surface. The body of the towed fish can be tilted 45° counterclockwise such that the beam directivity (red main lobes) related to the bottom (bold black lines) can be changed as shown.

The sonar beams formed by the 272TD towed fish are shaped especially for generating the highest resolution possible. In the field, we were using its specified lower frequency at 100 kHz, and produces a main sonar beam $1.2^\circ \times 50^\circ$ at half power point (-3dB) (EdgeTech 1988), or about $2.0^\circ \times 100^\circ$ at one eighth power point (-9dB) (Fish and Carr 1990). In addition, the beam axes are also directed 20° below the horizontal (figure 1).

As shown in figure 1, the acoustic pressure peak of the main vertical lobe is about 20° below the horizontal. The sonar sensitivity should be sharply reduced above the water surface, as well as reduced uniformly to the minimum vertical downwards at so-called nadir. For GLORIA long range side-scan sonar, the beam pattern shows the small null of signal about 20° off nadir (Searle *et al.* 1990). In the null, the loss of signal is significant, but several side lobes can be seen there. In fact, the minimum always occurred in a null between the main lobe and first sidelobe (Searle *et al.* 1990).

To create a clear scanned image on a steep slope using a side-scan sonar, rotating the towed fish or tilting the transducers to the dipping surface of the slope is suggested. Under these circumstances, only one channel is usable. This is because the main lobe of the other channel is easily pointed above the horizontal (figure 1), creating water surface reverberations or multipath images.

In general, the dipping angle of the scanned slope determines the degree of rotated angle of the towed fish as shown in figure 1. Figure 3 demonstrates the nadir located on the slopes while the towed fish is rotated 45° in the upslope direction. The calculations were based on a known water column depth (D), the slope dipping angle (θ), and the surveyed distance of first bottom return (L). As a result, the quality of sonar image on the slope may be controlled using the distance L related to the slope coverage. The best range setting was at 5 times L , which may cover all the way to the bottom of the slope.

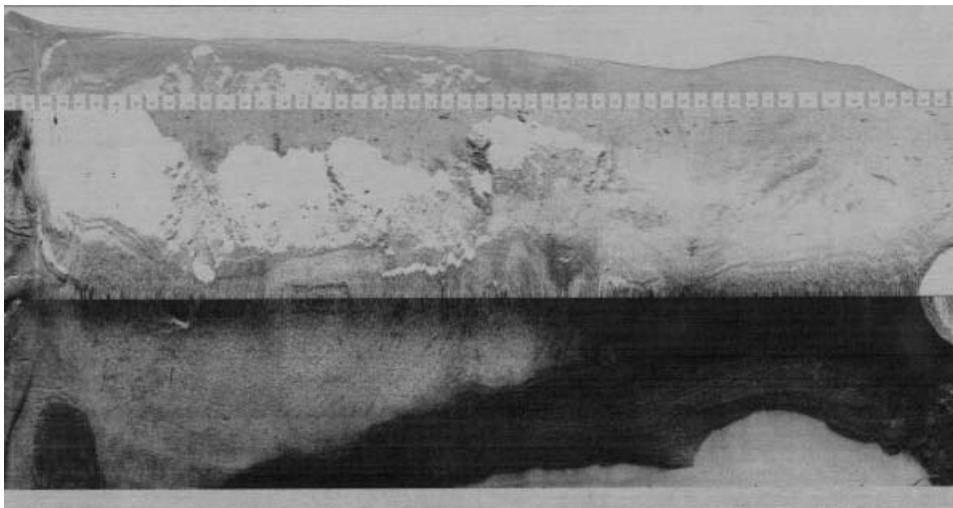
Figure 2. Side-scan image showing the slope area of the Wushieh Reservoir, Taiwan. There are three recorded portions displayed. The narrower upper portion is the third data channel showing mainly the towed fish altitude. The range scanned in this record is 50 m, so the total range from both channels (starboard channel on the top and port channel on the bottom) is 100 m. The images on both channels are shown in the slant range corrected mode. This removes the water column bringing the two first bottom returns together. Light area on the record indicates almost no acoustic energy returned.

Figure 2 shows the side-scan image of the shore of the Wushieh Reservoir. The gradient of the section is at about 20° ; however, different looks of the image are shown to either side of the channels. The acoustic lobe of the starboard component pointed downslope gave acoustic shadows on a large portion of the record; especially at places where the towed fish was towed at 20% ratio as recommended. In

contrast, the acoustic lobe of the port component pointed upslope gave very strong energy returns, especially at areas where the towed fish was towed higher than recommended.

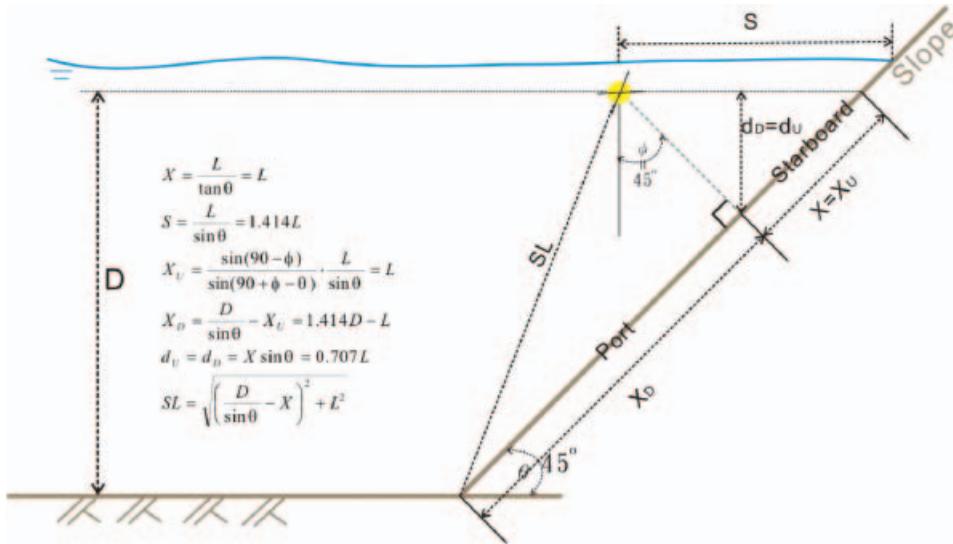
Figure 3. Geometry of scanned image by a 45° (ϕ) rotated side-scan towed fish. The slope dips at 45° (θ). There is a variant depth of water (D) from 25 m to 50 m in the Wushieh Reservoir, Taiwan.

Following figure 3, the depth of the towed fish to the bottom of the slope (D) is 37 m. The towed fish is rotated for a 45° slope accordingly. In this case, the port component is the only channel in view, and its scanned range (X_D) is at $52.3-L$. Then we design a survey route deploying the towed fish towed parallel to the shore line at a separation distance S (or at $1.414L$), such that it is satisfied with setting the distance of first bottom return (L) at 20% of the range X_D . Under the condition, the best combination of getting an optimal record is as follows; selected scanned range at 50 m and towed fish surveying at about 12 m from the shore line.

The above case presents about 9 m of the upper slope displayed in the starboard channel. This view is poorer in resolution due to the multipath effect. We can make the nadir increase by deploying the towed fish closer to the shore line. For instance, the fish height may be towed at a minimum of 10% of the range setting without totally losing acoustic returns in the outer range of the record (Fish and Carr 1990). Hence, the slope can be scanned and displayed in the port channel further upslope for another 4–5 m with a surveying track about 7 m away from the shore line. However, there is a greater chance of weak acoustic returns that may come from the lower section of the slope.

If the scanned image can include and identify targets lying on the flat area next to the bottom of the slope, the possibility of the accumulation of debris built up next to the foot of the slope can be investigated. For that purpose, the scanned range can be set at 75 m in the case shown in figure 3, and the ratio is at 12%, which is still acceptable for quality. However, the image may become poor in the area beyond the slope if the towed fish is rotated at respectively large angles. An alternative to inspecting the targets next to the slope is to rotate the towed fish less than the downwards angle of the slope.

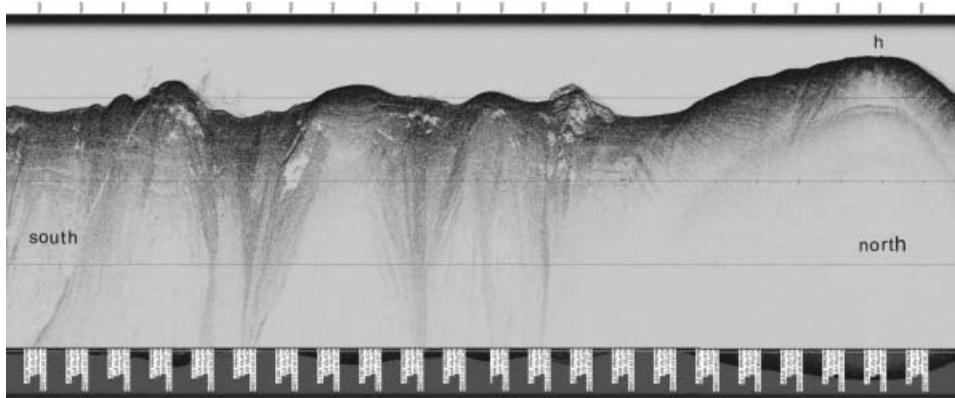
Figure 4. Port channel of the side-scan image to one western bank section of the Wushieh Reservoir, Taiwan. The scanned range is at 50 m, so the slant interval between each pair of scale lines is 12.5 m.

The first attempt was to rotate the towed fish as shown in figure 1 or figure 3. Starting from the first bottom return, we can see a very clear image of the slope of the reservoir on the record. The slope roughness as well as the slope meandering are shown in figure 4. However, the slope image cannot be displayed throughout the whole record on the port channel. This is because the downward angle of the slope in this section is too gentle compared with the 45° rotation of the towed fish.

the south of the section shown in figure 4, the dip of the slope becomes 20° , such that the insonified image on the slope extends wider in the record.

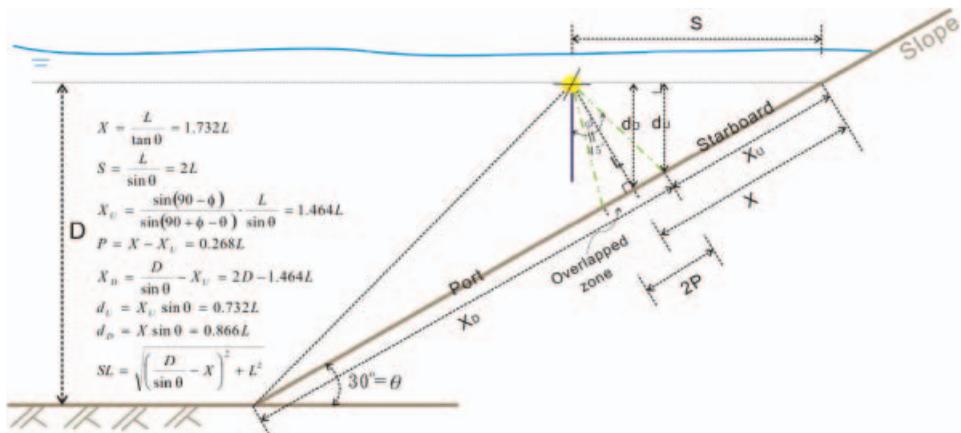
Figure 5. Geometry of the scanned image by a 45° (ϕ) rotated side-scan towed fish. The slope dips at 30° (θ).

Figure 5 shows the geometry of a 30° slope scanned by a 45° rotated towed fish. Some problems were created in terms of the target image that is displayed on the record, compared with that demonstrated in figure 3 of a 45° slope;

- (1) the nadir is not in the nearest point to the towed fish,
- (2) there is an overlap zone from acoustic returns at a distance of P ,
- (3) the point of the maximum of the signal migrates upslope,
- (4) a deeper L or a longer slant range setting (SL or X_D) to totally cover the targets on the slope is required.

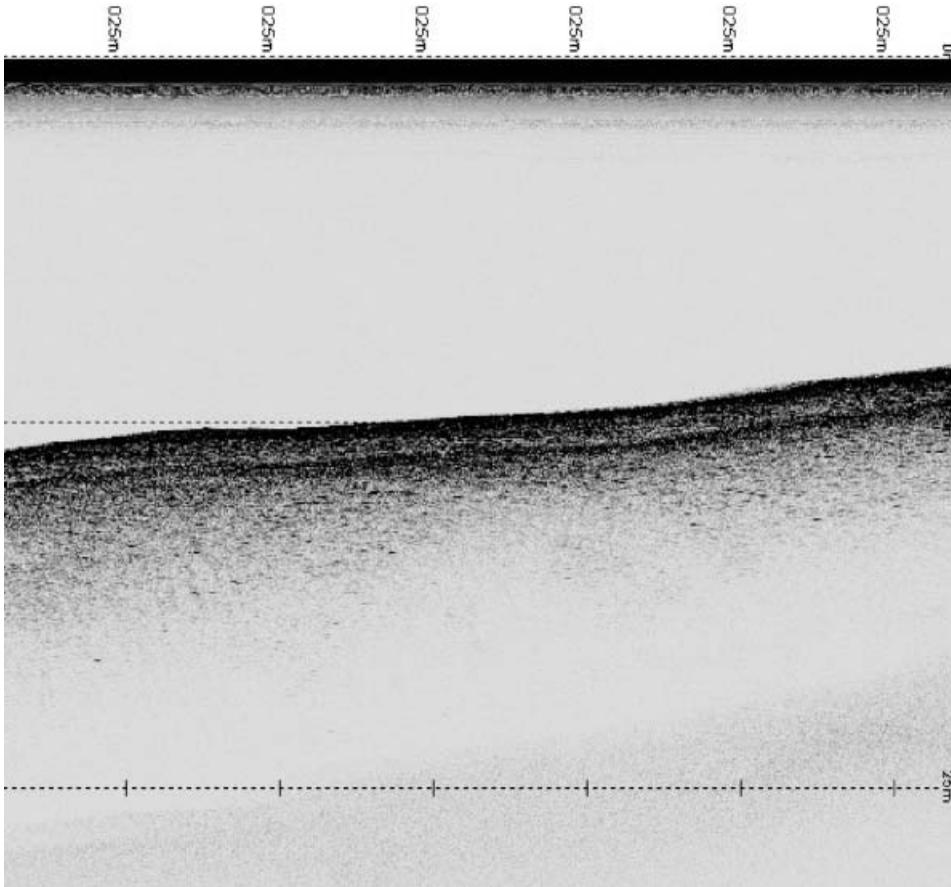
Figure 6. Side-scan image showing the overlapped zone in the area of the first bottom returns.

As a result, the image resolution could be poorer under the situation. The signal will be mixed with noises in the acoustic overlapped zone following the water column return (figure 6), and the signal strength will decay faster in the lower section of the slope if the slope is gentler. However, other than those, a proper increase in the tilted angle of the towed fish related to the dip of the slope, may provide an improved look to the upper section of the slope image.

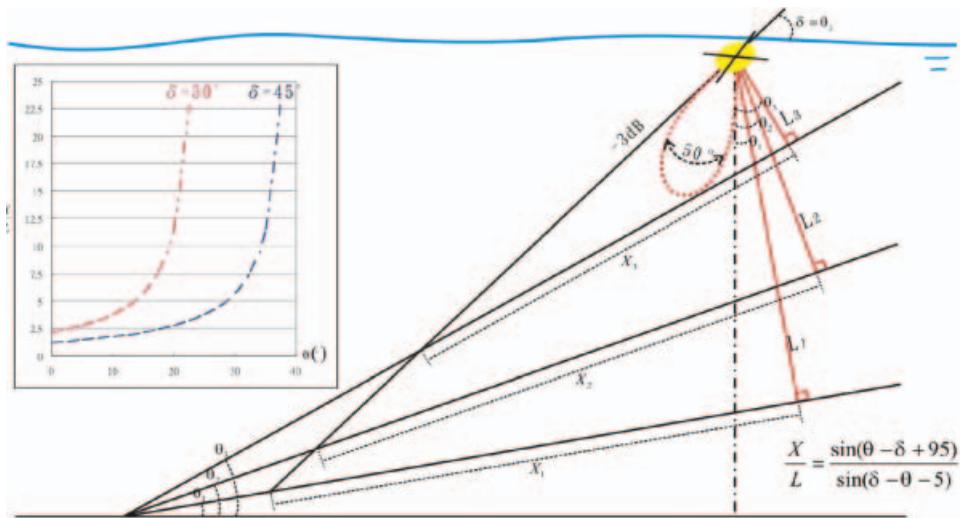
Figure 7. Coverage of the side-scan sonar beam at half power point (-3 dB) on the slope at an angle of θ . Geometry is illustrated when the towed fish is rotated by θ_3 . Three different slopes, $\theta_1, \theta_2, \theta_3$ give different beam insonification coverage at X_1, X_2 , and X_3 , respectively. The inset on the left shows the relationship between the X/L ratio at -3 dB beam width versus slope angles, with the towed fish rotated by 30° and 45° (δ), respectively. L stands for the distance of the first bottom return shown on the record.

Figure 7 demonstrates the insonified spatial relationship of a rotated towed fish sonar beam to the slope in the designed angles. It is assumed that the insonified area of the slope is merely covered by a half power point sonar beam. As a result, the lower portion of the slope will be outside of the insonified area with very weak acoustic return for slope angles less than 28.7° when the towed fish is rotated 45° , or less than 13.7° if the towed fish is rotated by 30° . Under these conditions, the distance of the first bottom return (L) is located at 20% of the slant range setting. As shown in figure 4, the 'h' section poses a narrow insonified region, followed by an acoustic multiple return (a second bounce reflected from the water surface). The dip of the slope in this section is around 12° (Song 2004), giving an insonified distance at $1.85L$ according to figure 7, which matches with the image shown in the record. To

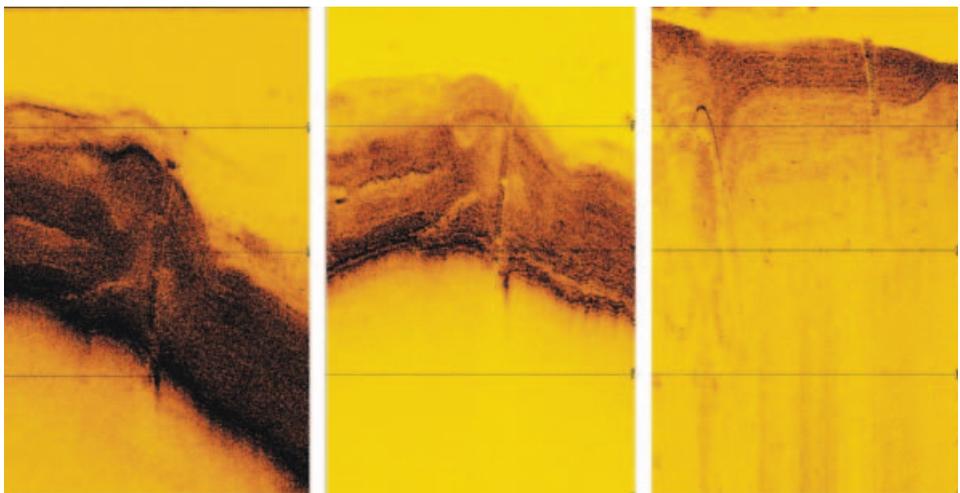
Figure 8. Stair images located downslope of the water bank of the Wushieh Reservoir, Taiwan. From left to right, the towed fish was rotated further upwards related to the bank. The slant range of the images is at 75 m.

Figure 8 gives the side-scan images showing the stair incised on the slope. The one on the left, rotated angle of towed fish was adjusted based on the slope angle. It then displays a stronger energy returns from the slope than the others. However, the image of upper end of the slope became poorest due to the nadir insonification. In

the middle of figure 8, the towed fish was rotated at a slightly larger angle than the desired angle in respect to the slope, giving a nice quality image through the entire stair to the bottom of the reservoir. On the right, using a greater towed fish angle produced an image similar in quality to figure 4. Figure 9 shows the enlarged image to the slope in the vicinity of the stairs using the towed fish rotated at an angle similar to the right of figure 8. In this image, we can clearly identify strand lines shown on the bank. Furthermore, it also exposes the variant upslope gradient following the stairway trend.

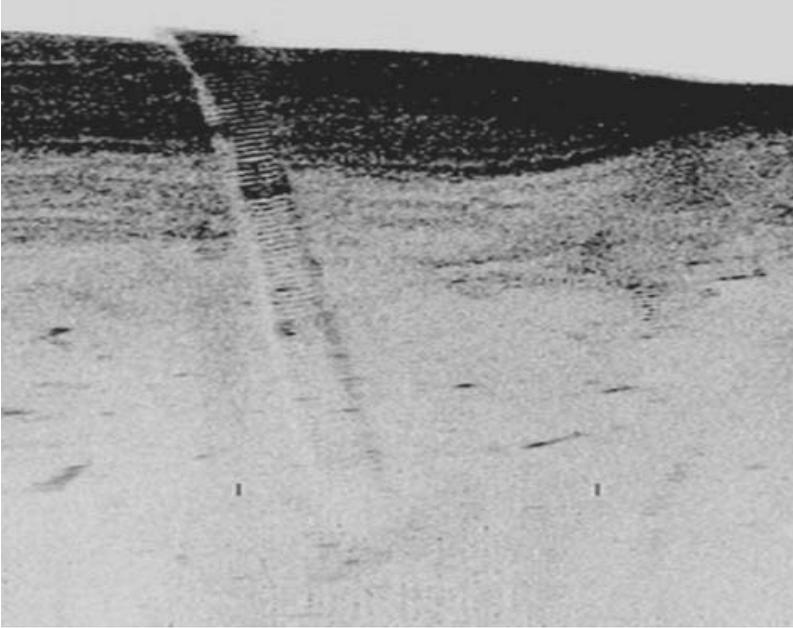
Figure 9. Enlarged image of the stairs to the bank of the Wushieh Reservoir, Taiwan, using a towed fish rotated 30° . The lower portions of the slope, having always been submerged, show no strand line incised by water energy.

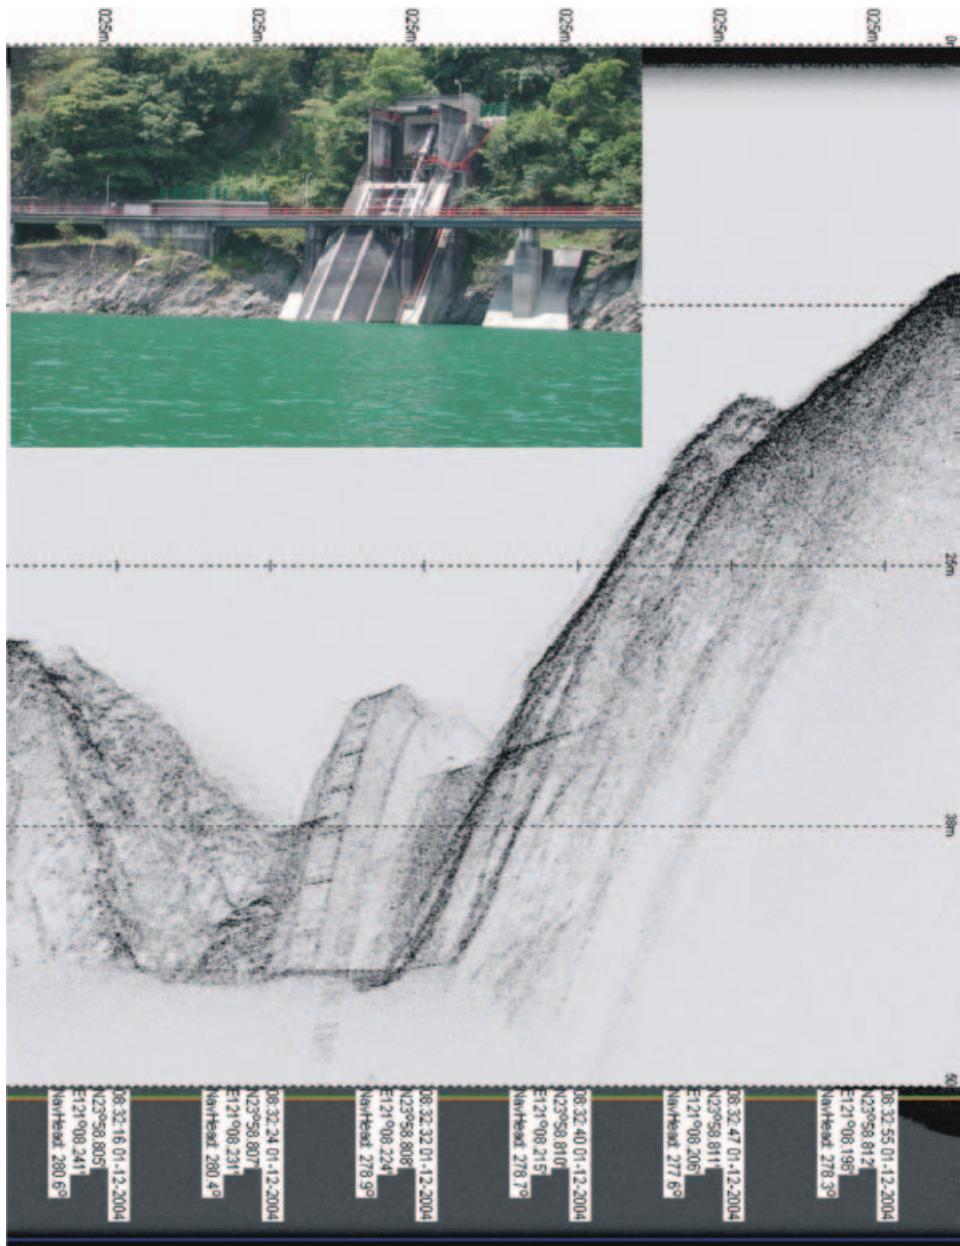
Figure 10. Side-scan image showing the electric power plant water intake in the Wushieh Reservoir, Taiwan, in the water column. A look above the surface refers to the picture on the corner. The slant range of this port channel was set at 50m.

Figure 10 shows the details of the scanned image with the towed fish rotated 45° facing the intake structure into the water at a downwards gradient of about 45° . Although at the front of the towed fish intake was distant at 60% of the range setting from the first bottom return, it provided the exact shape of the structure. However, partially without a slant range correction to the image, we can still observe the structures' appearance with a little distortion, with the intake image in the upper racks being compressed and curved. Furthermore, when we compare the images in its vicinity with those images conducted by rotating the towed fish 30° (figure 11), it looks like those images were taken by observing the bank with two variant inclinations. Lower inclination (more downwards) gave the same effect as from a 30° rotated towed fish. When facing a $30\text{--}40^\circ$ slope, a clear foothill image stood by the steep slopes was shown. Obstacles in front of the bottom racks of the water intake were observed.

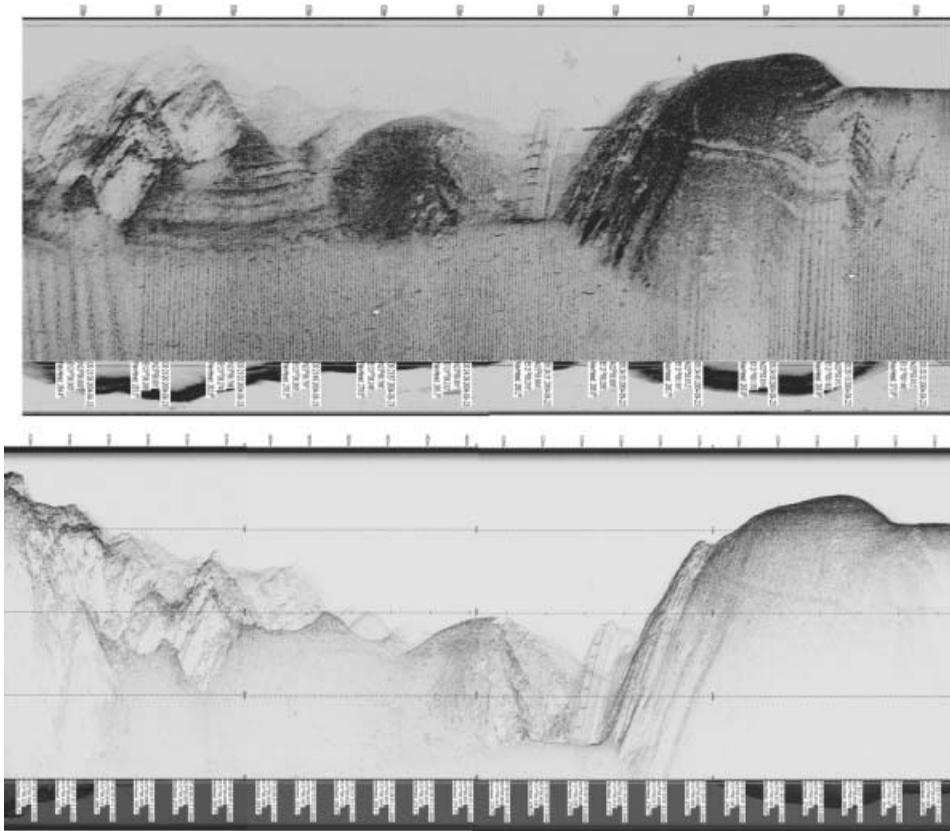
Figure 11. Side-scan images to the slopes of the intake area. (a) Image produced by rotating the towed fish 30° with a slant range at 75 m. A clear strand line shown on the slope indicates the elevation at 979 m (Song 2004). Down across the foot of the slope, the flat bottom is at 960 m. (b) Image produced by rotating the towed fish 45° with a slant range set at 50 m, giving a null signal return to the bottom portion of the slope.

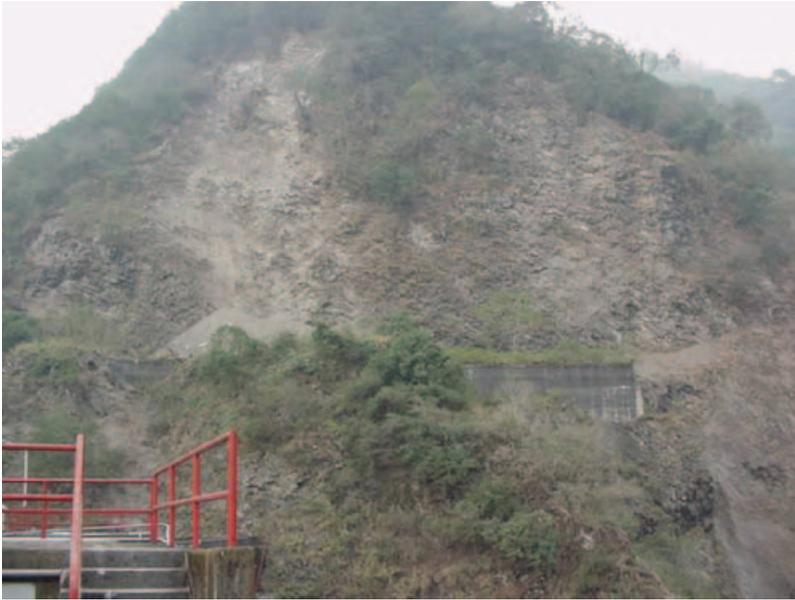
Figure 12. Picture showing the local slumping occurring on the wall off the slope in the Wushieh Reservoir, Taiwan, from the 921 Chi-Chi Earthquakes.

After the 921 Chi-Chi Earthquake, the bank of the Wushieh Reservoir suffered a landslide (figure 12), such that the possibility of debris accumulation along the steep under-water slopes could not be precluded. By rotating the towed fish to view the foothill territory of the reservoir under water, the location of the landslide denoted

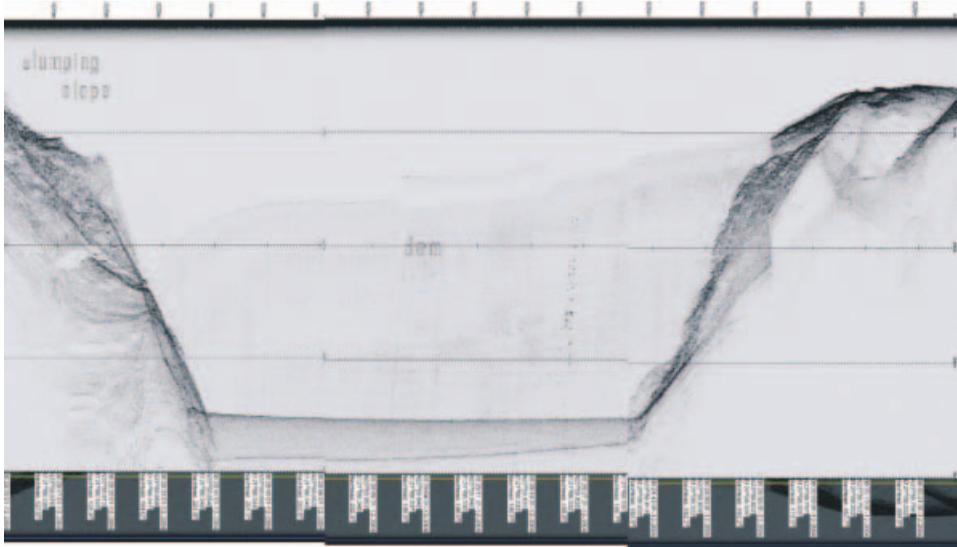
Figure 13. Side-scan image view of the slope foot at the slumping area. The location was close to the end of the Wushieh Reservoir dam, Taiwan. It is on the left hand side of the figure. It is clear that the bottom of the slope is clean without any accumulation debris.

in figure 12 showed that almost no debris is accumulated beneath the water surface (figure 13). Even more, those steep slopes surrounding the water of the Wushieh Reservoir were checked accordingly (Song 2004). The wall beneath the strand line of the slope has been submerged in the water since the power plant was built. Except for one place this investigation indicated that the slope had been firm without sub-aqueous slumping, as shown in figure 14.

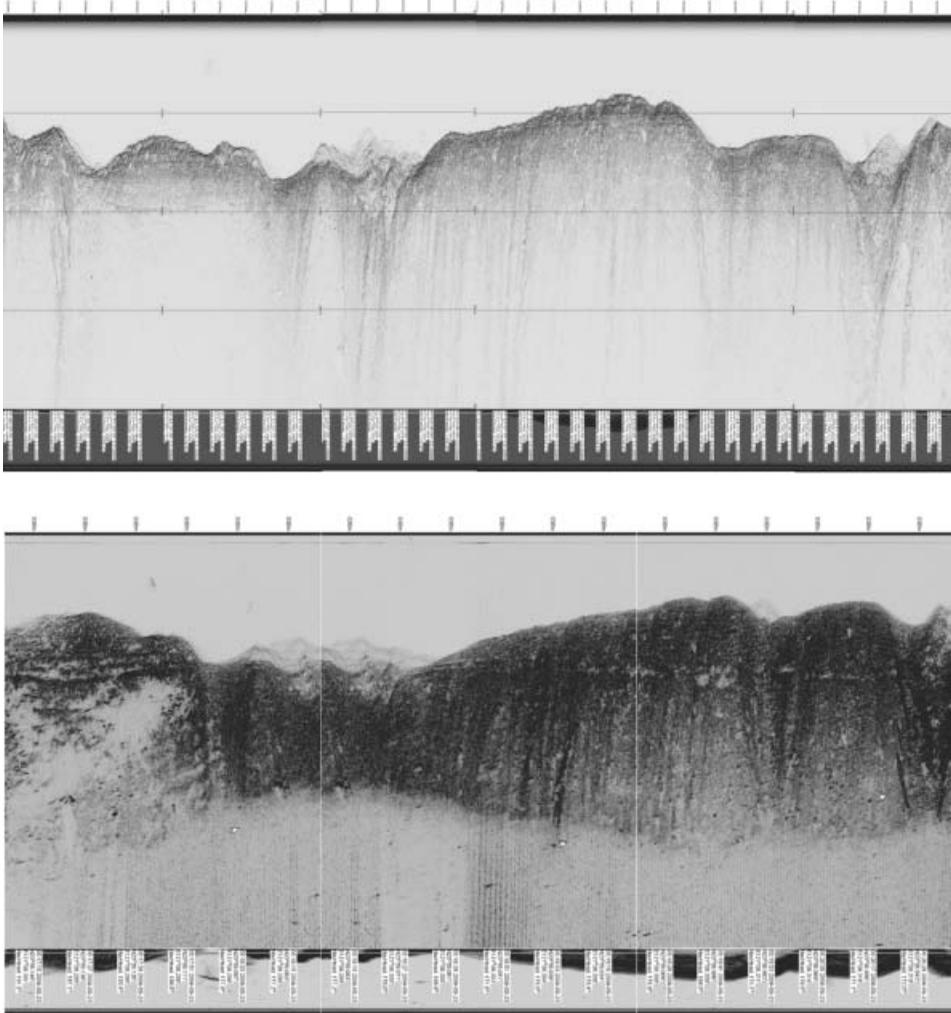
Figure 14. Side-scan images to the 30° slopes of the reservoir. (a) Image produced by rotating the towed fish 45° with a slant range at 50 m. (b) Image produced by rotating the towed fish 30° with a slant range setting at 75 m.

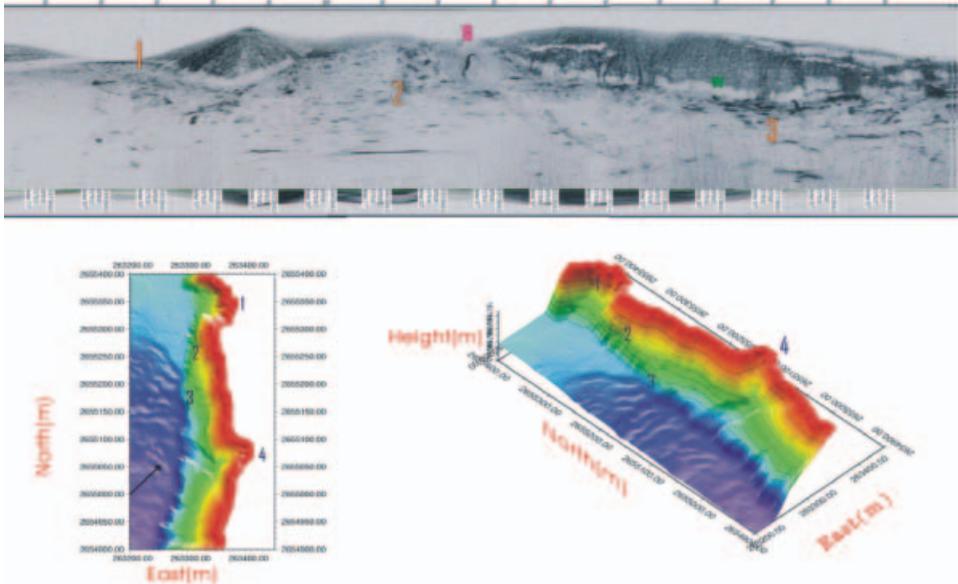
Figure 15. Subaqueous landslide, marked by 'S', shown in the port channel of the side-scan image at location 2. The lower two diagrams show multibeam underwater topography, with a 3-dimensional plot on the right-hand side. The respective locations are marked on the diagrams.

Figure 15 shows the sole slump location found across the strand line of the slope. Observing the underwater topography measured by the multi-beam echo-sounder, the location around the edge of the deposit fan in the reservoir is indicated (Song 2004). The sediments once crossing the edge creep down following the slope of the fan, as shown in the 3-dimensional diagram. However, in figure 15, the side-scan image presented evidence that some deposits were carried into the reservoir by landslides from the slopes in this location. In position 2, the bank was covered by slump debris. Debris was transported outwards from the foothill side of the bank, with coarser grains left behind in position 3. On the slope where the wall was not covered by the slump material there is a steeper gradient at the foot of the slope, delivering an acoustic shadow in the region (the white band in between the slope and the flat bottom).

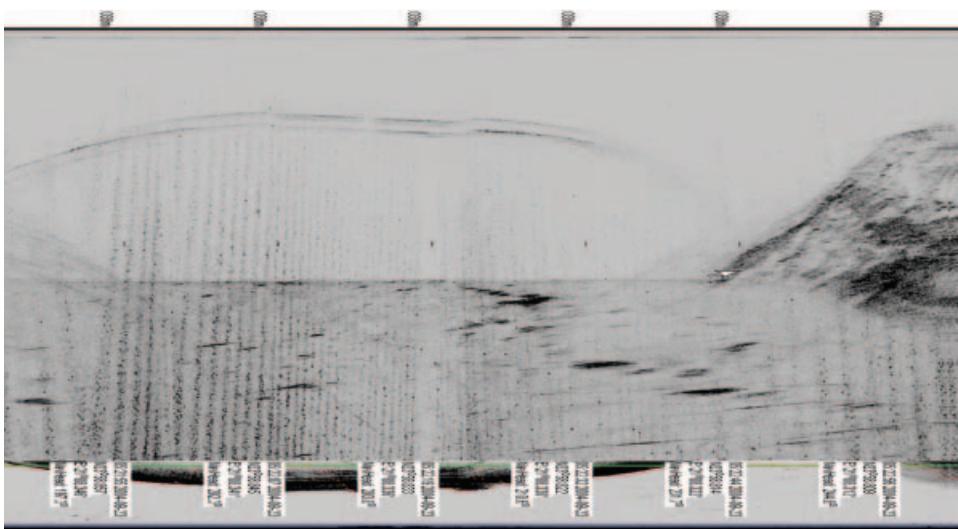
Figure 16. Bottom view of the reservoir in front of the dam in which lots of strong acoustic returns were shown to be fragments of wood lying on the clayey bottom.

Using a towed fish rotation, side-scan images can display some details even to the flat bottom next to the steep slope beneath the water mass. Figure 16 shows many linear acoustic signals spreading over the bottom area. The evidence taken from the video by a towed underwater camera in that area indicated that they were fragments

of wood carried by river flow from the catchments during the flood caused by stormy weather (Song 2004). Debris was found dropping into the deep with the silt resting at the bottom (figure 17). Figure 16 indicates that debris was abundant all over the places where the suspension load was dominant (Song 2002, 2004).

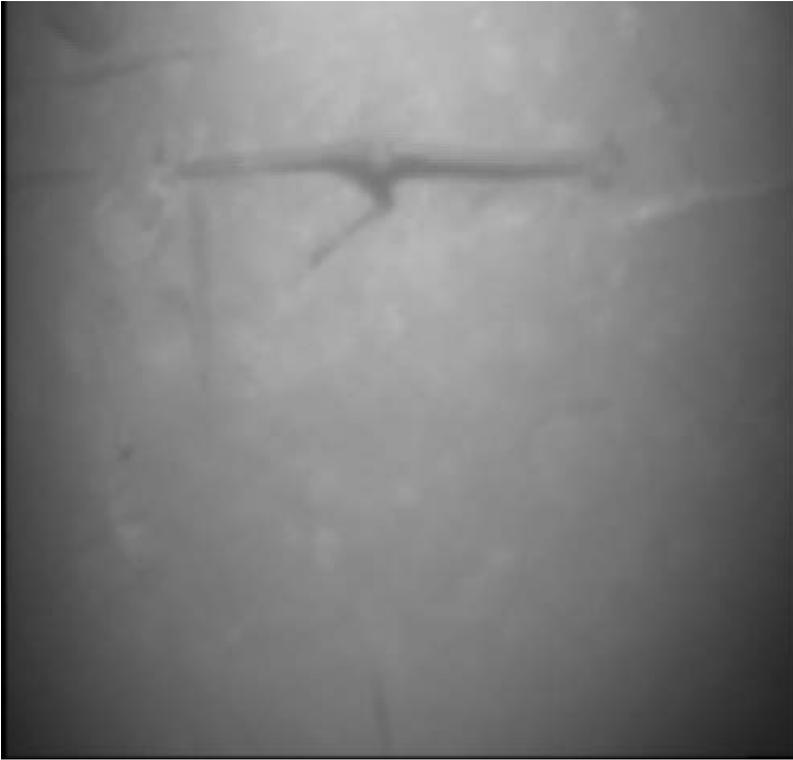
Figure 17. Underwater picture taken from the video showing the bottom view in the front of the water intake of the Wanda Hydroelectric Power Plant, Taiwan.
