行政院國家科學委員會專題研究計畫成果報告

新竹科學園區活動斷層地震地質學研究

計畫編號： NSC91-2119-M002-010

執行單位：國立台灣大學地質學系
中華民國九十二年三月

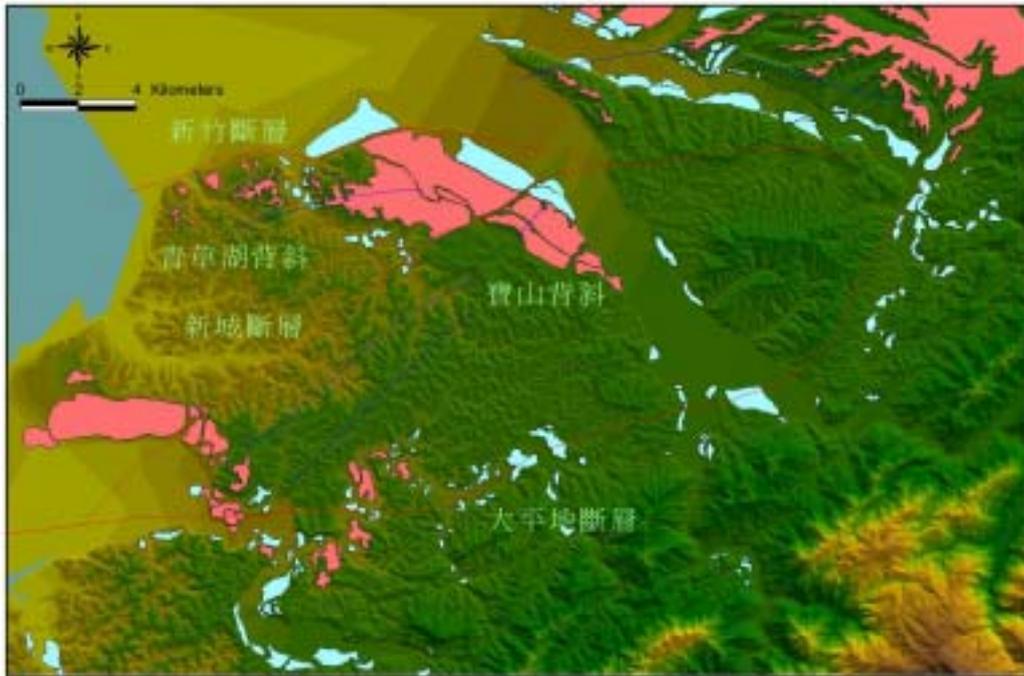
圖一、新竹地區構造線位置圖與河階地形。

新竹地區的地質構造區屬於西部麓山帶，斷層-褶皺構造一直延伸至新竹外海地區。此地區西部麓山帶的構造系統大致可以分為兩區為，內麓山帶與外麓山帶兩個斷層-褶皺構造帶。兩個斷層-褶皺構造帶的分界大致以大平地斷層來劃分，以東為內麓山帶，以西為外麓山帶。內麓山帶的地層主要為中新世岩層，此區域的構造皆屬於緊密的褶皺構造並伴隨逆衝斷層，斷層的活動性雖無確切的資料，但以 1935 年的中部大地震造成紙湖斷層的地表破裂，顯示此區域的構造可能都還屬於活動的構造。外麓山帶位於大平地斷層以西區域，岩層都較內麓山帶的岩層年輕都屬於上-更新世岩層。此區域的褶皺構造都屬於開放式型態，構造特性屬於斷層展延褶皺帶（fault-propagation fold），是由逆衝斷層構造在上盤形成的背斜構造，新竹科學園區就位於外麓山帶的構造區中。此地區的主要構造由西北向東南計有湖口斷層、新竹斷層、新城斷層、竹東斷層與大平地斷層（圖一）。褶皺構造計有青草湖背斜位於新竹斷層的上盤，寶山背斜位於新城斷層的上盤

三、地形 (圖一)

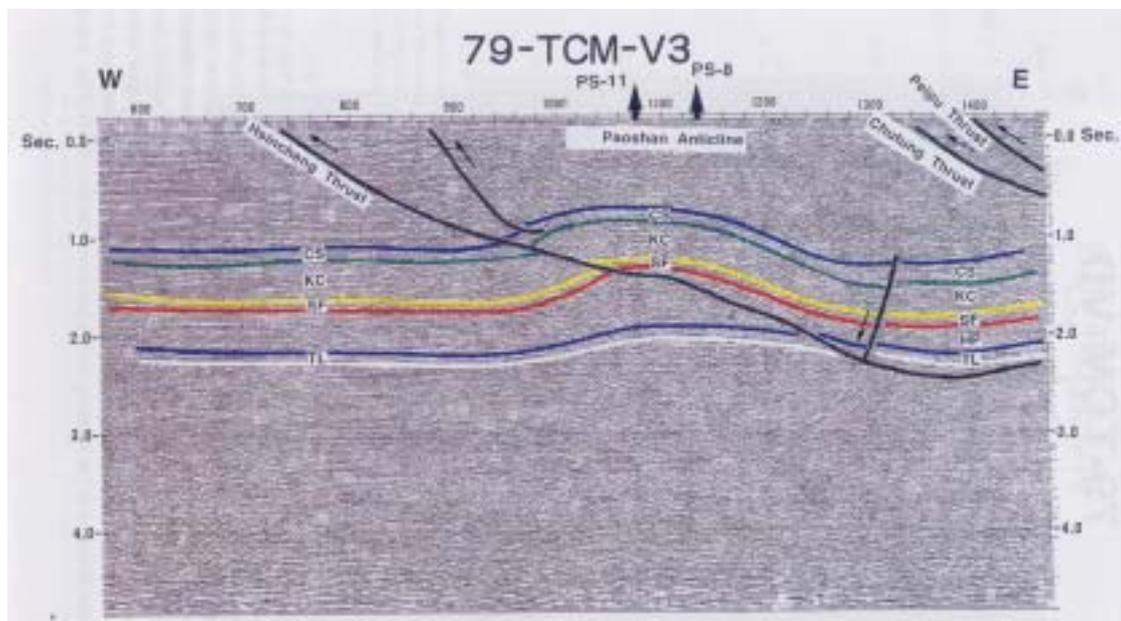
圖二、新城斷層與寶山背斜反射震測圖

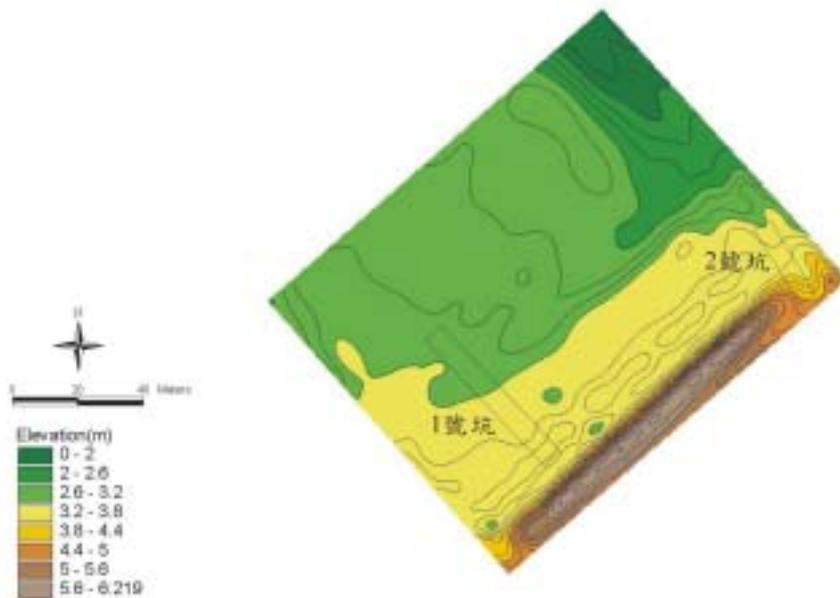
圖三 篤行營區槽溝位置地形圖。

現今斷層出露地表位置的地形呈現平坦的地形面，地形隆起的崖面位在上盤處，距離斷層的位置約 30m。從槽溝剖面中地表的人工回填土來看，顯示地表已遭受修整破壞，原來斷層所形成的崖坡已經被破壞，所以在斷層出露地表的位置未能呈現斷層崖的地形特徵。新竹科學園區管理處於篤行營區內為工程需要進行鑽探調查，本研究建議重新調整其中數個鑽探孔位位置以利勘查斷層位置。因此槽溝開挖之前主要是以鑽探岩心資料來判斷斷層大致的位置。篤行營區 1 號槽溝的開挖位置就是依據鑽探岩心資料來判斷斷層的位置。從鑽探的岩心資料可以明確了解斷層兩側岩盤的關係，以及斷層大致位置 (圖四)。圖四是鑽探的位置以

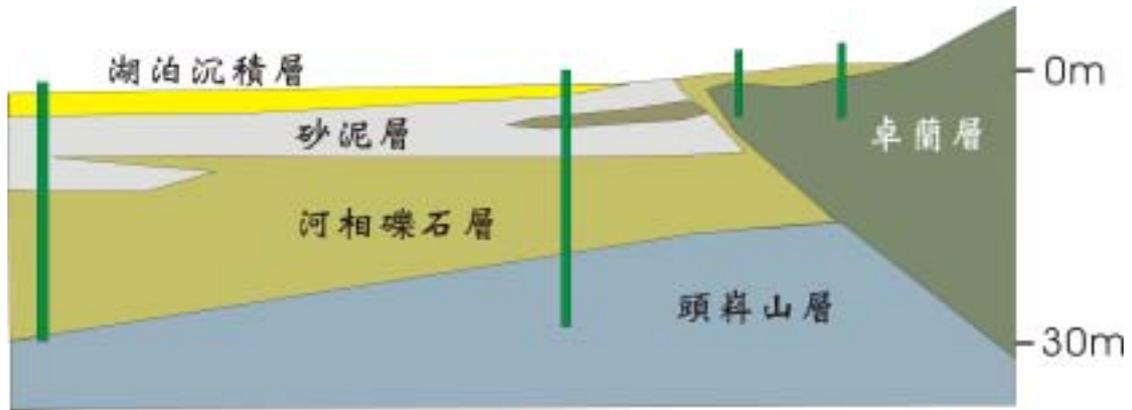
圖四、一號槽溝地下剖面圖。

及各岩心的大致岩性，以及配合槽溝開挖結果繪制的地下剖面圖。

本槽溝中切穿卓蘭層基盤(M1)及其上部河道礫石層(G2)逆衝斷層, 走向 N88°E, 傾角 29°, 藉由槽溝開挖前之鑽井得知的岩盤深度為 18m, 該逆衝斷層兩側基盤落差達 15m。位於上盤的 G3 礫石層被拖迤至斷層帶之中。主斷層之上的上盤岩盤中亦有一位移量較小的斷層, 該斷層截切覆蓋在上盤的 G3 礫石層。

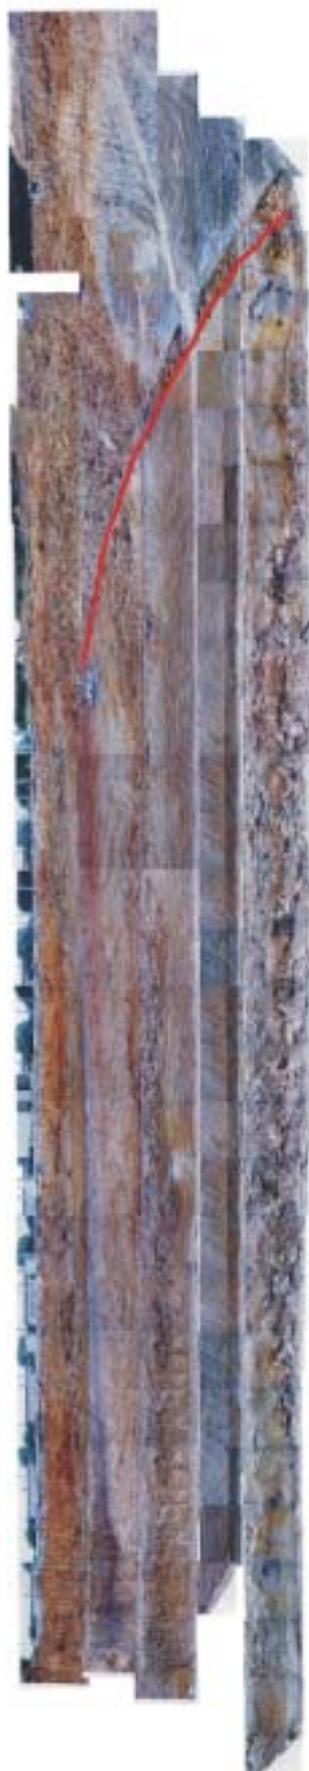
圖五 1號槽溝北牆照片

- (1) 地表回填土 (B1)：最厚達 1.4m，包含人為擾動的紅壤層、混凝土塊等人工建物，底部為整地造成的不連續面，人為的擾動面之下即屬於自然的沉積層。回填土中埋有 1983 年 12 月 25 日製作的鋁箔包，因此推測回填土應於其之後的填方，可能於 1984 年整地時的回填土方。
- (2) 黑色有機土壤層 (O1)：層厚 30-40cm，黑褐色有機質土壤，原為溼地或湖相沉積物，有機質為植物所產生的腐植質，基質為粉砂至泥質。黑色土壤層之下為黃色砂層，厚度約 20-30cm，底部亦為灰黑色泥層。砂層的淘選度非常良好，可能屬於河流搬運至湖泊的沉積層。砂層與泥層呈現液化現象，砂層具有火焰狀與荷重構造，顯示產生液化現象。此湖泊沉積層經由碳 14 的定年表示沉積年代為小於 300 年，屬於近代沉積物。
- (3) 磚紅壤層 1 (L1)：基質為細砂至粉砂質，最大厚度 2m，由上而下顏色逐漸變淡，呈橘色。此磚紅壤層應屬於紅土台地最表層的土壤層。
- (4) 褐色風化砂層 (S1)：層厚大致均維持在 1.5m 左右，細砂至粉砂質，含有風化作用產生的淡灰色細斑。
- (5) 礫石層 (G1)：粒徑 20cm 以下的變質砂岩礫石所組成，細砂質基質支持，部分呈透鏡狀構造。
- (6) 褐色風化砂層 (S2)：厚 3.5m，粉砂質，含有風化作用產生的細斑紋。此砂層經碳 14 定年結果表示年代老於 5 萬年。

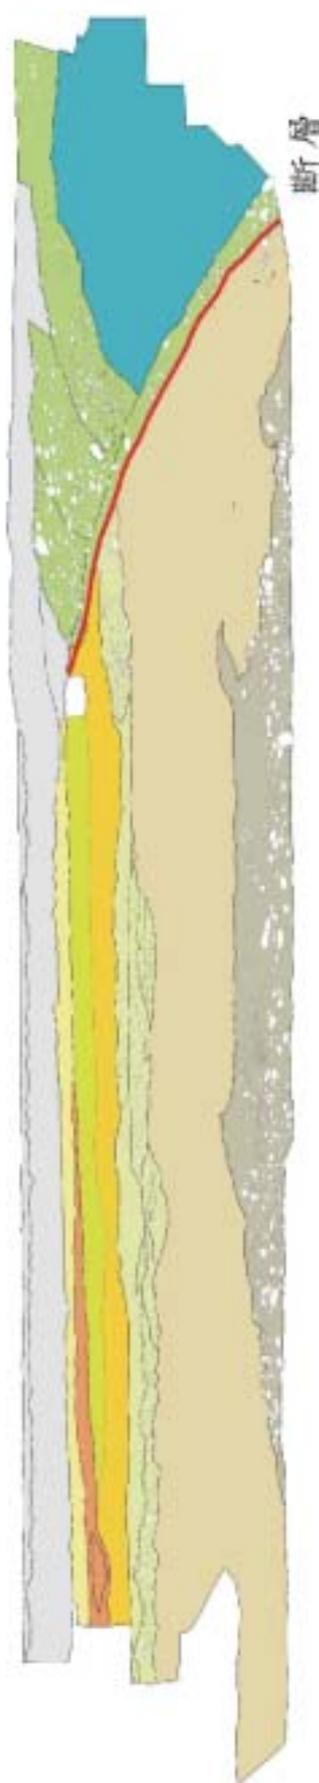
圖六 1號槽溝北牆剖面圖

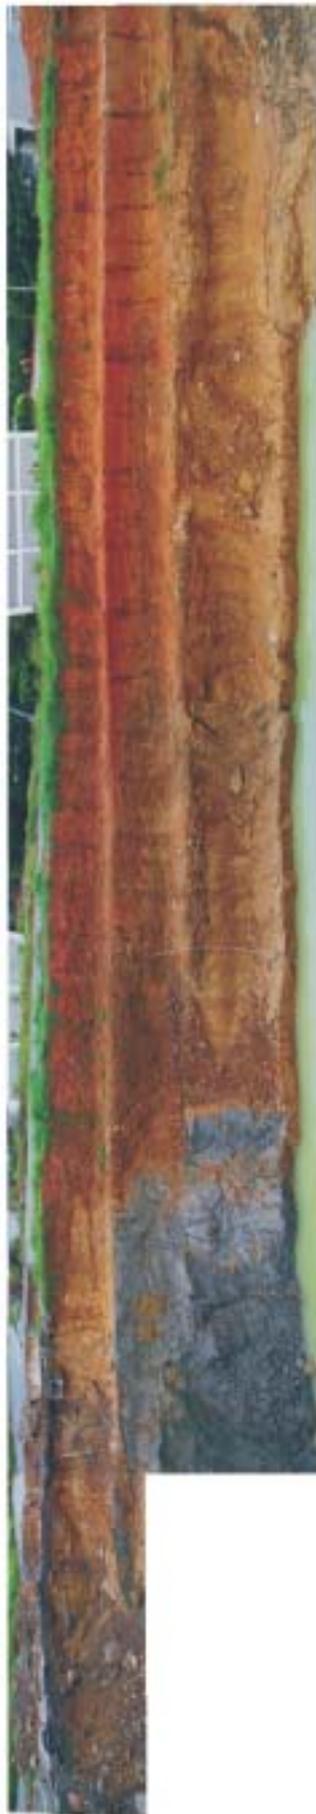
圖七 1號槽溝南牆照片

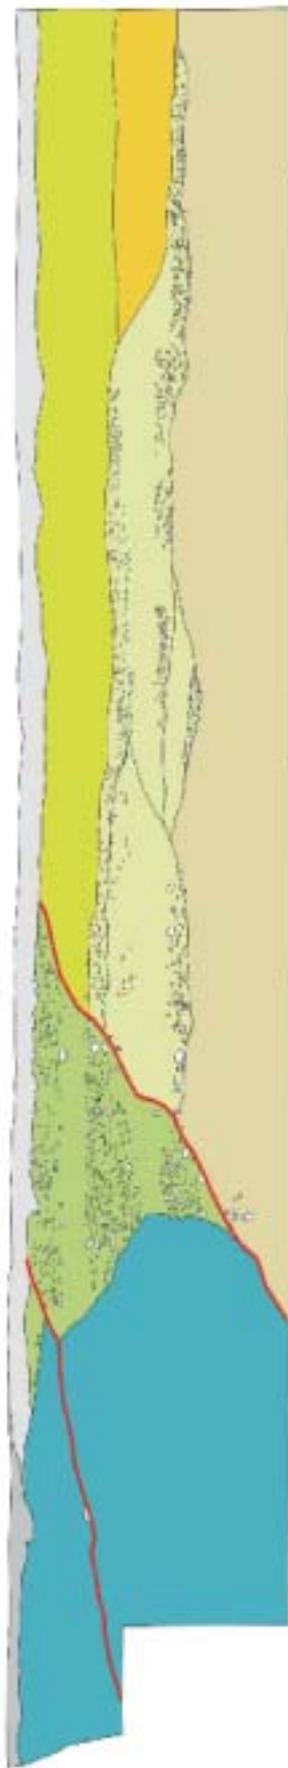
圖八 1號槽溝南牆剖面圖

1 號槽溝剖面的南牆除了主斷層之外，還存在一次要斷層，次斷層位於主斷層的上盤，此斷層截切 G3 礫石層。但是因 G3 礫石層沒有發現可定年的材料，因此無法判斷斷層的活動時間。

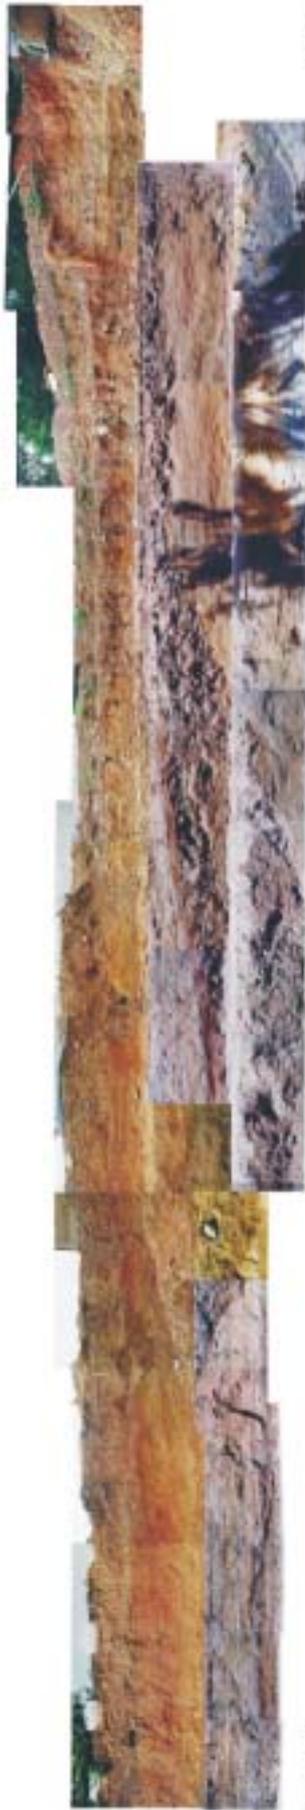
圖九 2號槽溝北牆照片

- (1) 地表回填土(B1): 層厚 1-2m 不等, 含有混凝土塊及塑膠、紅磚等雜質, 礫石受挖掘所擾動破損且排列十分紊亂, 表面為柏油路面與地基, 下部夾雜水管與鋼條, 地表成一緩坡, 傾斜約 8°。
- (2) 磚紅壤層(L1): 平均約厚 1.5m, 深赭色紅土, 基質為細砂到粉砂質, 風化程度高, 黏聚性強, 硬化程度相當高, 可見長期暴露於地表, 顏色向下漸變為黃棕色, 下部與 Ys1 黃棕色土層相接。
- (3) 黃棕色風化土層(Ys1): 與 L1 相接, 均為同一時期沉積的產物, 呈現黃至棕色, 且風化程度較 L1 小, 厚約 30cm-50cm。
- (4) 磚紅壤層(L2): 厚度 15-20cm, 與 L1 相同, 粒度、質地亦相同, 位在 Ys1 之下。
- (5) 灰色黏土層(C1): 平均厚度約 15cm, 為位於 L1 之下, 高粘聚性土層, 基質呈粉砂至泥質。
- (6) 黃褐色砂層(Bs1): 位於 C1 與 C2 土層間, 呈現黃褐色至暗褐色。

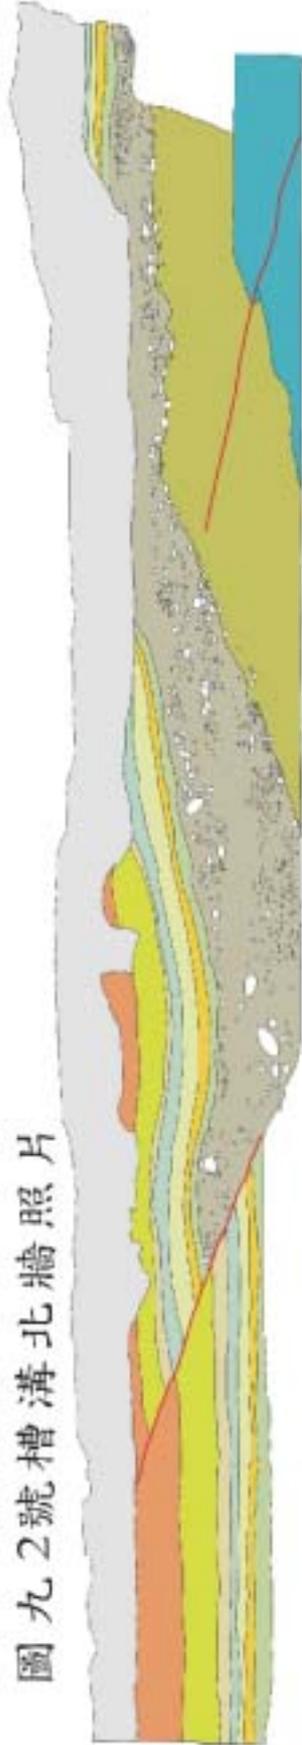
圖十 2號槽溝北牆剖面圖

本槽溝中發現有兩組逆衝斷層的剪切帶，其一切穿青灰色泥質岩盤，斷層面延續至礫石與砂層之不整合面為止，於槽溝底部可以發現切穿卓蘭層，滑移量約 6cm，傾角 15°。另一主要斷層切穿紅土及下部黏土層，傾角 25°，走向 N55°E，斷面延伸至距地表 1m 深被回填土所覆蓋。此斷層為本槽溝剖面最主要的斷層。斷層截切剖面中最上部的地層，從地層對比來看其滑移量約 3m，上下盤岩層垂直落差約 1.3m。從地層的位移量以及表層的地層被錯移現象來看，此斷層作用應屬於較後期的事件所造成。

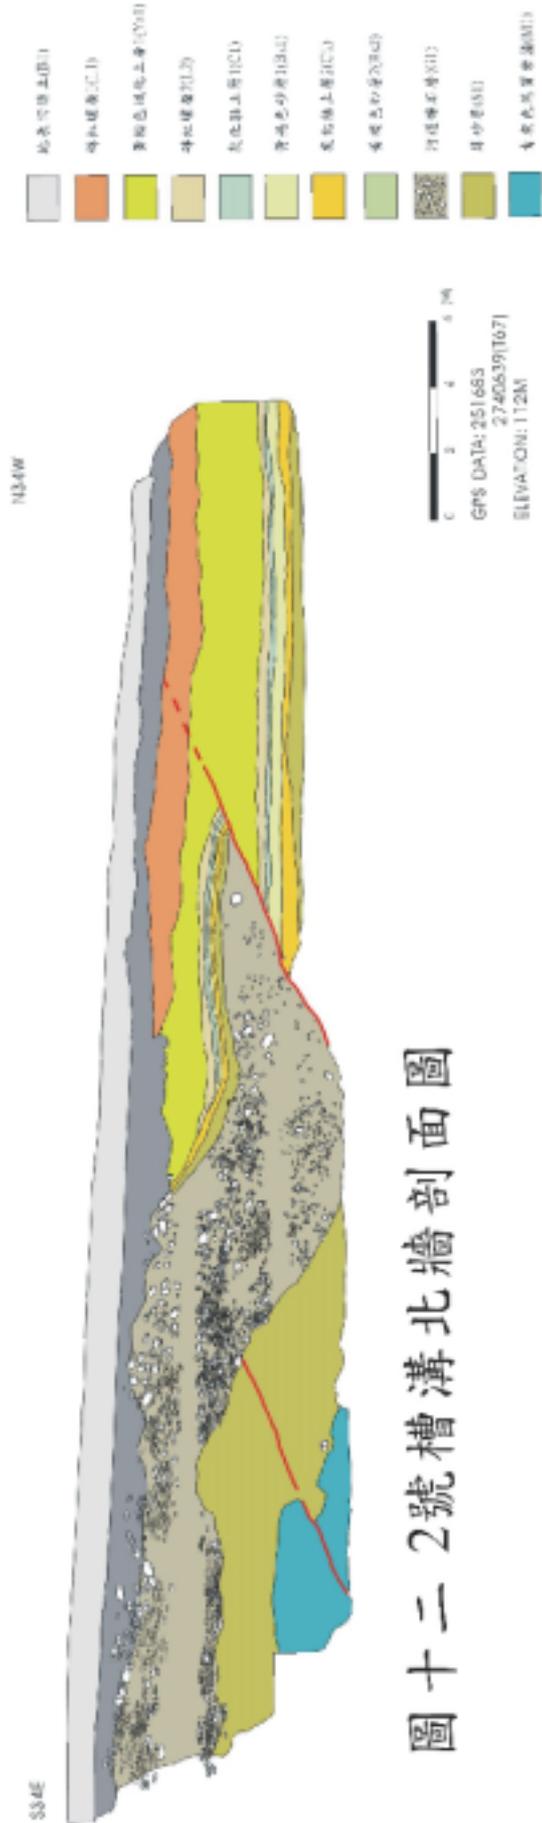
圖十二 2號槽溝北牆剖面圖

2 號槽溝位在 1 號槽溝的北側，槽溝所在地形位在斜坡之上，此處地形較沒有經過太大的人為修整。2 號槽溝中的主要斷層切穿地表的紅土層，顯示紅土層形成的後期有受到新城斷層的擾動。紅土層之下具有數層連續性良好的薄層砂泥層 (Ys1, L2, C1, Bs1, C2, Bs2)，這些砂泥層沉積在主斷層的上下盤。因此，可以明顯的判斷斷層的錯移量，滑移量約 3m，上下盤岩層垂直落差約 1.3m。

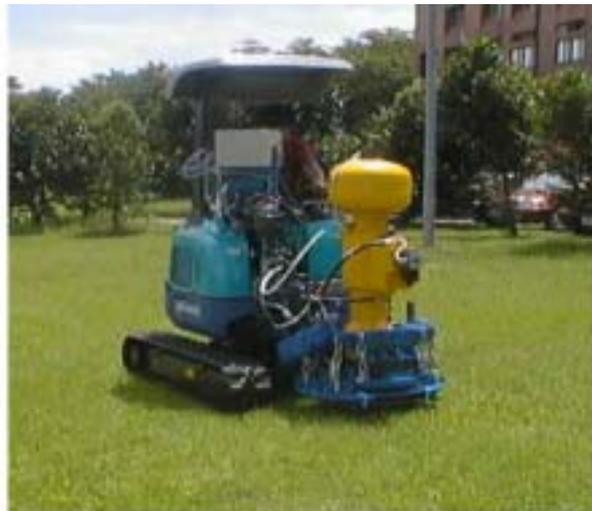
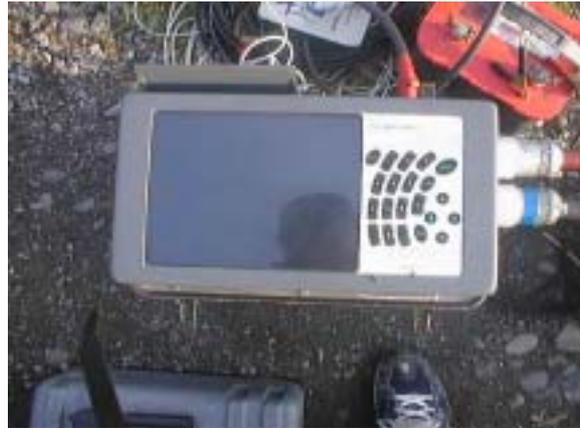
圖1、本計畫使用之震測設備：(a) JMS Mini65迷你機械式撞擊震源；(b)受波器；
(c) Geometrics StrataVisor NX 48波道震測儀。

反射震測法能夠探測的深度與震源能量息息相關，本計畫使用 2000 焦耳之高能迷你機械式撞擊震源(JMS Mini65)產生震波，並利用 3 個一組之高精度之垂直受波器陣列來接收信號，蒐集到之信號則記錄於 24 位元之 48 波道震測儀(Geometrics StrataVisor NX)。圖 1a,b,c 分別為本次研究所使用之震測設備。

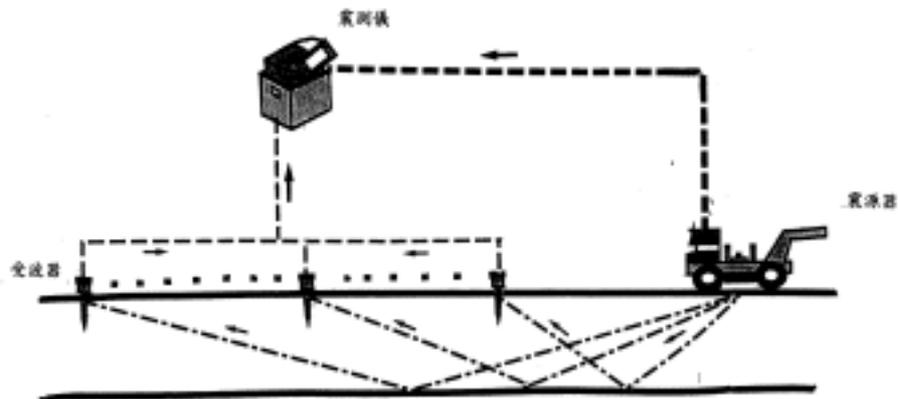
圖 2、震測作業之資料傳輸

圖 2 為震測作業時資料的傳輸流程，圖中右下方的儀器為震源產生器，震測系統由此啟動。震源產生器一方面將震源信號傳輸至地下，另一方面同時啟動圖

中左上方的震測儀。震測儀經啟動後將會記錄到位於圖 2 左下方之受波器所接收到的地動信號。

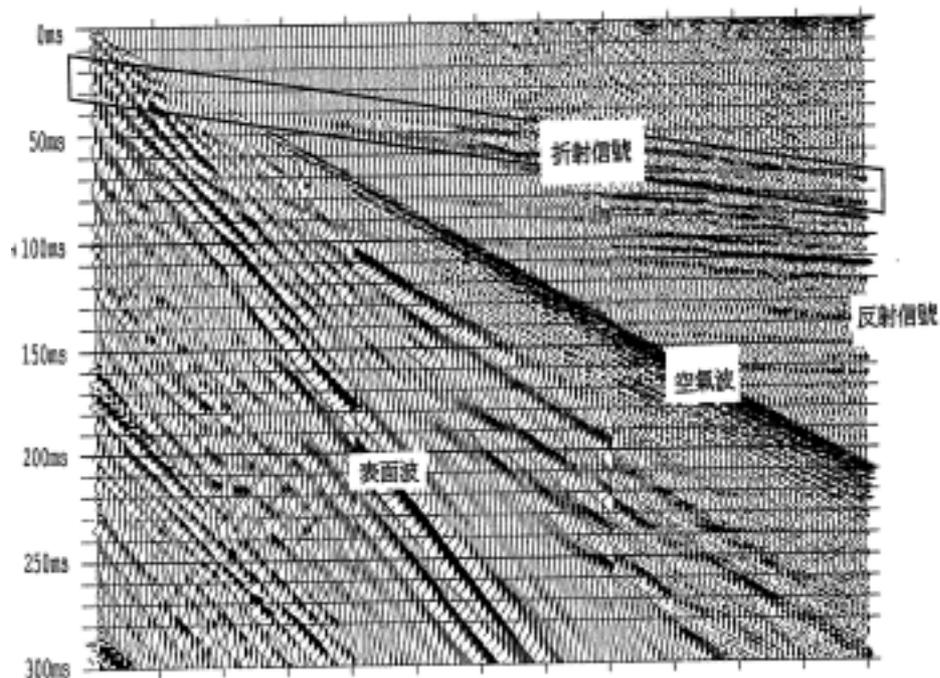
圖 3、野外作業時所記錄到的信號。

圖 3 為利用撞擊式震源器於野外作業時所記錄到的信號，該記錄共 0.3 秒。圖中可以見到包括折射、反射、空氣波與表面波等信號。反射震測所需要的信號僅有反射波，其餘雜訊皆是野外作業與室內資料處理時須壓抑的對象。淺層反射震測最主要的雜訊為地滾波，在 P 波反射記錄中最主要之地滾波為表面波（雷利波），具有波速慢、振幅大、頻率低且頻散等特性。因為 P 波波速較雷利波快許多，所以淺層地層的反射雖然歷經雙程走時，反射訊號仍較地滾波早到。為了提高反射訊號的有效視窗，P 波反射施測時宜將測線之展距距增長，以拉開反射波與地面波之時距，並且利用受波器陣列來壓抑表面波。

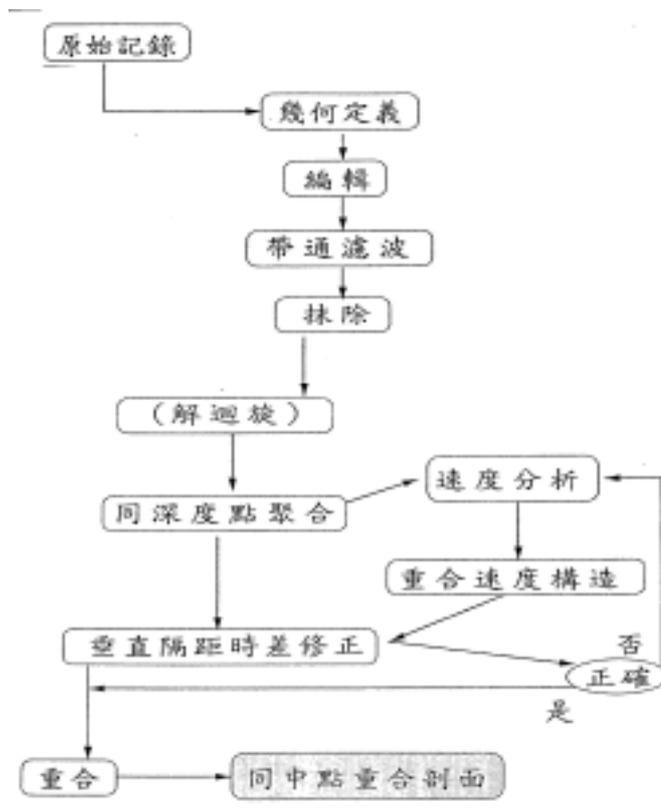
圖 4、反射震測資料處理流程。

本研究之震測資料將以同中點重合方式處理，圖 4 為震測資料的處理流程。本次研究之資料處理於 SUN 與 PC LINUX 工作站上執行，資料處理軟體為紐西蘭地質與核能研究所開發，與油工業資料處理軟體同等級的資料處理軟體 GLOBE Claritas。

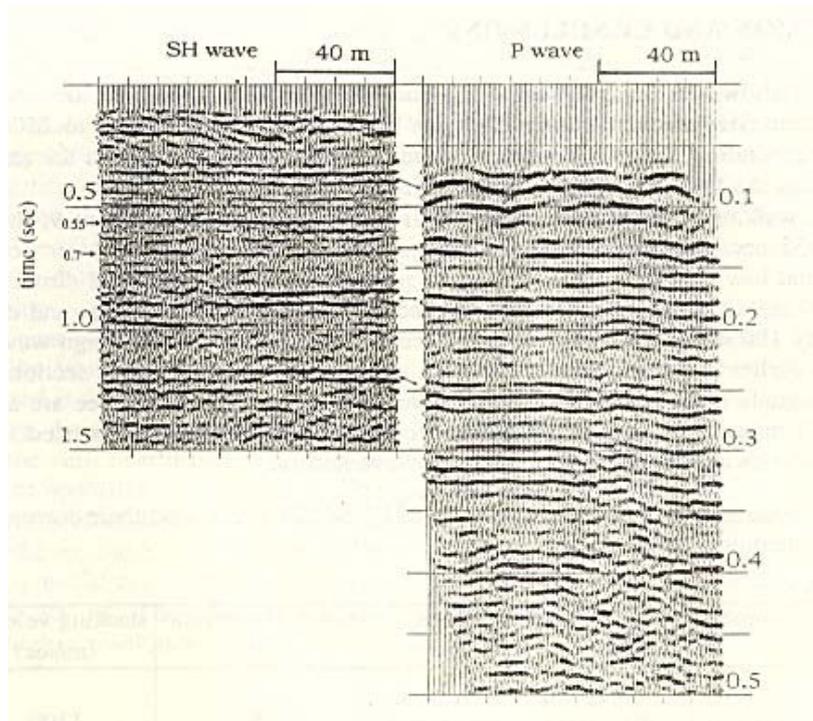
圖5、SH波剖面與P波剖面之比較。

長比取值(15%)而被切掉，而無法解析近地表的反射，範圍的深淺會依測線不同的布置而改變。為了獲得進地表處的地層資訊，除了提高震源的頻率外，採用波速較慢的 SH 波反射也是一種非常有效的方法。圖 5 為 P 波反射與 SH 反射重合剖面的比較，圖左為 SH 波，圖右為 P 波，兩者依一致的比例繪製。由圖 5 中可以看出，P 波剖面能夠穿透較深的深度，但是 SH 波能解析的較淺部的地層。

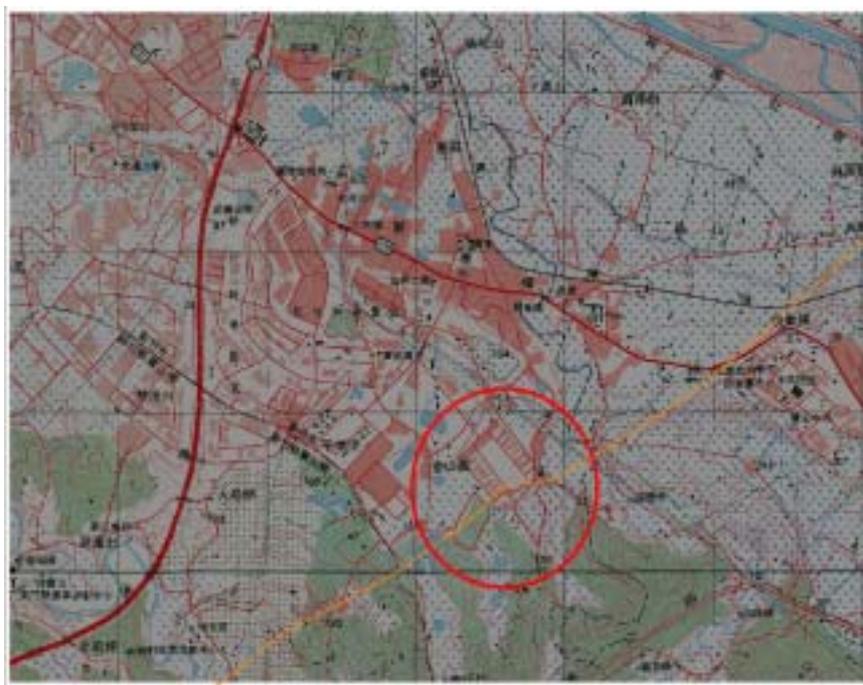
圖 6、本次研究之測區位置以及經濟部中央地質調查所公佈之新城斷層位置圖。

圖中圓圈範圍為測區而橘黃色線代表新城斷層。

圖 6 為本次研究之測區位置以及經濟部經央地質調查所公佈之新城斷層位置圖。圖中圓圈為測區範圍而橘黃色線代表新城斷層。圖 7 為本次研究測區內的測線配置，包括 3 條 P 波與 2 條 SH 波淺層震測線，以西北-東南走向配置，跨越圖 6 中之斷層線。

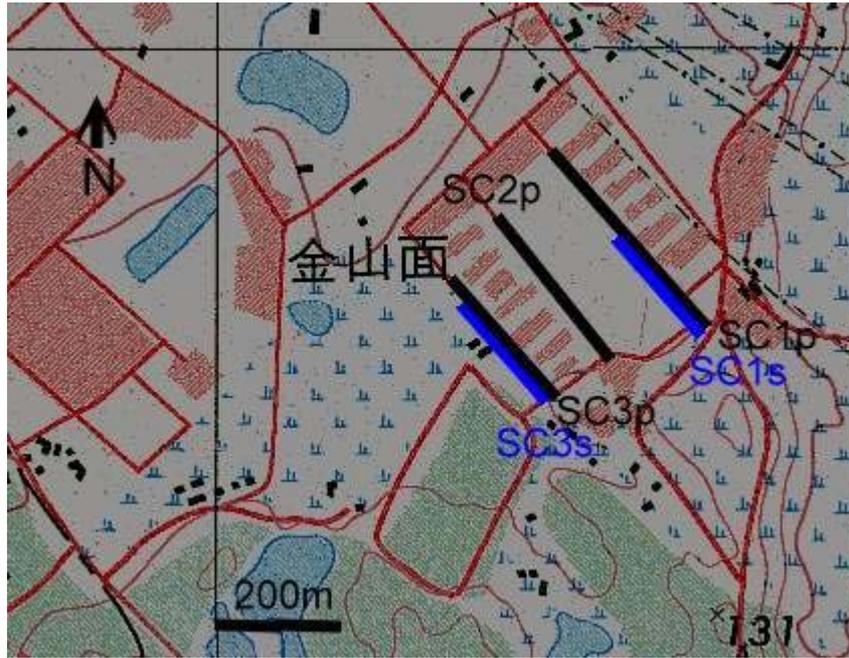
圖7、本次研究測區內的測線配置，測線以西北-東南走向配置，跨越圖6中之斷層線，包括3條P震測測線與2條SH波測線。

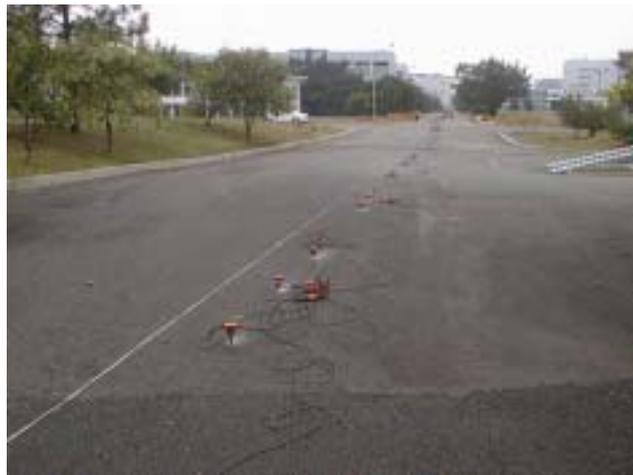
圖8、本次研究之測區中震測測線沿線之地形地貌。

圖 8 為本次研究測區內震測測線沿線之地形地貌。測區中地勢平坦，測線佈於柏油路上，圖中所示之受波器組為測量時之受波器配置方式。圖 9a 為測區中之兩個代表性 P 波測點紀錄，信號品質極佳；而圖 9b 則為測區中之兩個代表性 SH 波測點紀錄，信號品質不若 P 波優異，但仍可見到清楚之反射信號。

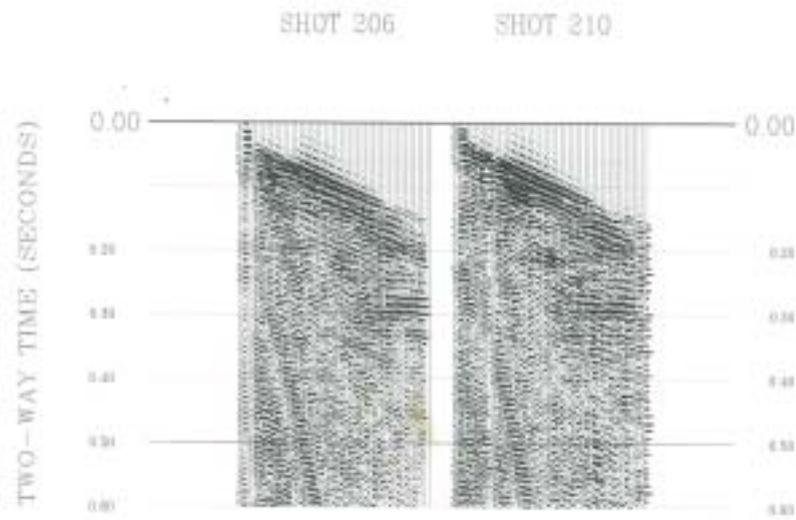
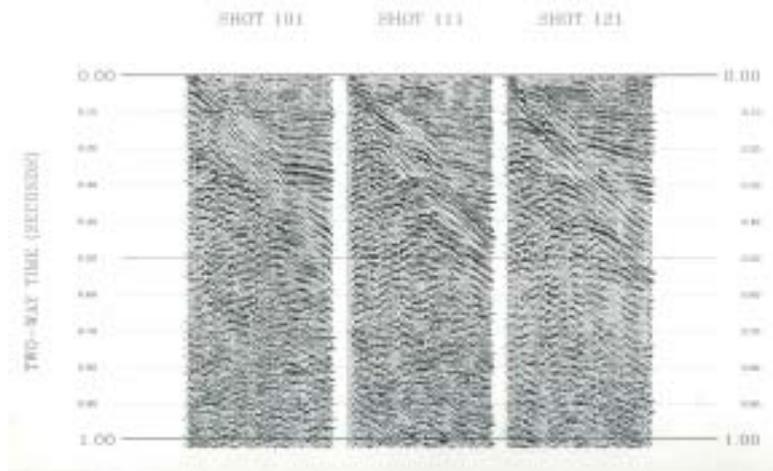
圖9、本次研究測區中之代表性測點紀錄。圖9a為P波測點紀錄；圖9b為SH波測點紀錄。

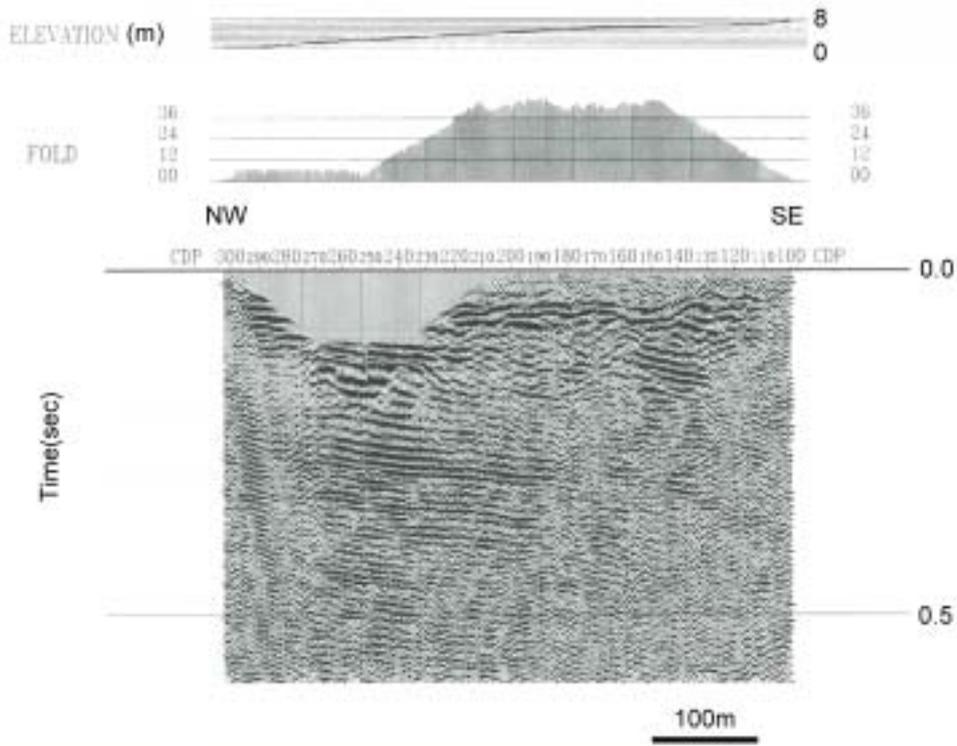
圖10、測線SCn2P之48重合P波淺層震測剖面，長約500公尺，深約600公尺。

圖 10 為測線 SCn2P 之 48 重合 P 波淺層震測剖面，長度約 500 公尺，深度約 600 公尺。該測線位於測區中央，是最早進行槽溝開挖之測線。震測作業時使用的震源為 JMS-MINI 65 人工震源車，受波器組以 3 個受波器為一組排列，每組間距為 5 公尺，每一個受波器間距為 1 公尺，炸點間距 2.5 公尺，近支距為 5 公尺，各炸點撞擊約 40 次，最大重合數可達 48 重合。由於本測區之測線展距有限，測線的配置造成了如剖面中左上方之信號缺口；加上 P 波因波速快，近地表地層的反射信號與初達波常無法區分，以及 P 波的淺層反射信號會在處理時因超過合理的垂直隔距時差伸長比取值而被切掉，P 波反射剖面之淺部構造影像常不可信。圖 11 同為測線 SCn2P 之 48 重合 P 波震測剖面，其中灰色辨透明顏色遮蓋部分即為不可信賴之淺部雜訊。經去除淺部雜訊後，圖中剖面顯示了此區域地

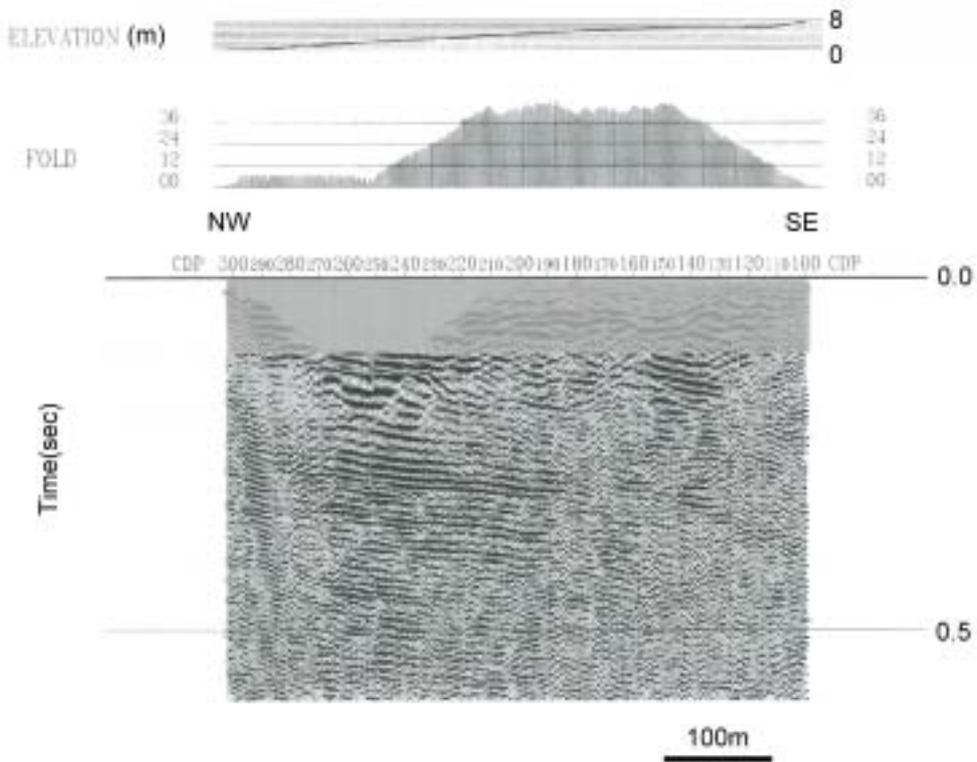
圖11、測線SCn2P之P波48重合剖面，灰色半透明顏色掩蓋部分為淺部雜訊。

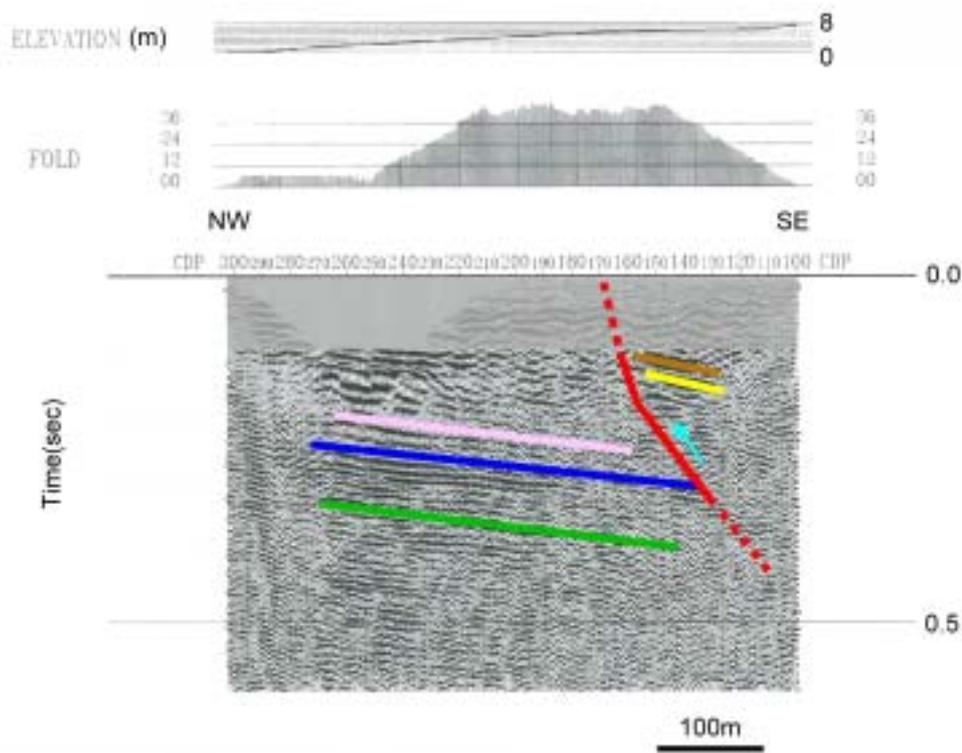
圖12、測線SCn2P之解釋剖面。剖面中斷層線以紅色線條表示。本區域中岩層一致地以低角度往東南方傾斜，而不同傾角的上下盤地層以逆衝斷層為界，上盤角度較高而下盤角度稍小。

層往東南傾斜之大趨勢。圖 12 為測線 SCn2P 之解釋剖面，剖面中斷層以紅色線條表示。圖 12 的剖面中可以清楚地看出，本區域岩層一致的以低角度往東南方傾斜，而逆衝斷層以不同傾角的上下盤地層為界，上盤角度較高而下盤角度稍小。本剖面的準確性已經由測區的鑽井、地質與槽溝開挖資料證實。

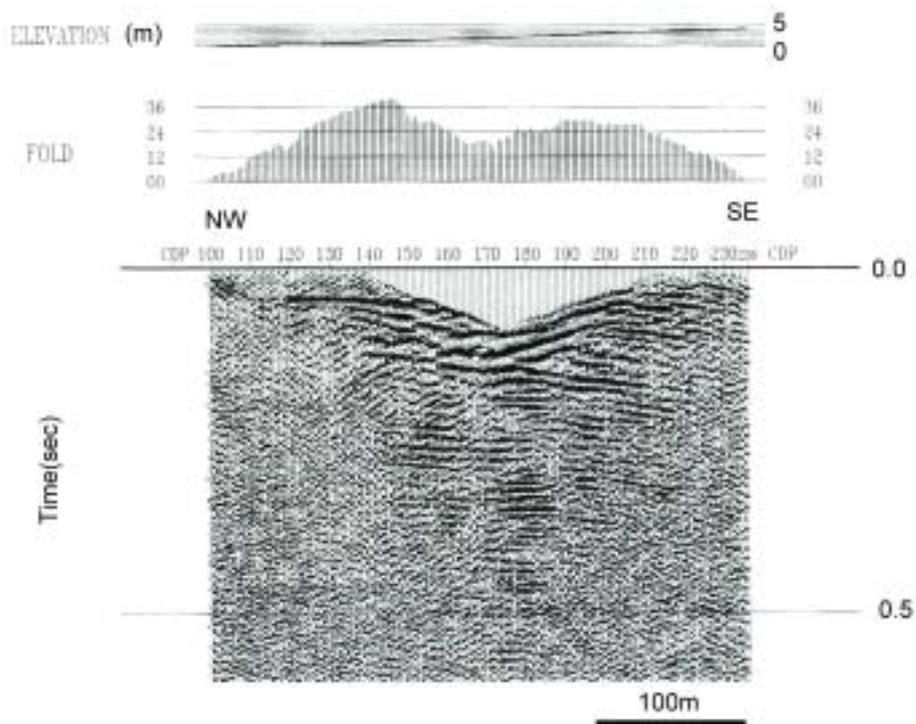
圖13、測線SCn3P之P波48重合剖面。長約350公尺，深約600公尺。

圖 13 為本測區另一條 P 波淺層反射震測剖面（測線編號：SCn3P），剖面長度約 350 公尺，深度約 600 公尺。本測線位於測線 SCn2P 之西南方約百公尺，施測時受波器亦以 3 個為一組排列，每組間距為 5 公尺，每一個受波器間距 1 公尺，炸點間距 2.5 公尺，近支距為 5 公尺，各炸點撞擊約 40 次，最大重合數亦可達 48 重合。同剖面 SCn2P，圖 14 為剖面 SCn3P 經去除淺部雜訊後之重合剖面。剖面中信號一致地往東南方傾斜，並無斷層切過之跡象，圖 15 即為該剖面之解釋。由於測線 SCn3P 與 SCn2P 僅相距約百公尺，但測線 SCn3P 的 P 波震測結果顯示並無斷層通過。為了進一步證實上述結果的可靠性，本次研究再沿著測線 SCn3P 實施了 SH 波淺層反射震測（測線編號 SCn3S）。

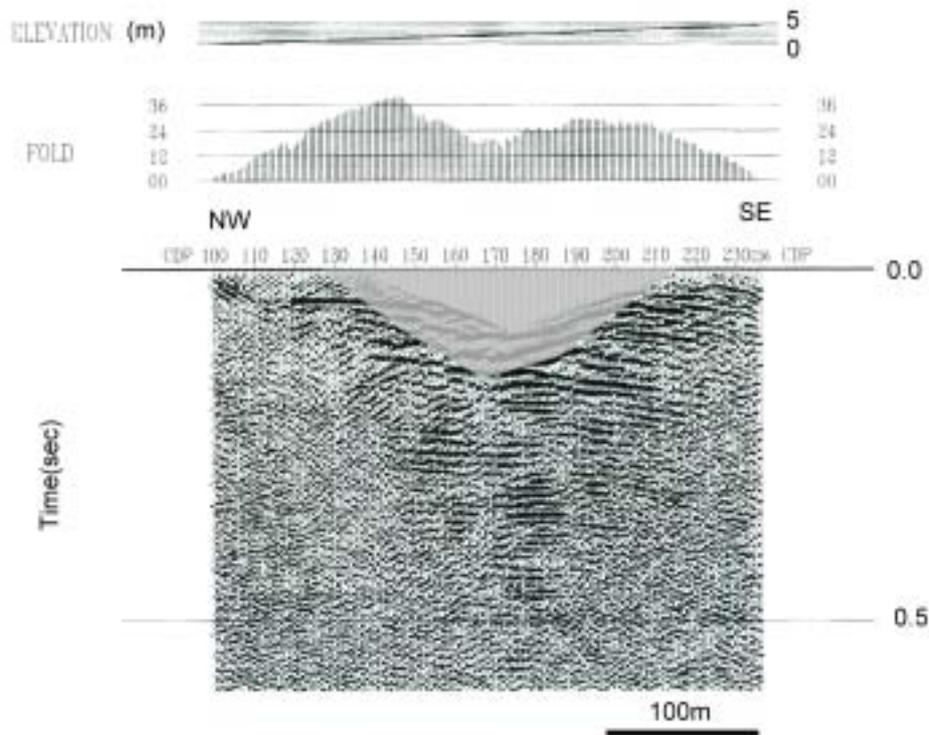
圖14、測線SCn3P經去除淺部雜訊後之重合剖面。剖面中信號一致地往東南方傾斜，並無斷層通過之跡象。

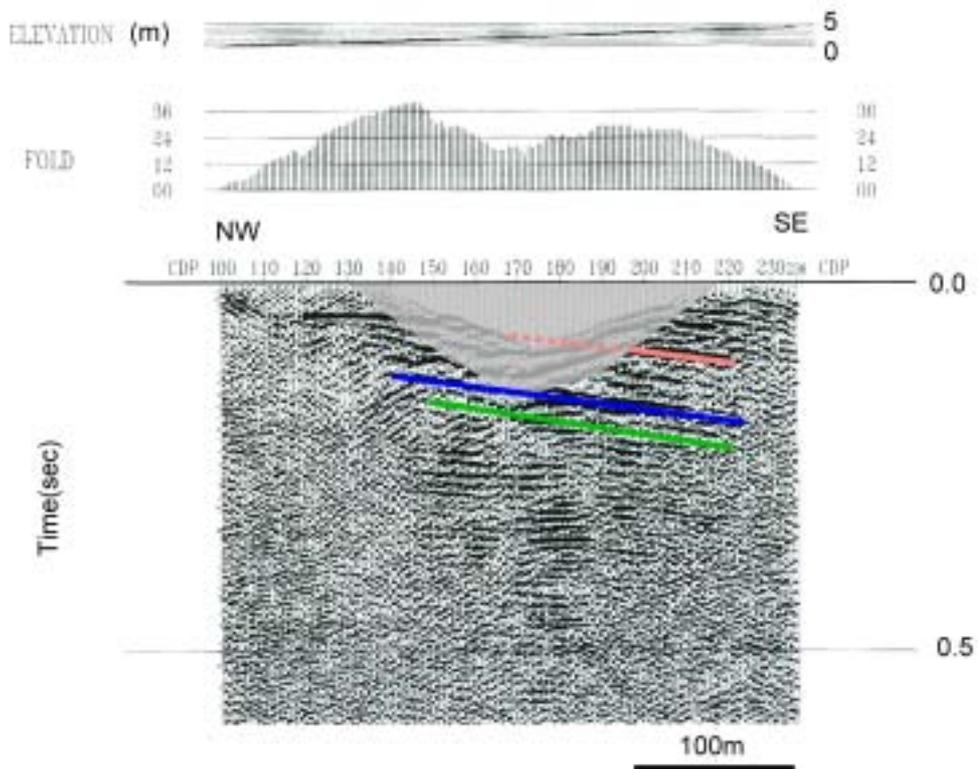
圖15、測線SCn3P之解釋剖面。影像中並無斷層通過。

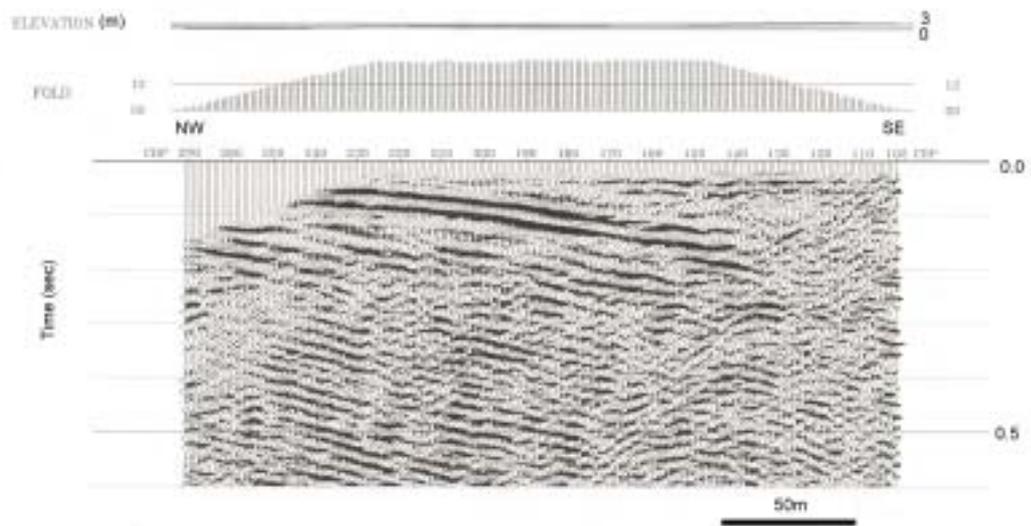
圖16、測線SCn3S之SH波24重合剖面。剖面長約250公尺，深約200公尺。

圖 16 即為測線 SCn3S 之 SH 波 24 重合反射剖面，長約 250 公尺，深度可達約 200 公尺。施測時亦使用 JMS-MINI 65 為震源（撞擊器需傾斜），受波器以 2 個為一組排列，每組間距 3 公尺，每一個受波器間距為 1 公尺，炸點間距 2.5 公尺，近支距為 2.5 公尺，各炸點撞擊約 60 次，最大重合數可達 24 重合。圖 16 剖面中可以見到一致往東南方傾斜之淺層地層，圖 17 即為該剖面之解釋。

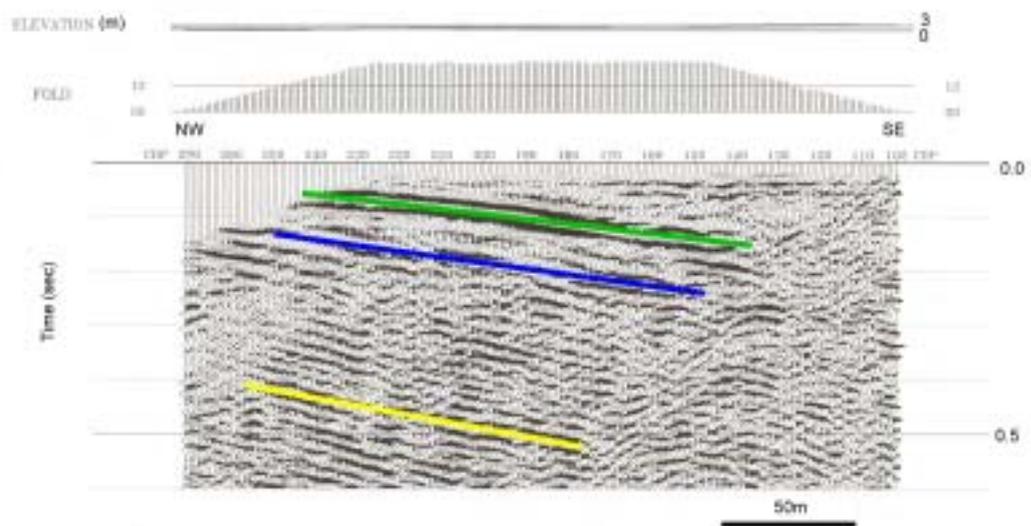
圖17、測線SCn3S之解釋剖面。剖面中可以見到一致往東南方傾斜之淺層地層。

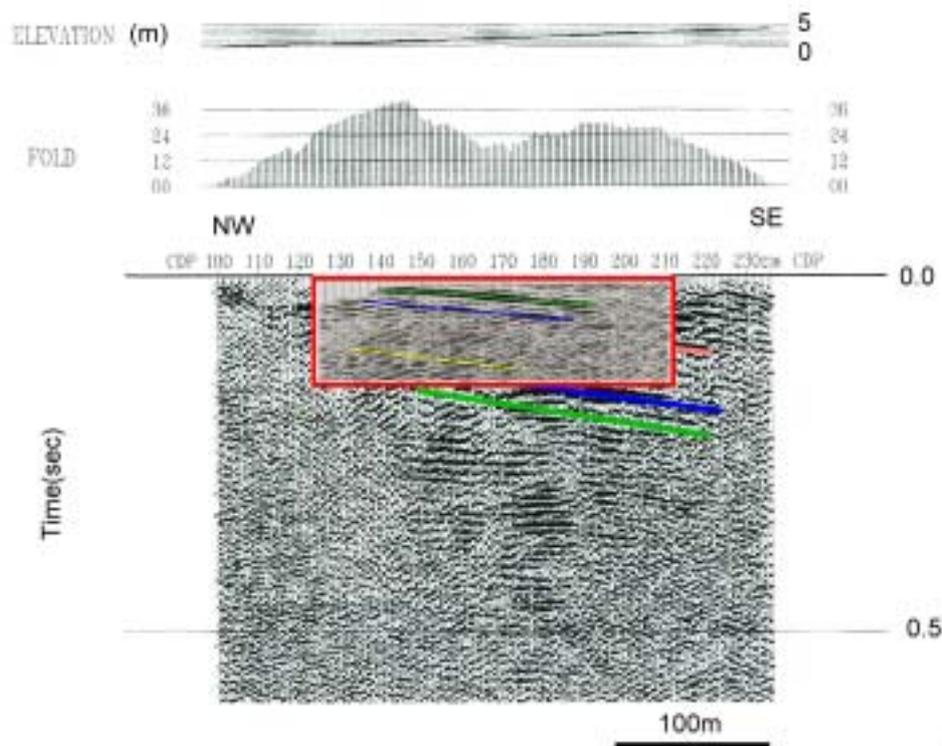
圖18、測線SCn3之P波與SH波整合解釋剖面。測線底下之地層由淺至深一致地往東南方傾斜，並無斷層經過。

若將 P 波反射剖面與 SH 波反射剖面一併解釋（如圖 18 所示），可以發現測線 SCn3 底下之地層由淺至深一致地往東南方傾斜，並無斷層經過。圖 19 同為該測線 P 波與 SH 波反射整合之剖面，僅圖中 SH 波剖面以半透明顯示，以便更清楚地看出地層之一致性。槽溝開挖結果也證實本測線並無斷層由此測線經過。

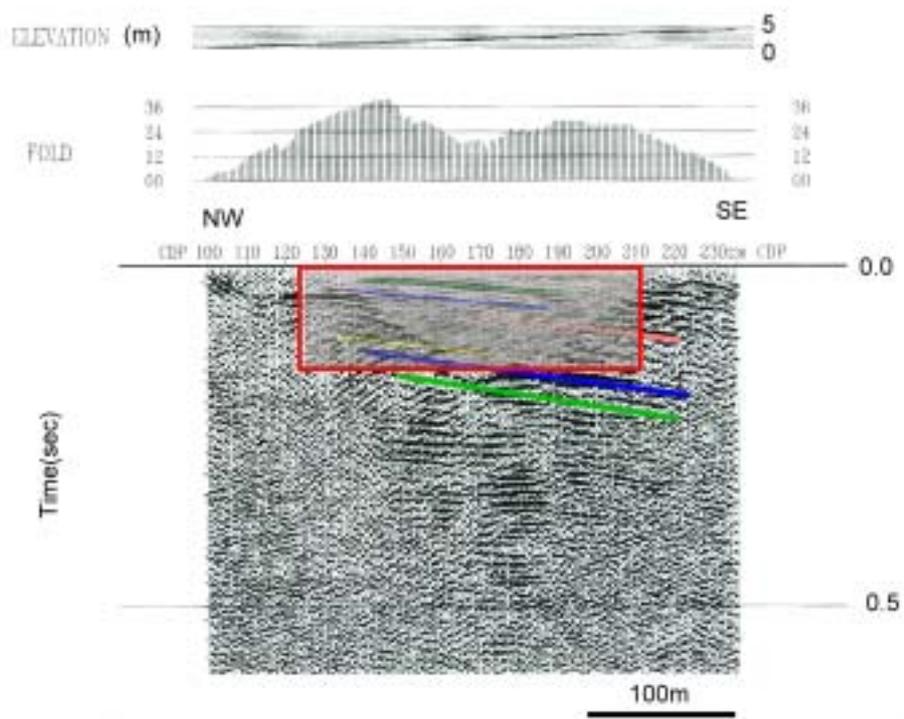
圖19、測線SCn3之P波與SH波整合剖面。圖中SH波剖面經半透明顯示以便更清楚地看出地層之一致性。

圖 19 中 P 波反射剖面能夠穿透較深的深度，但是 SH 波反射剖面能解析較淺部的地層。由圖 19 之綜合剖面可以看出，SH 波反射於極淺部構造的研究能比 P 波反射獲得較佳的解析能力。為了獲得近地表處的地層資訊，除了提高震源的頻率外，採用波速較慢的 SH 波反射也是一種非常有效的方法。

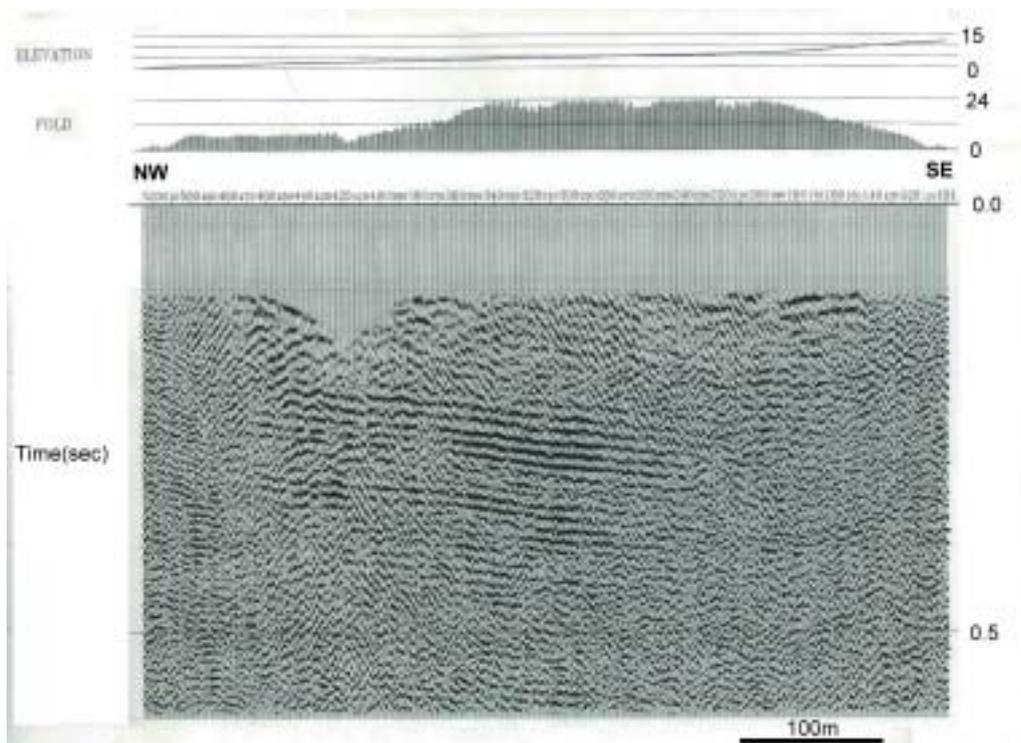
圖20、測線SCn1P經去除淺部雜訊後之24重合P波剖面。測線長約650公尺，深約600公尺。

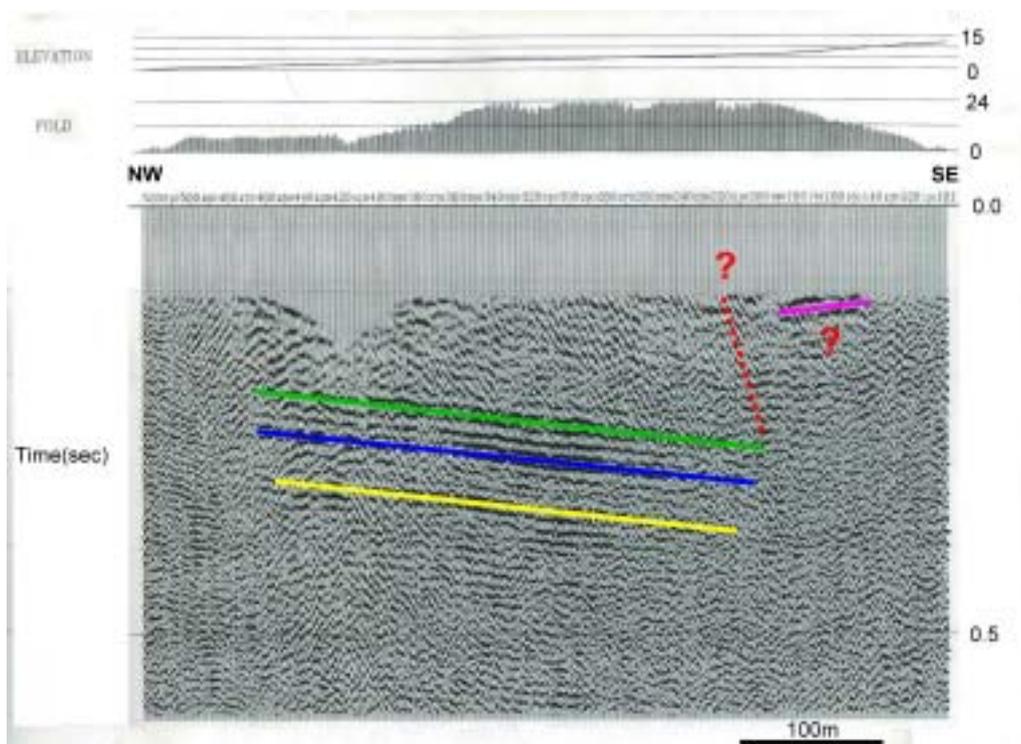
圖21、測線SCn1P之解釋剖面。剖面中間至中間以西部分，信號一致地往東南方傾斜，無斷層通過之跡象，然剖面右方之信號品質不良，極難研判是否有斷層經過。

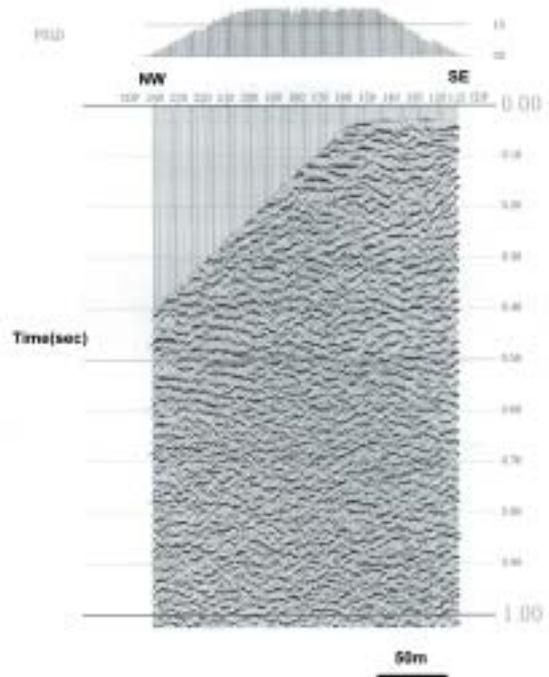
圖22、測線SCn1S之SH波24重合剖面。剖面長約250公尺，深約400公尺。

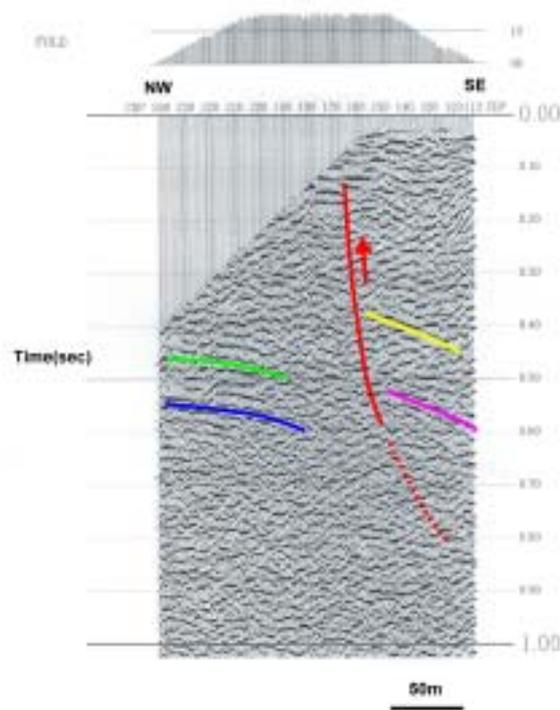
圖23、圖22中剖面之解釋。剖面中西側與東側各有信號出現，但中央部分信號不佳，斷層以紅色線條表示。

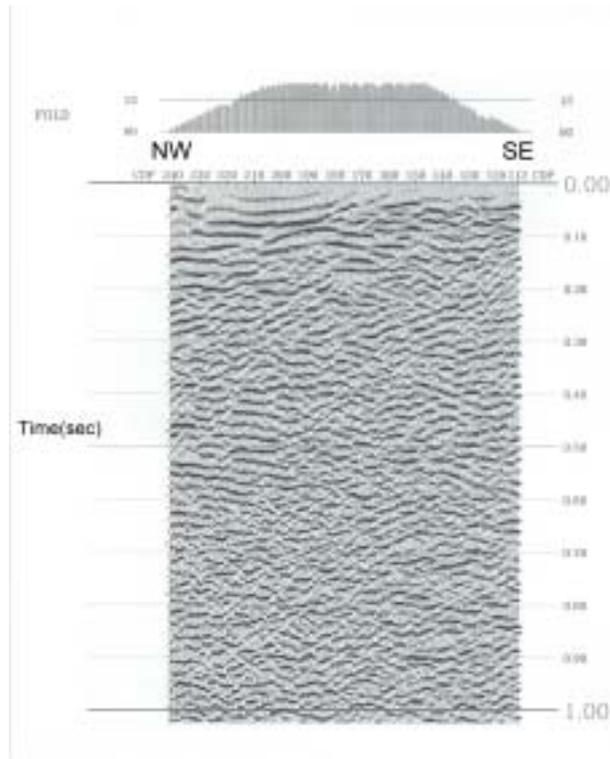
圖24、測線SCn1S經不同方式處理之24重合SH波剖面。

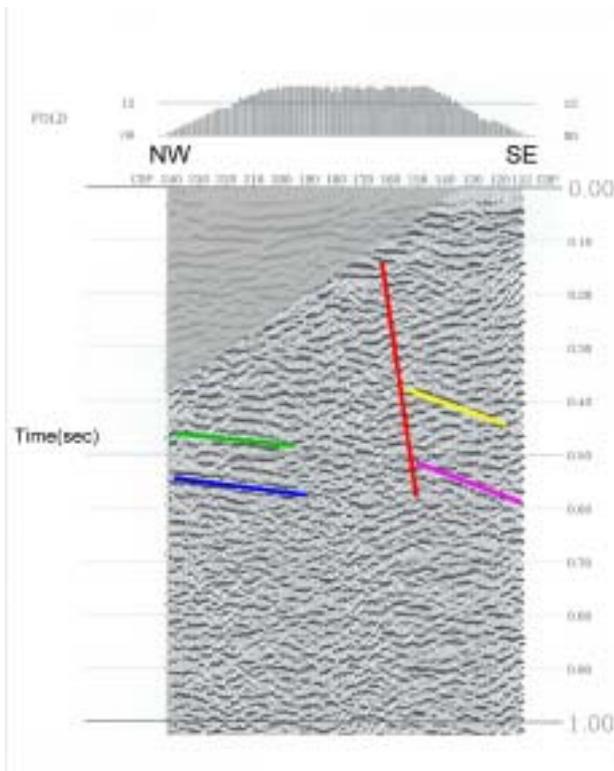
圖25、圖24中剖面之解釋。剖面中斷層兩側之地層皆往東南方傾斜，但傾角不同。
