行政院國家科學委員會專題研究計畫成果報告

新竹科學園區活動斷層地震地質學研究

計畫編號： NSC91-2119-M002-010

執行單位：國立台灣大學地質學系
中華民國九十二年三月

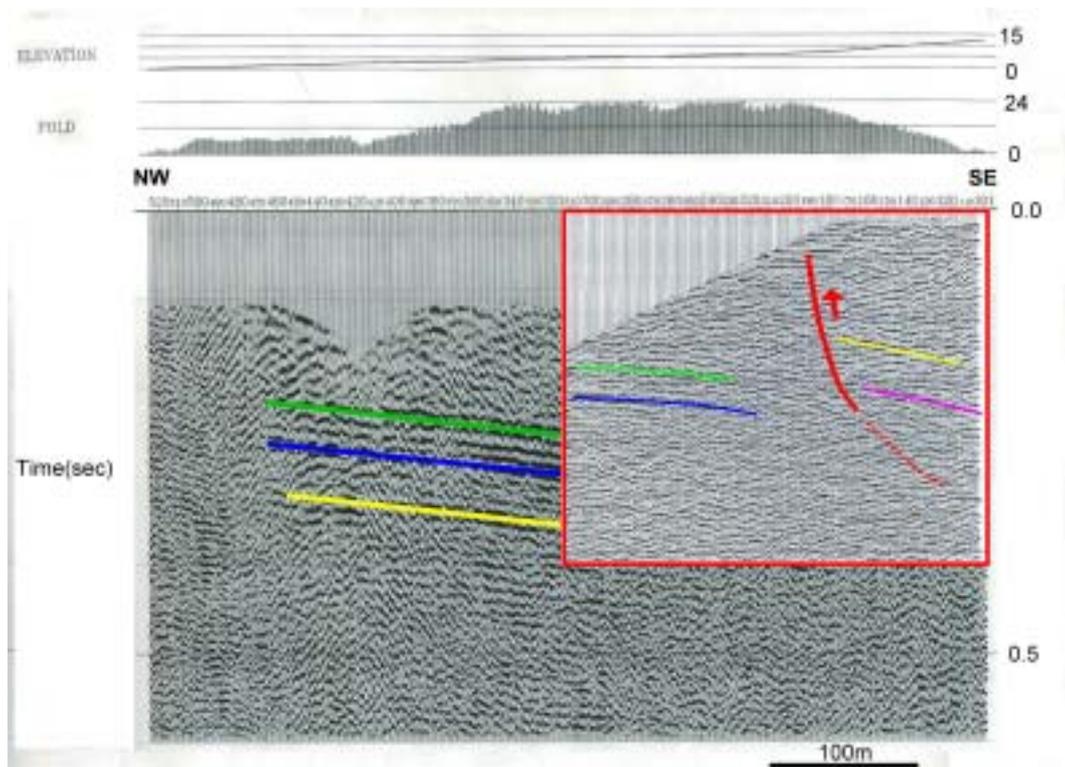
圖26、測線SCn1之P波與SH波整合解釋剖面。測線底下之地層皆往東南方傾斜，但斷層上盤地層的傾角較陡。

圖 26 為測線 SCn1，之 P 波與 SH 波反射整合解釋剖面，剖面中可以發現斷層上下盤的地層皆往東南方傾斜，但斷層上盤地層的角度較陡，而下盤地層的角度較平緩。槽溝開挖結果也證實斷層由此經過。

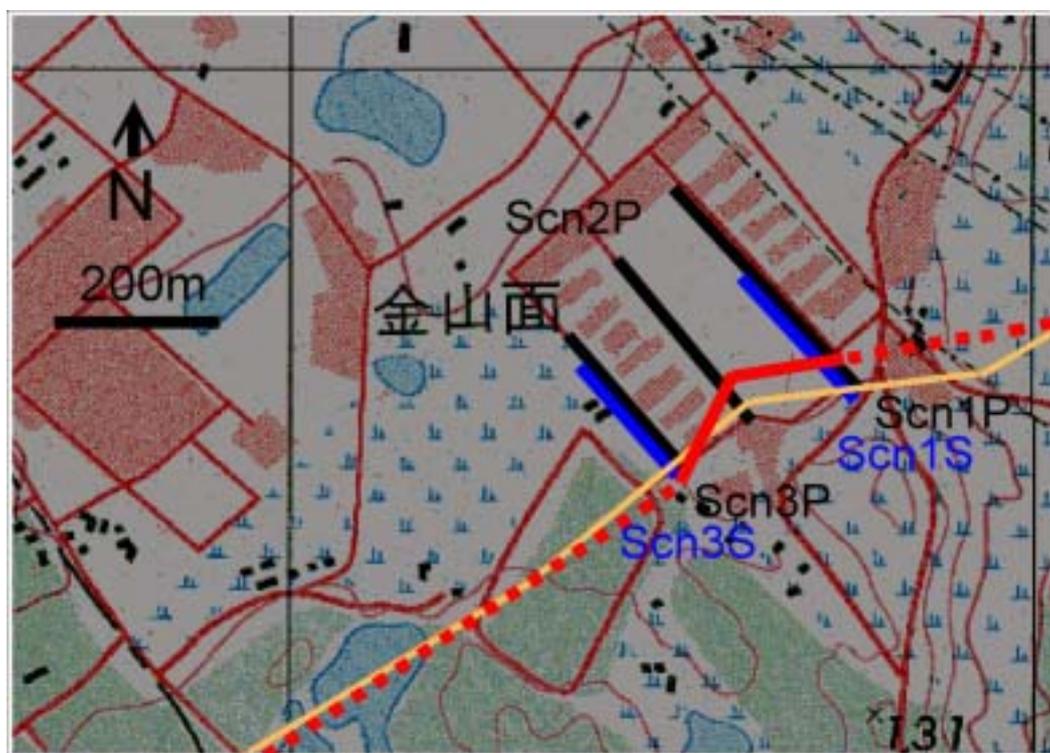
圖 27、本測區斷層研究之結果。圖中紅線為即本研究所得之斷層延伸位置。

綜合本測區中的研究結果顯示，本區域於 600 公尺以上之地層一致地往東南方傾斜，逆衝斷層亦往東南方傾斜，斷層上盤地層之傾角較陡而下盤地層之傾角較平緩。由於斷層由測線 SCn1 與測線 SCn2 中之東南方經過，而未經過測線 SCn3，斷層於本測區之延伸位置於測線 SCn1 與測線 SCn3 之間應比原先瞭解的位置往西北方偏移，而在測線 SCn3 一帶的斷層位置應往東南方偏移。圖 27 中所示即為本測區斷層研究之結果，圖中紅線即為研究結果之斷層延伸位置。而斷層於測線 SCn1 與測線 SCn3 之間應有一轉折存在。

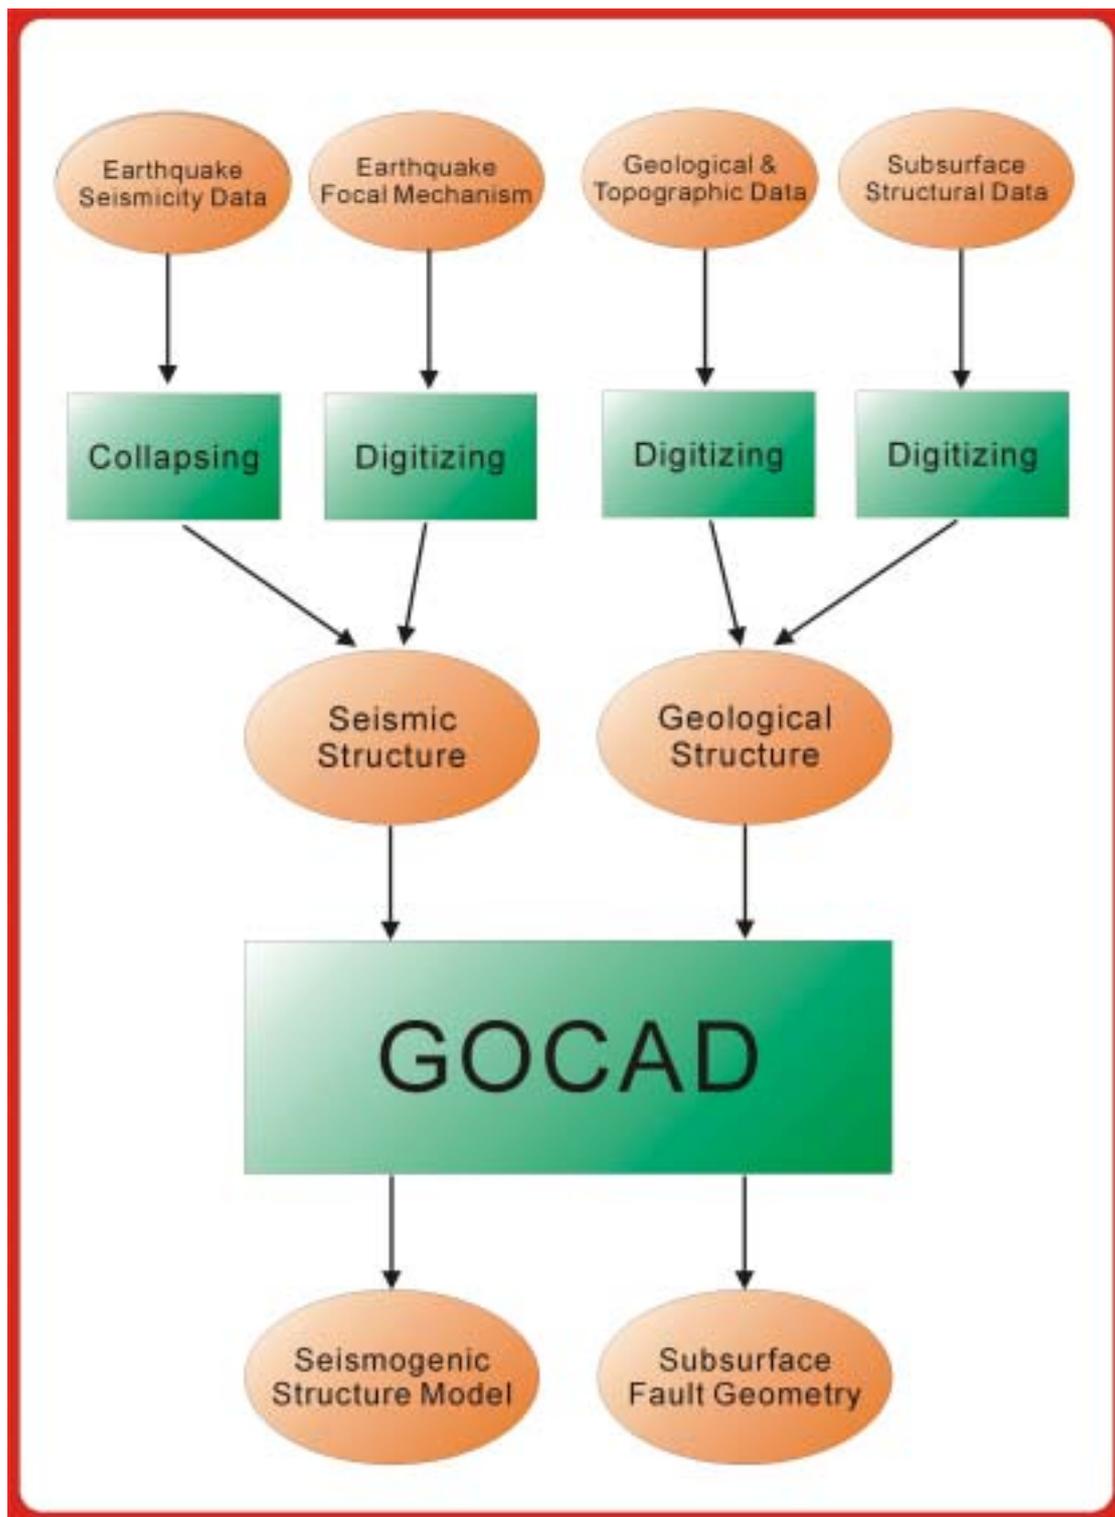
圖 4、流程圖。

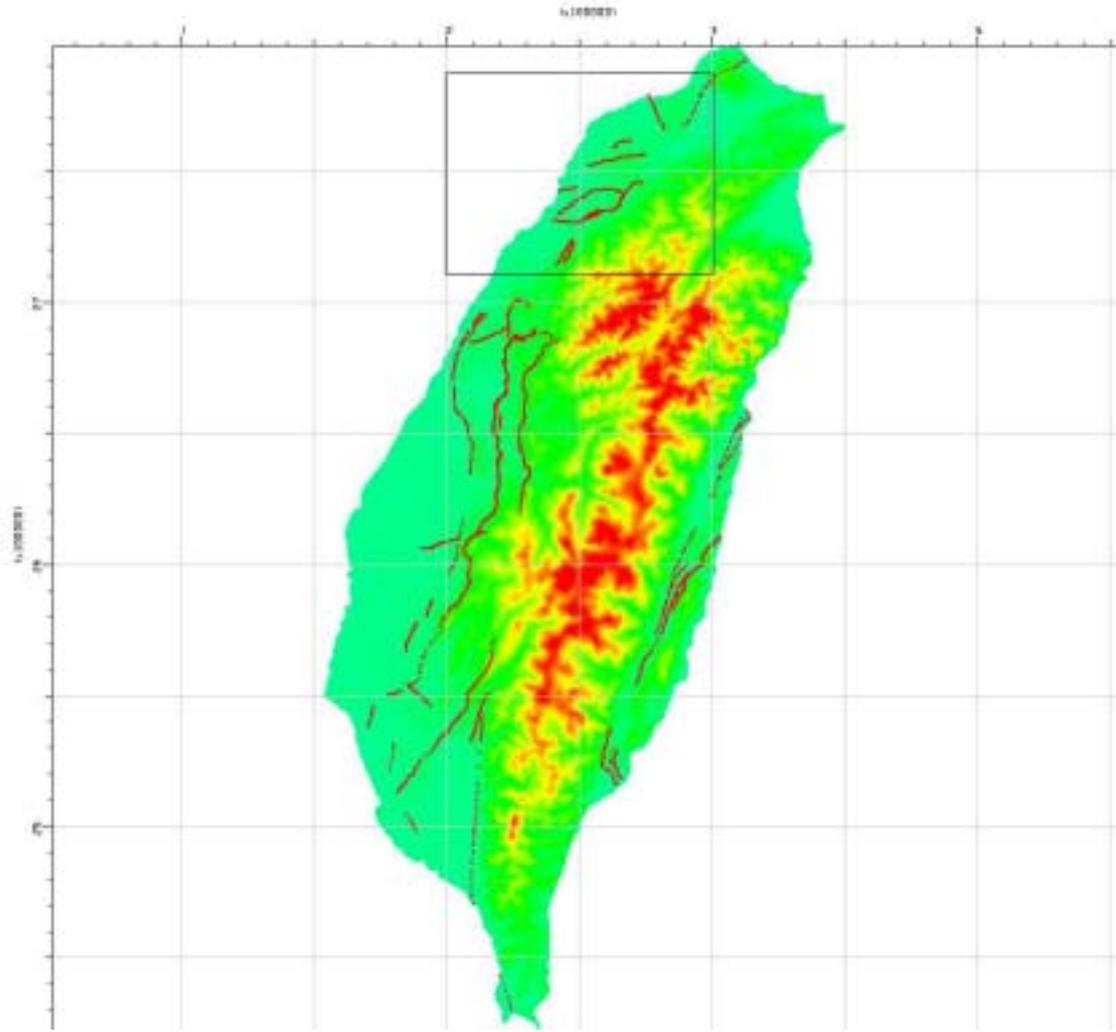
圖 5、黑色框線內為研究區域，紅線為活動斷層。圖上方及左方標示之座標系統為二度分帶 (TWD67)。

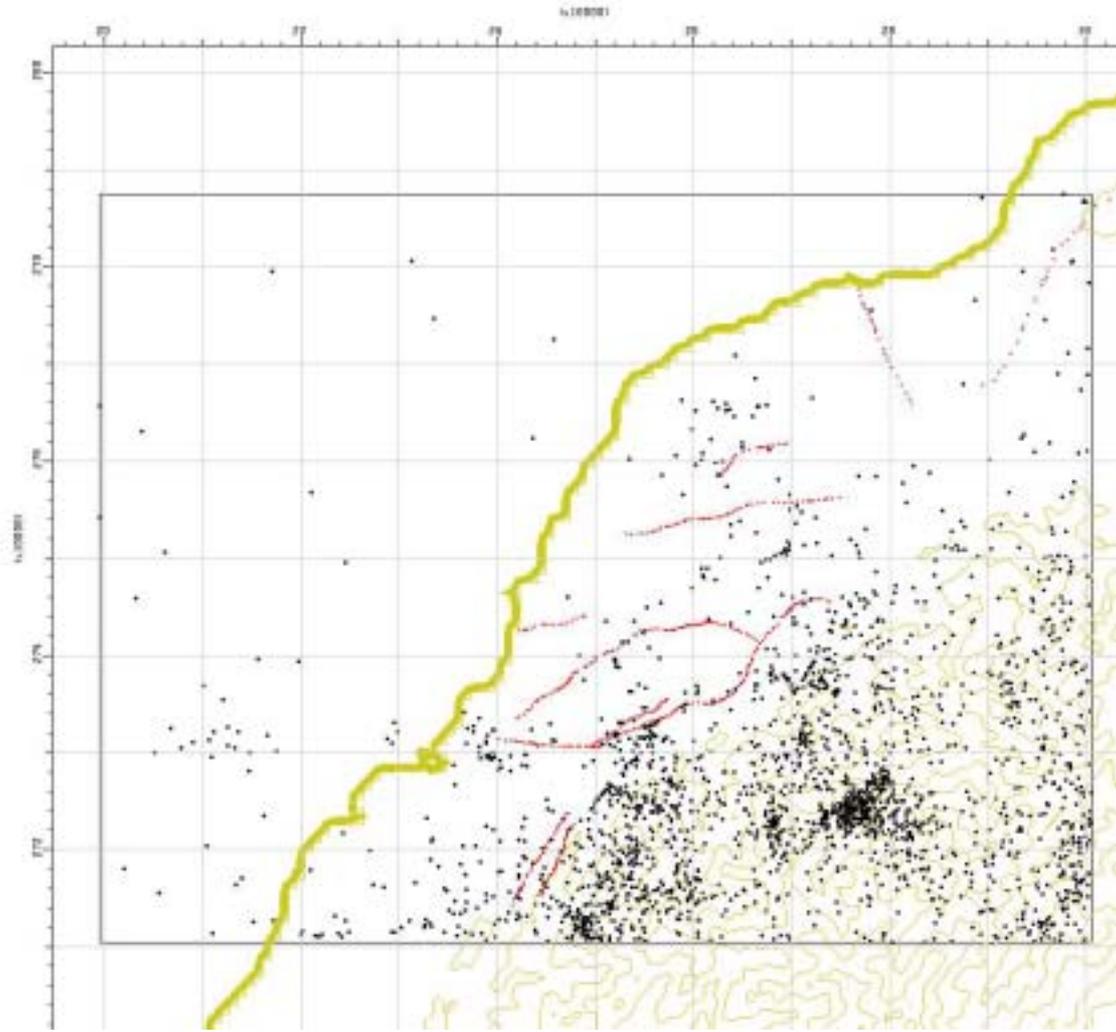
圖 6、研究區域放大圖。黃線為等高線，粗黃線標示海岸線位置，紅線為活動斷層位置，黑點代表地震震央，大部分地震震央位於東南角落之山區內。

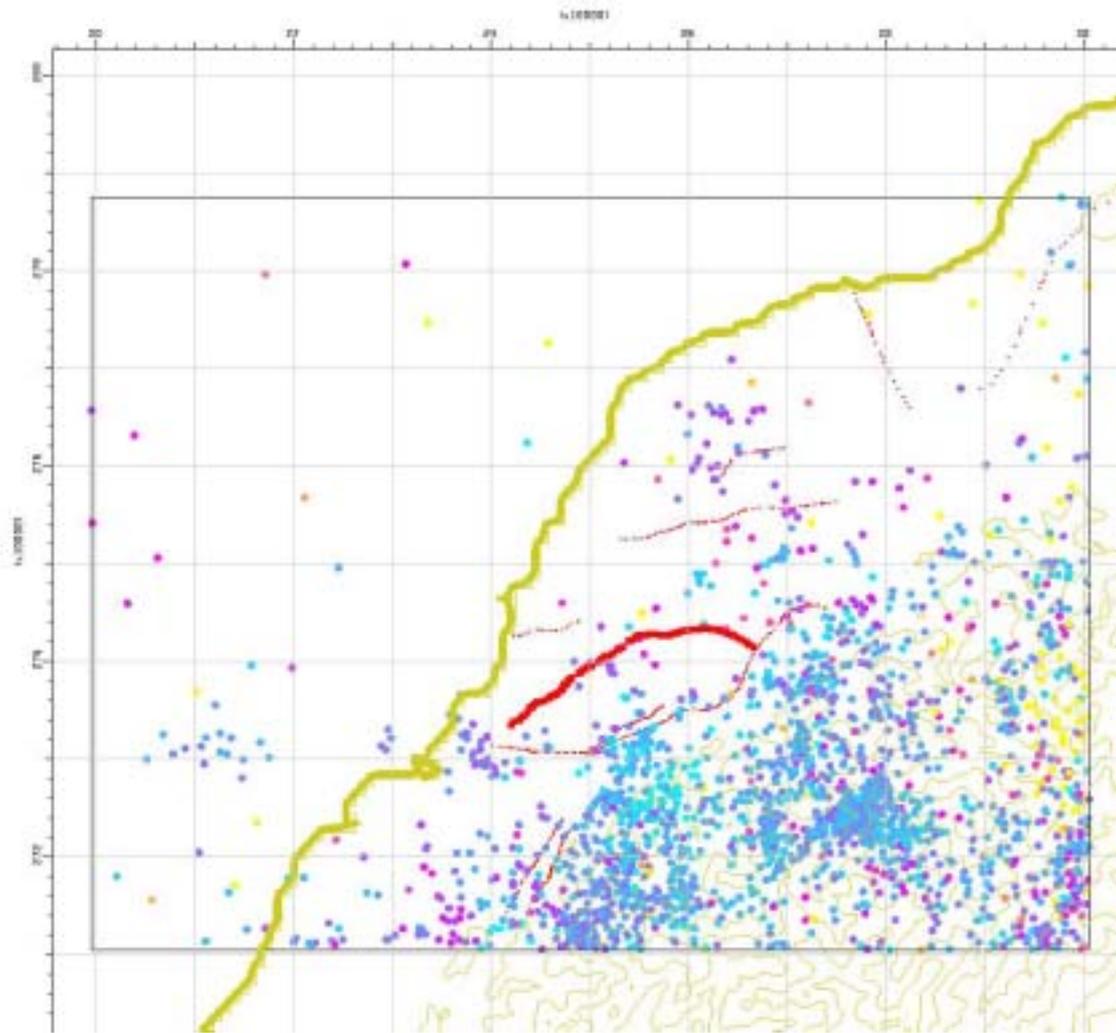
圖 7a (上)、震源深度分佈圖，粗紅線為新城斷層位置。
 7b (右)、深度對照索引，單位為公尺，此後所提及之本研究新竹地區的震源分佈圖，其深度對照皆以此為準。大多數地震深度在 25 公里以內。

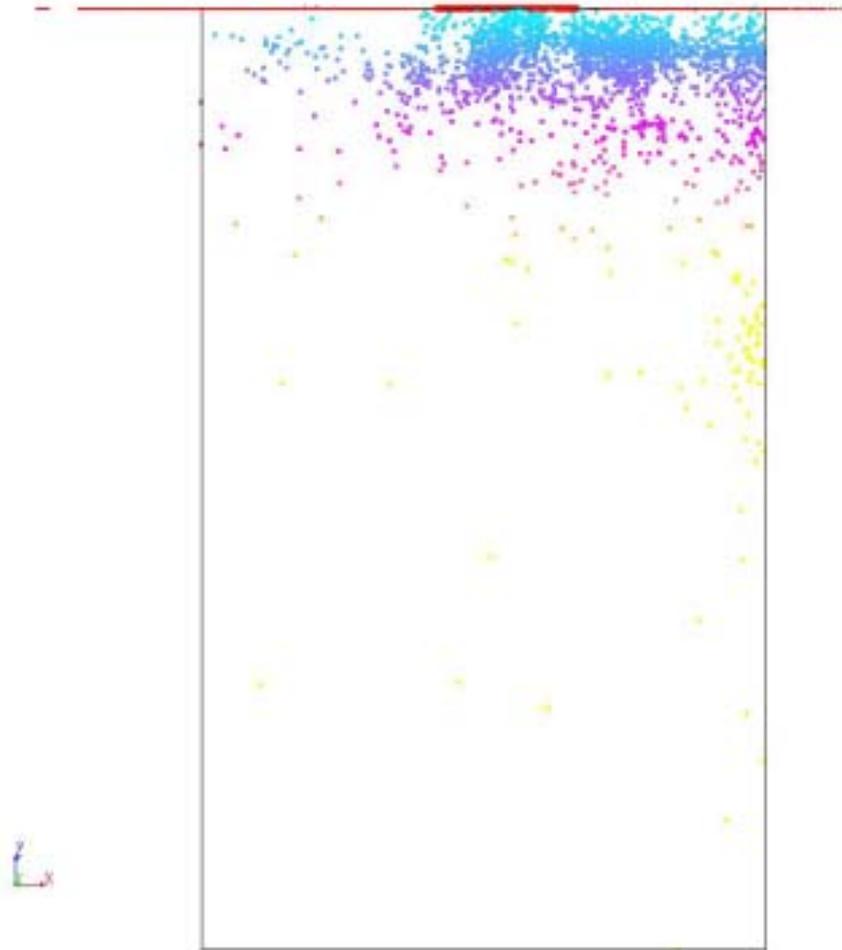
圖 8、由南向北之水平透視圖。呈現視角為平行視角 (parallel view)。地震震源深度分佈大致呈現一個往東方加深的趨勢。

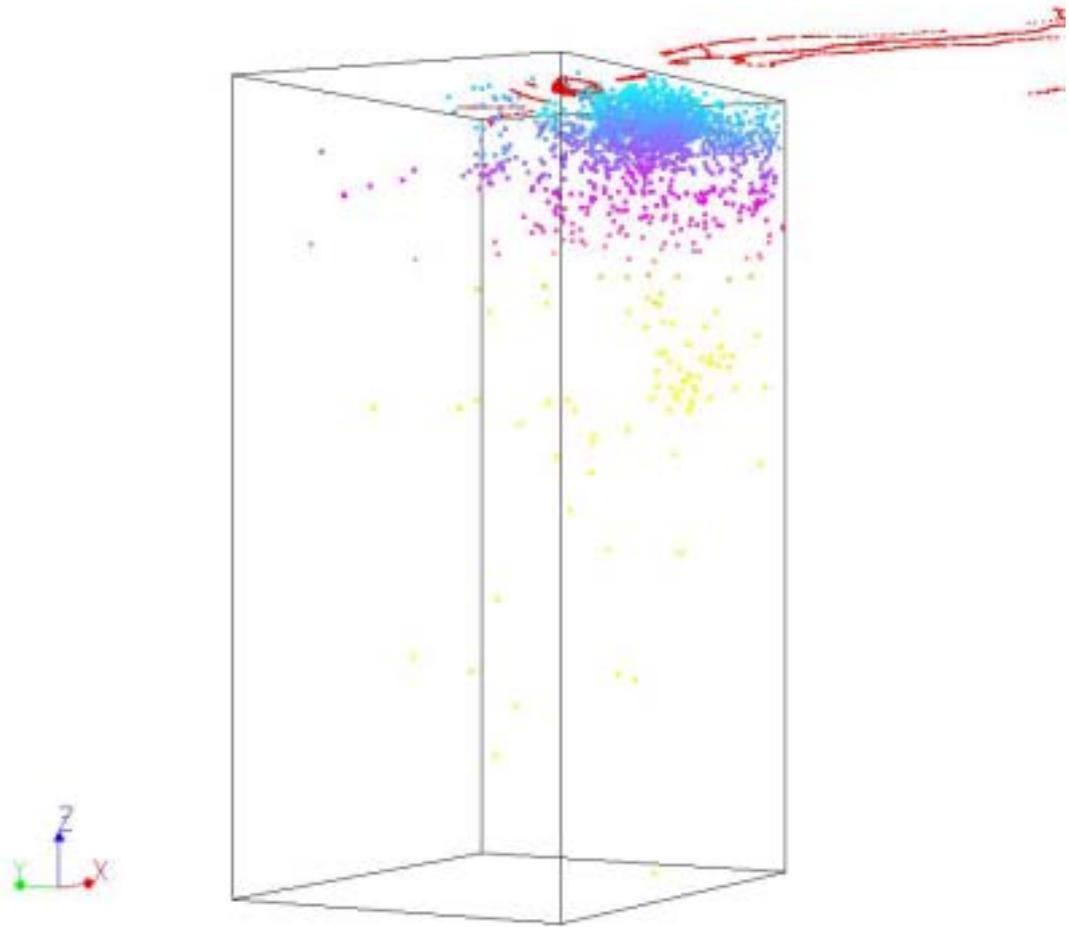
圖 9a、以 $N60^{\circ}E$ ，約略平行新城斷層（粗紅線）的視角（perspective view）下，所顯示之地震震源分佈。左下方之座標軸顯示目前的視角方位，其中紅色 X 軸正向指示東方、綠色 Y 軸正向指示北方、藍色 Z 軸正向指示上方。

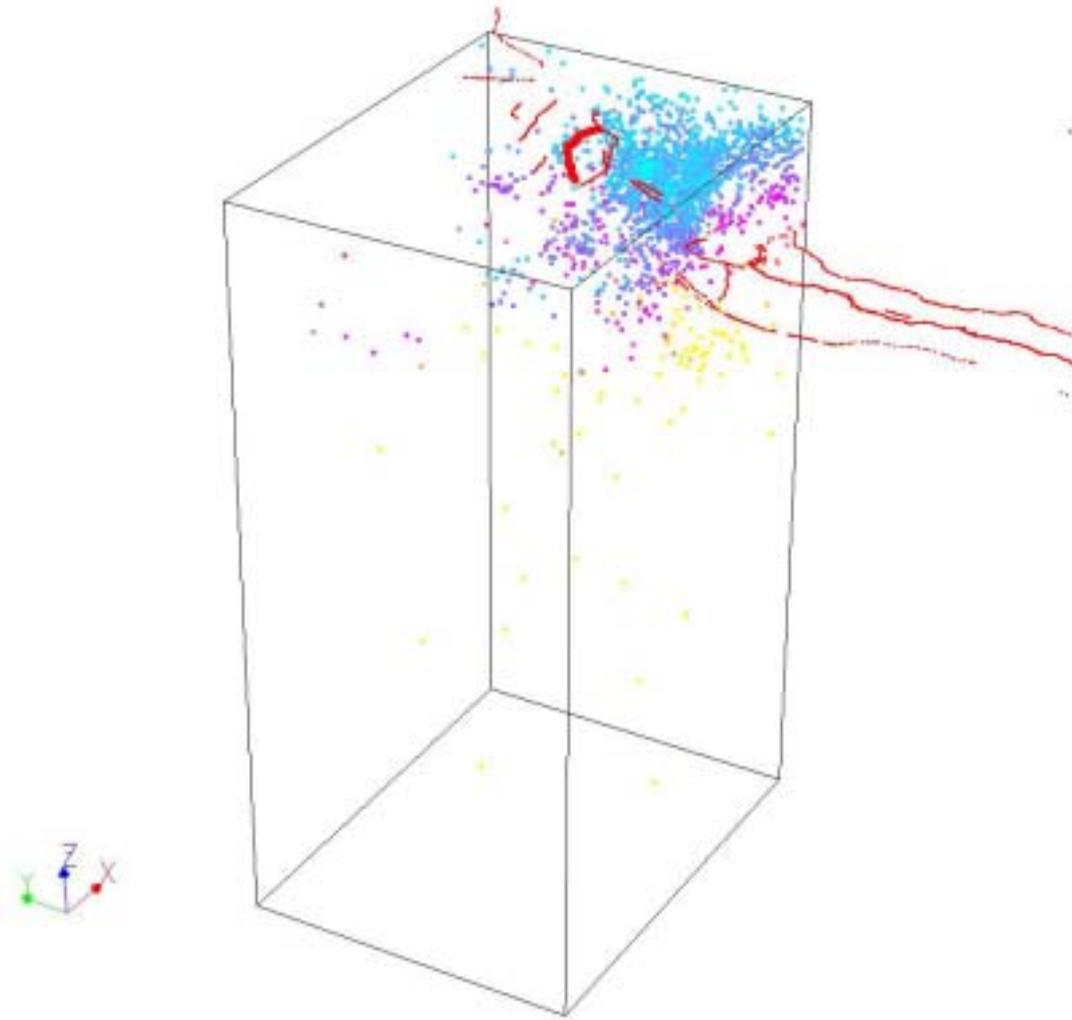
圖 9b、以 N60°E、30 度俯角，約略平行新城斷層（粗紅線）的視角（perspective view）下，所顯示之地震震源分佈。

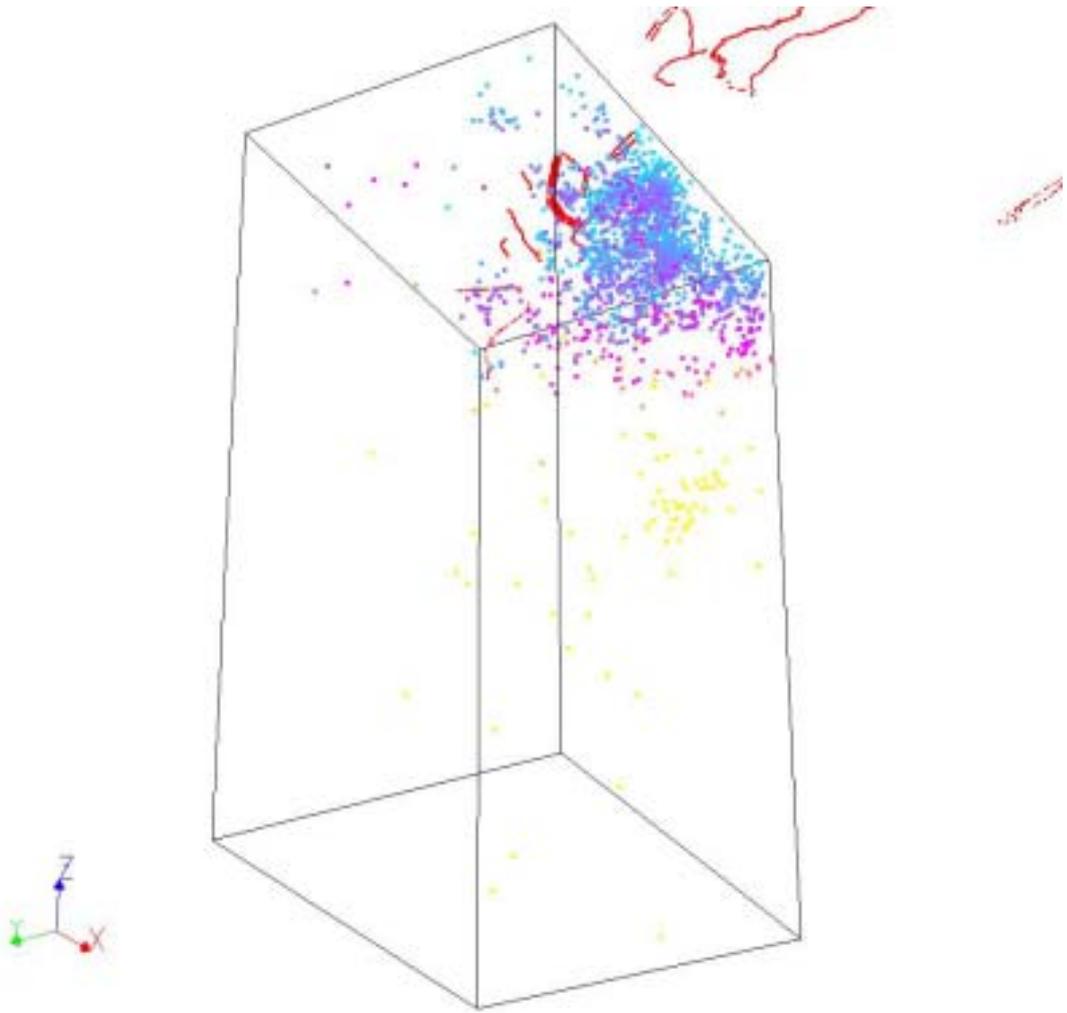
圖 9c、以 $N60^{\circ}E$ 、30 度仰角，約略平行新城斷層（粗紅線）的視角（perspective view）下，所顯示之地震震源分佈。

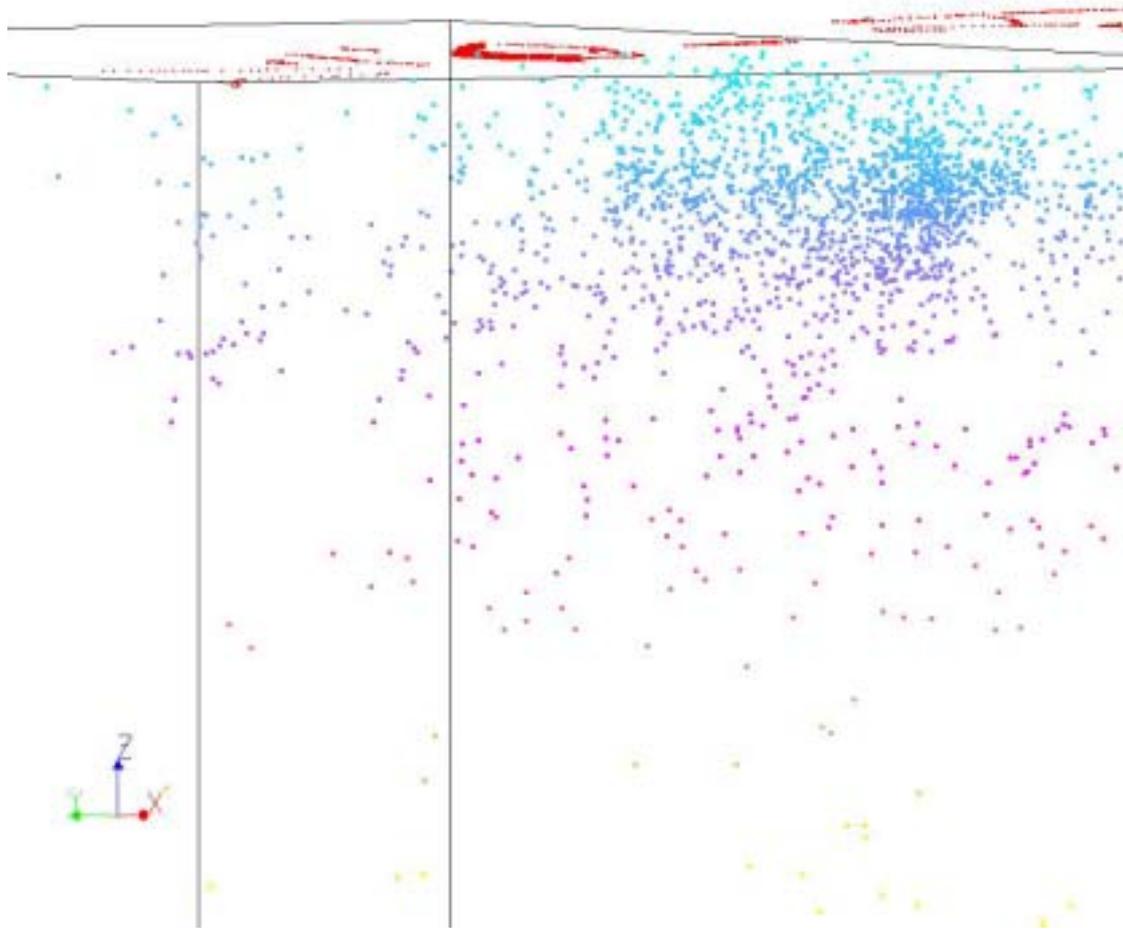
圖 9d、圖 9a 之局部放大圖。圖 9a、9b、9c、9d 所顯示之地震震源分佈，並未存在有特殊之趨勢。

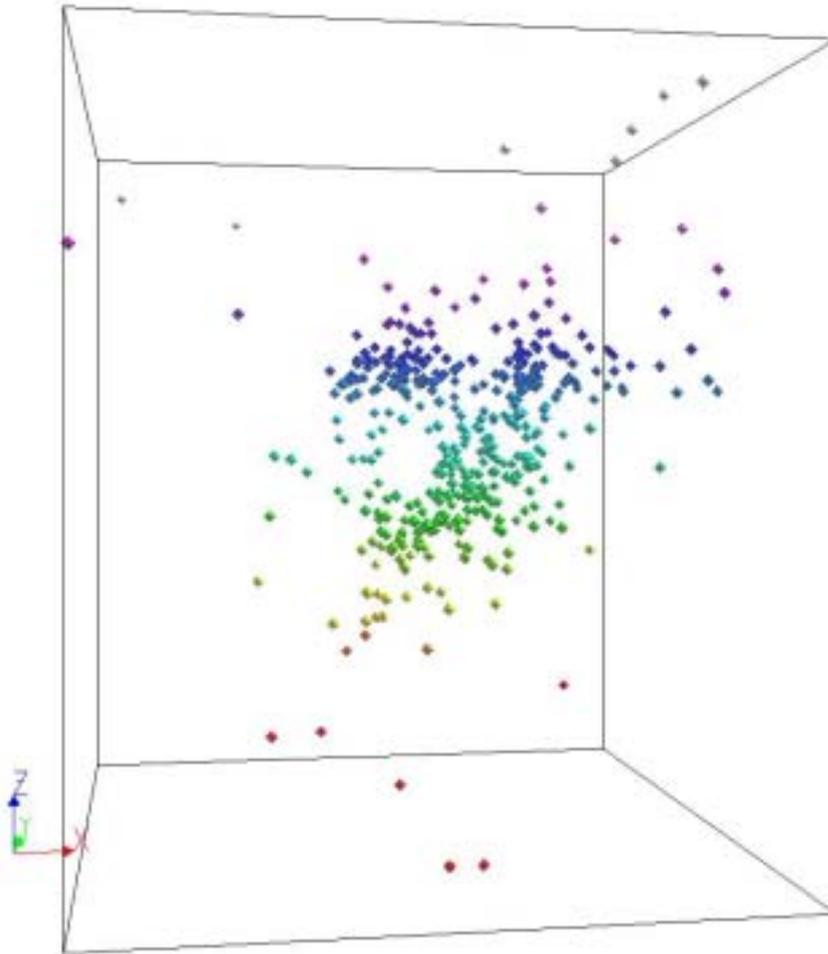
圖 10a(上)、1999 年 10 月 22 日嘉義地震餘震分佈、圖 10b (右)、嘉義地震餘震分佈的深度顏色參照。由圖 10a 可見，地震在北偏東 15 度的透視下，呈現兩個趨勢分佈，一為圖中藍色地震分佈，另一為圖中藍綠色至黃色地震分佈。

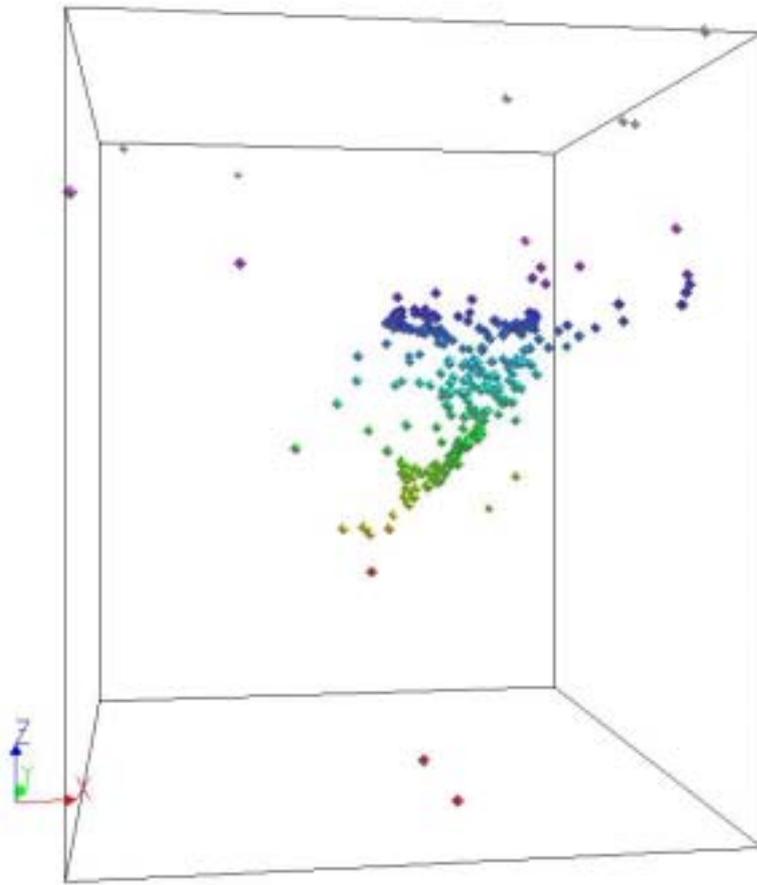
圖 10c、經過震源機制疊合法處理後之嘉義地震分佈。在與圖 10a 相同的視角下，明顯可見經過 collapsing 的地震有較為集中的趨勢。

理後，如圖10c所見，雖然於兩個構造的連接處的地震分佈較為混亂，但在遠離連接處的地震分佈更為明顯的集中在兩個趨勢線上。然而，此兩群地震分佈在向東的視角下，如圖10d，較深層的綠色地震群事實是由兩個線性的排列所構成，而在中央部分的地震分佈卻顯得稀疏。我們將上部較為集中的地震，利用GOCAD處理建立一個曲面，如圖10e，為曲面與地震分佈正上方鳥瞰圖。假設上部的藍色地震大多數都屬於同一個發震構造，則此曲面即為嘉義地震中較淺層地震的假想發震構造曲面。

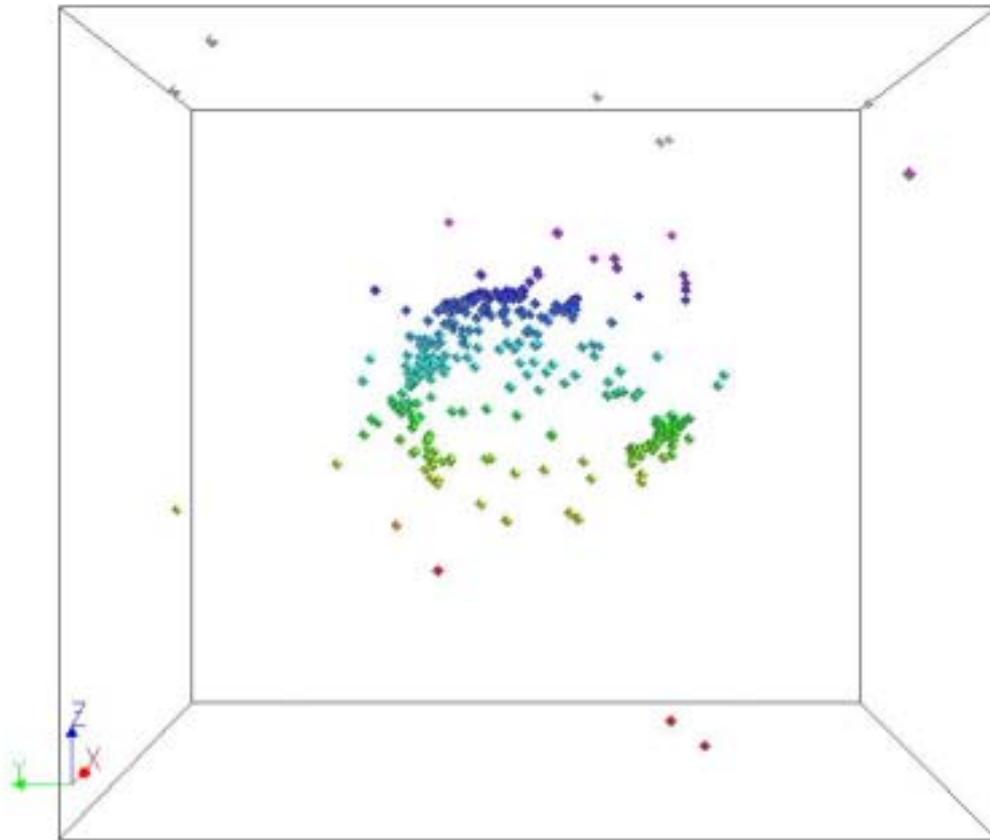
圖 10d、朝向正東方的透視圖。圖中綠色地震的分佈分為左右兩群，且成線性排列，而中央部位地震的分佈明顯較少，形成一空缺。

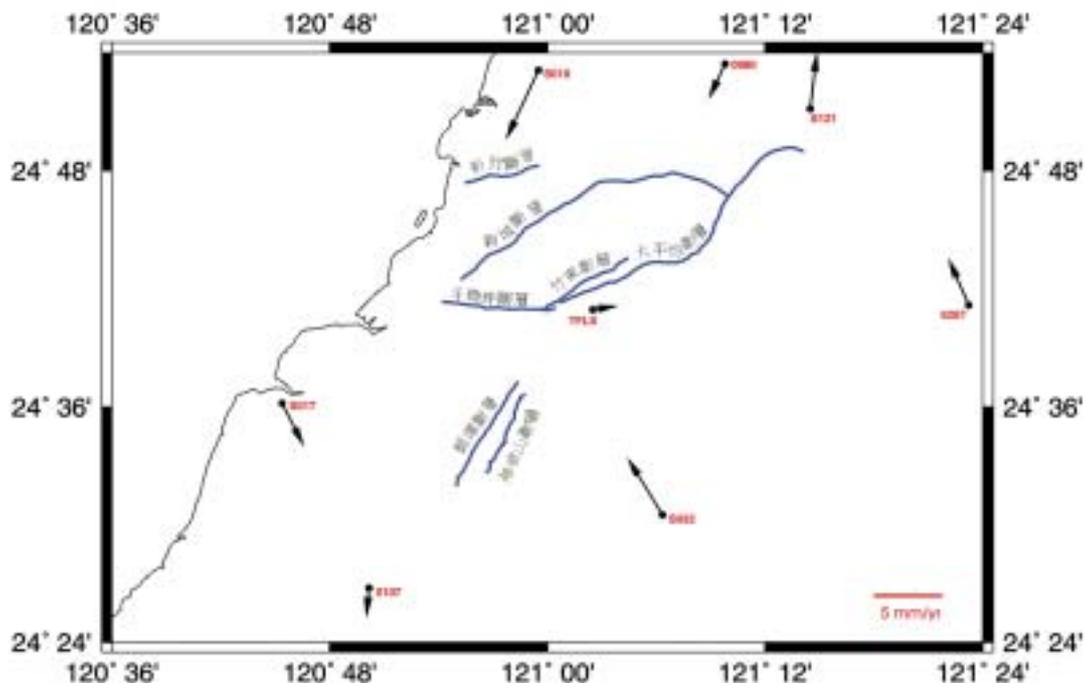
圖一、新竹地區舊有之 GPS 點(余水倍, 1997)

台灣地區斷層密布，過去全島性的全球衛星定位系統測量網在本區僅有零星分布的測量點(Yu et al., 1997)，而大部分測網測點間距為數十公里，無法提供足夠而詳細的資料以獲知個別斷層的活動情形。本計畫第一年選定新竹地區主要活斷層如新竹斷層、新城斷層、竹東斷層實施密集分布的水準測量點及全球衛星定位系統測量網(圖一)。密集全球衛星定位系統觀測結合高精度水準測量，提供包括水平及垂直方向的詳細高精度殼變形資料，以估算斷層滑移率，並與地質觀測的較長期間平均滑移率比較，即可據以評估個別斷層的地震潛勢。

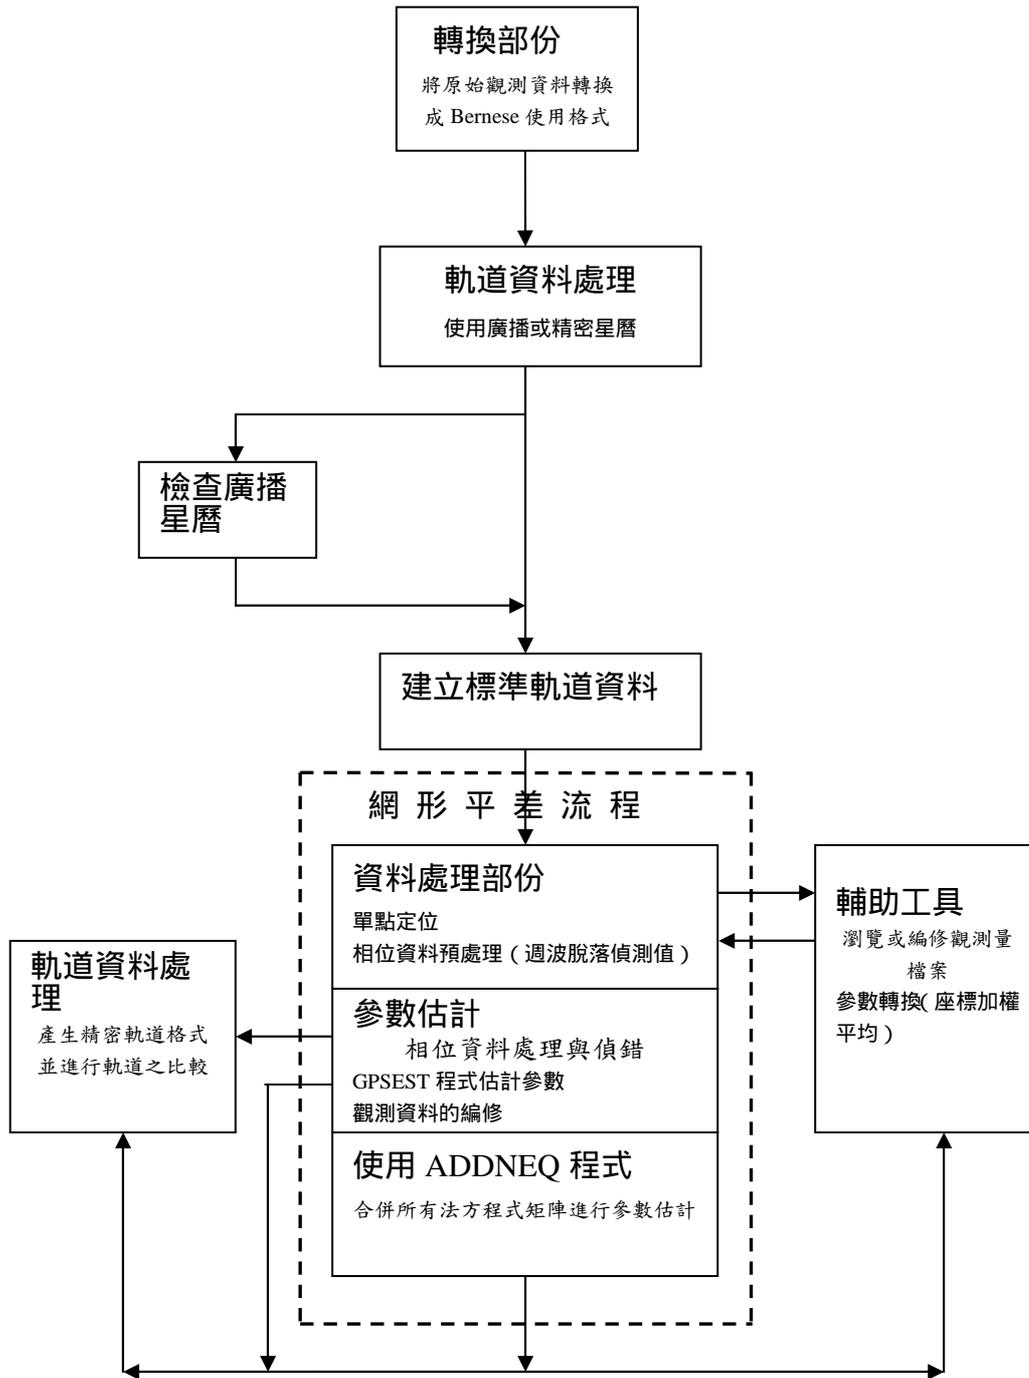
圖二、 Bernese 軟體資料計算與網形平差處理流程圖

此步驟採用連續的最小二乘估計方式，進行所有法方程式的合併求解，理論上與使用所有資料進行一次求解的成果相同。其優在於不需要一次求解所有的資料，可以分次計算而得到相同的成果，故此演算法可以節省大量計算空間，此外若時間段夠長（至少半年以上）還可以估計點位的速度量。所使用的程式為 ADDNEQ。

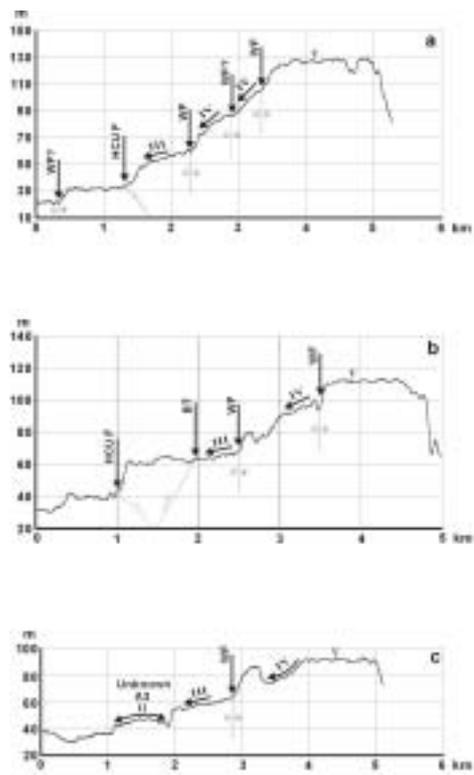
Figure 7

Fig. 7 Transverse cross-sections cutting through the flight of terraces at six locations from lower reach upstream. Obviously, terrace surfaces are individually affected by the active tectonics, leading to differential deformation. In particular, the surfaces are warped by back tilt associated with the faulting. Although so far no geologic evidence to confirm the origin of the terrace scarps, we tentatively suggest them as fault scarps since they divide the surfaces with differential deformation. The high tilting angle of terrace IV is probably caused by axis turning of the Chingtsaohu anticline. Small anticline, A3, is also shown in profile C. Circles with a dot in the center represents the movement outward the paper and vice versa the circles with cross. The other symbols follow Fig. 6. Vertical exaggeration is also 20 times.

The wrench fault system mentioned above is composed of two to three parallel but discontinuous surface traces (Figs. 4 and 7). They are all generated from the Hsinchu Fault in the west and all the way truncating the Hsincheng Fault, then reaching the eastern end of the study area. It is very difficult to distinguish this structure using available seismic profiles since the profiles are deep ones worked out for petroleum exploration. The field investigation also failed to find geologic outcrop showing faulting evidence. Nevertheless, in terms of geomorphic features, pressure ridges, back-tilting terraces and pull-apart depressions (albeit they are thought being initiated by bending moment tensile stress associated with the Hsinchu Fault) presented in this study, such a wrench fault system possibly exists. It is characterized by two to three long scarps trending NNW to SSE, which were thought being terrace risers because of their orientations parallel to modern river (Fig. 4).

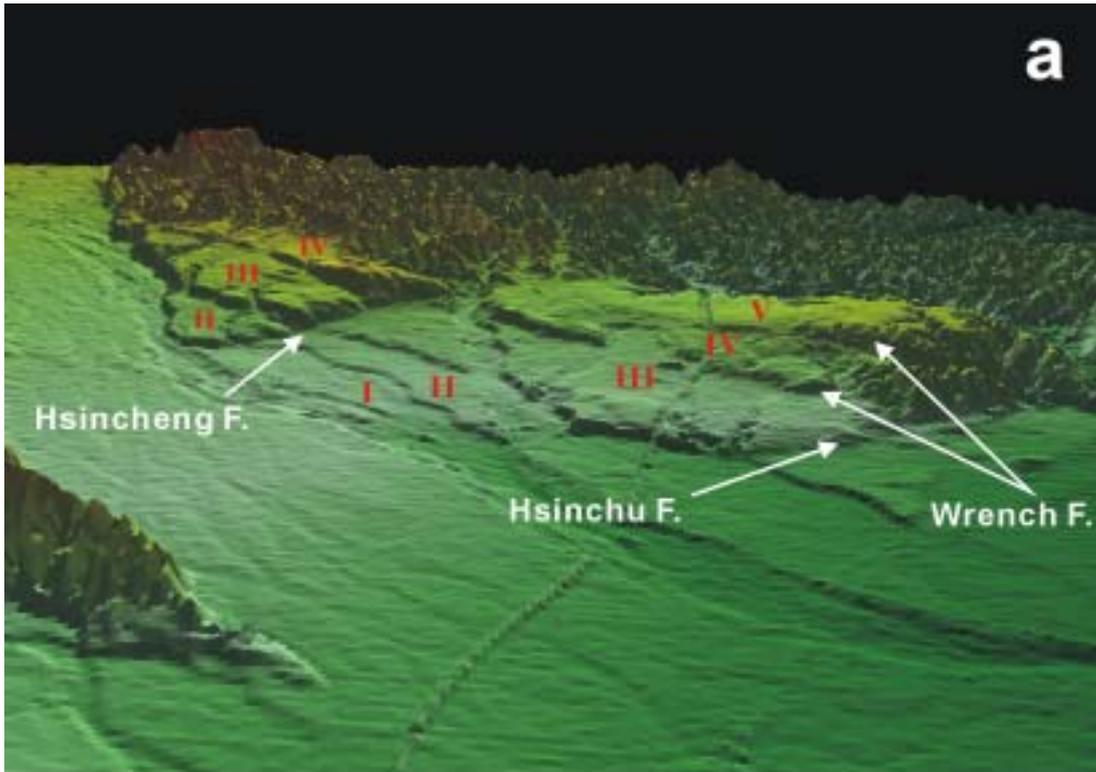
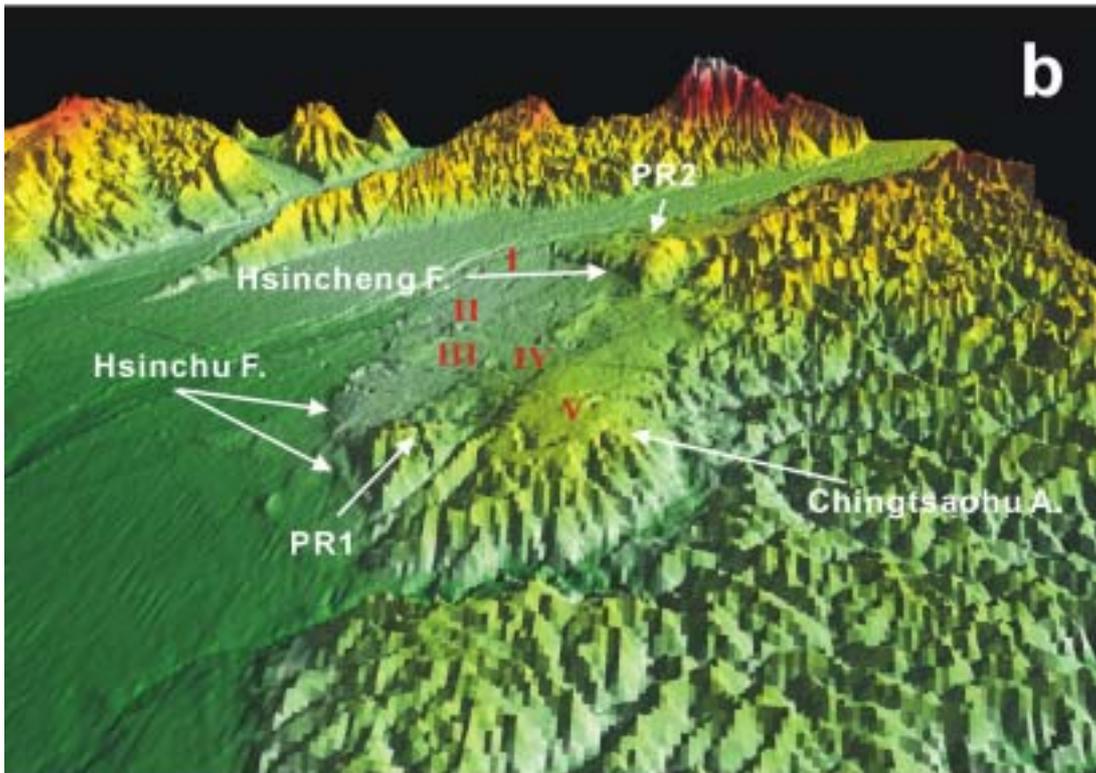
Figure 8

Fig. 8 Two oblique scenes showing the geomorphology of the study area.

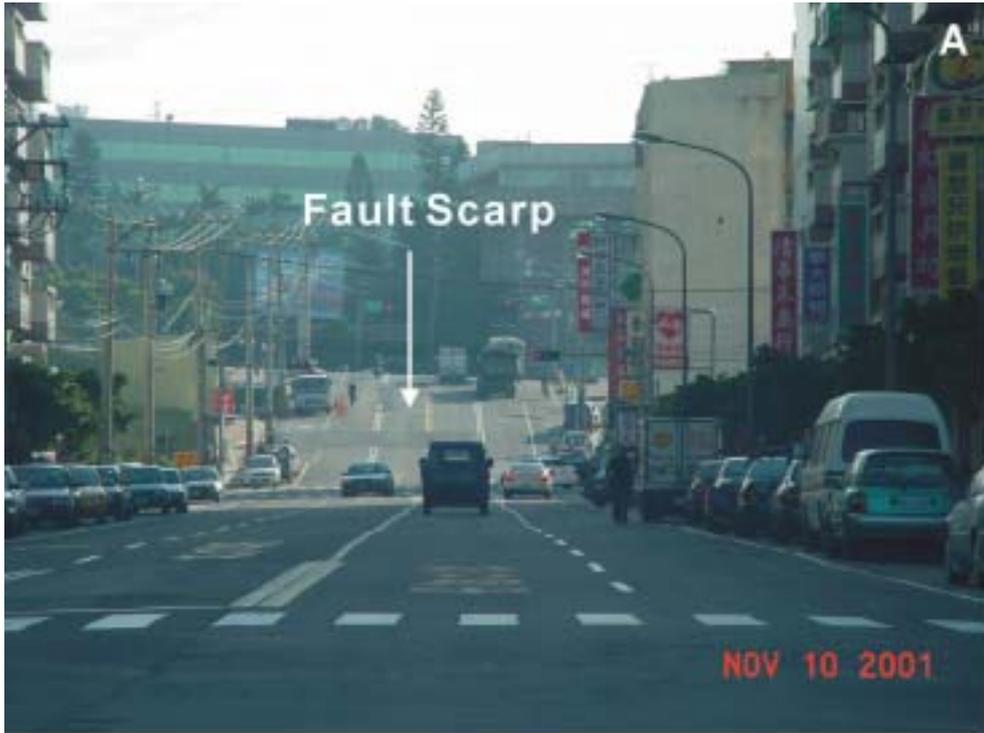
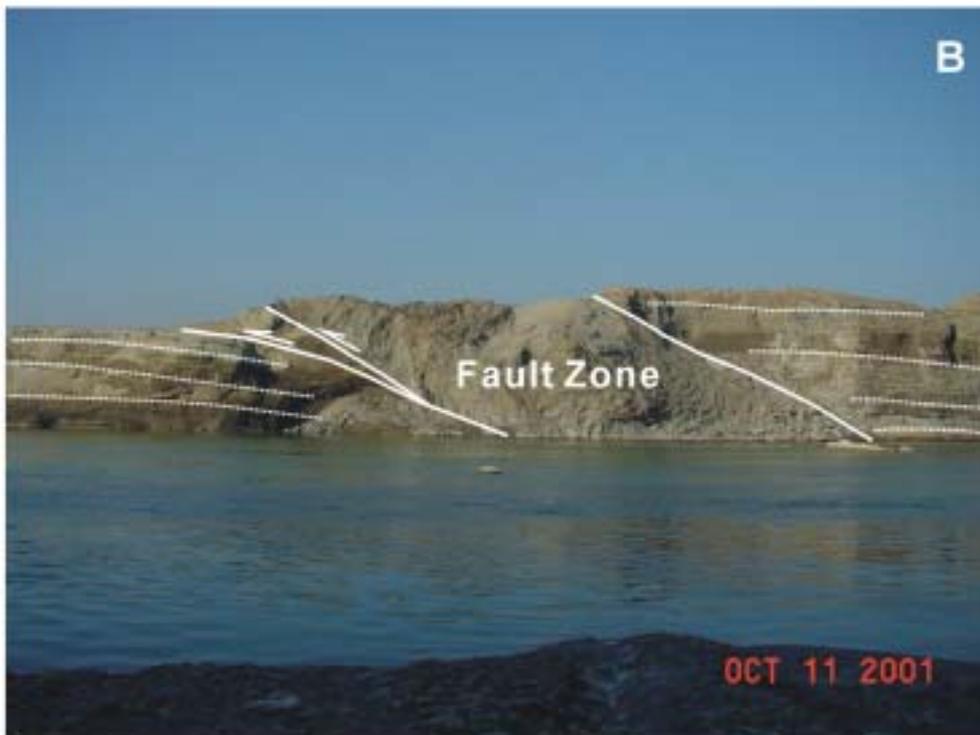
Figure 9

Fig. 9 A. Photograph of the fault scarp of the Hsinchu Fault in Hsinchu City. The foundation excavation of the far building in hanging wall showed upright and brecciated bedrock, which is the only field evidence of the Hsinchu Fault. B. Photograph of an outcrop of the Hsincheng Fault along the Touchien river. White dash-lines represent the beddings. A low angle thrust with vergence to the west reaches the ground surface with a fault zone of 4 to 5 meters in width that bound by two slip planes. The hanging wall is composed of Pliocene coastal deposits, sandstones and shales, while the footwall is the younger (Pleistocene) sandstone dominant unit that is believed as the distal part of an ancient fan-delta created in the mountain front.
