Challenges on reservoir sedimentation management for sustainable hydropower operation

Yoichi YOSHIKAWA

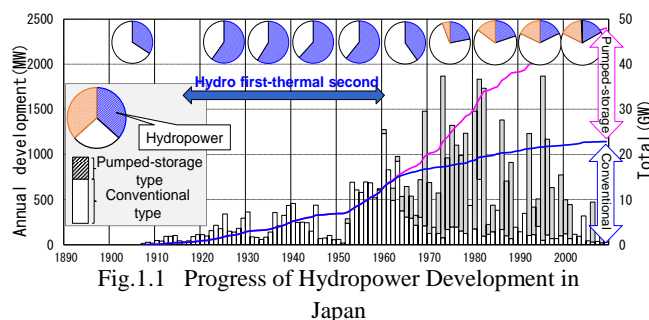
Fig.1.1 Progress of Hydropower Development in Japan

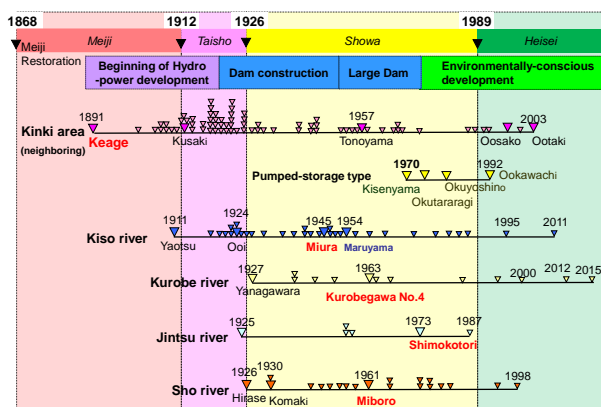
Fig.1.3 Progress of Consistent Hydropower Development in KEPCO

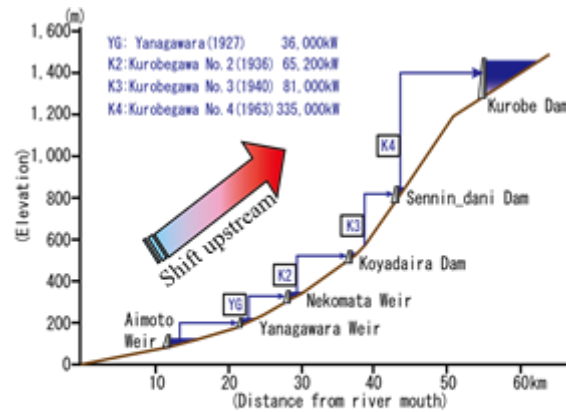
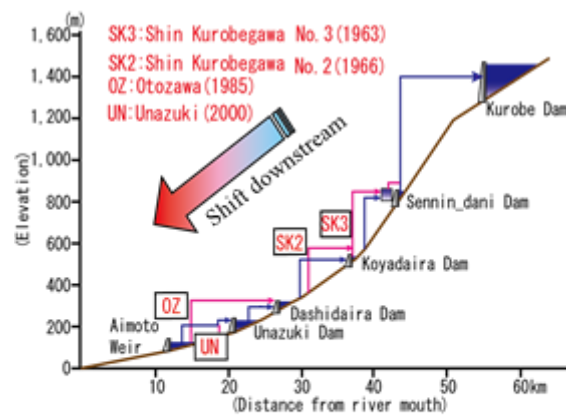
(a) Development moving upstream (1934–1963)

(b) Development moving downstream (1963~)

Fig. 1.4 Steps in the development of hydropower on the Kurobe River

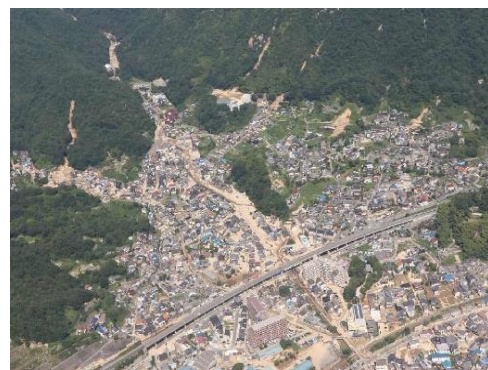
Photo 1.3 Sediment runoff and flooding due to torrential rain in July 2018 (Kure, Hiroshima Prefecture)¹⁾

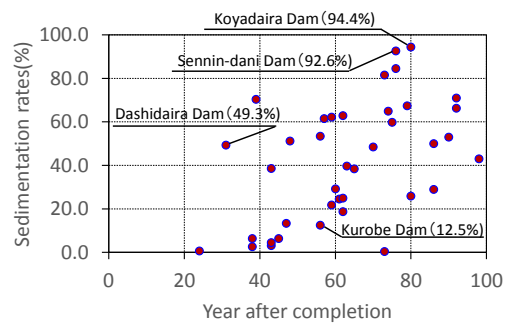
Fig.1.5 Sedimentation rates for dams of KEPCO

How to proceed with measures against sedimentation in situations of accelerated sediment inflow to reservoirs and regulating ponds is a major issue that affects the future of hydropower projects. Fig. 1.5 shows the relationship between the year of completion of the dam and the sedimentation rates for dams of KEPCO.

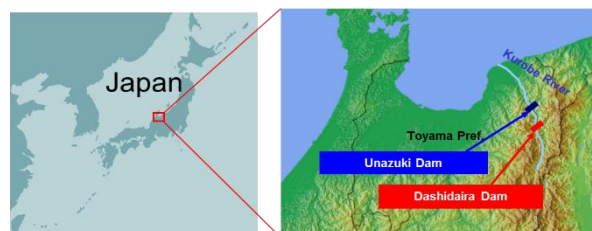
Fig. 2.1 Location of Dashidaira Dam

With the floods in July 1995 and July 2017, the riverbed at Nekomata near the end of the Dashidaira Dam reservoir rose. This caused damage, including burying the water outlets at the Kurobegawa No. 2 Power Station and the Shin-Kurobegawa No. 2 Power Station, and increased tailwater levels.

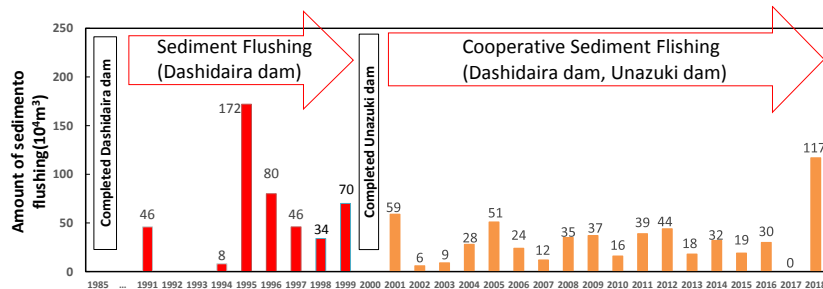
Fig. 2.4 Amount of sediment flushing (Dashidaira Dam)

Similar facilities were also built at the Unazuki Dam (completed in 2001), which was constructed about 7 km downstream. Efforts to flush sediment are conducted cooperatively. A chronology of flushing at the Dashidaira Dam and amounts of sediment flushing are shown in Fig. 2.4. The history of sediment flushing at Dashidaira Dam can be split roughly into two periods: flushing conducted by Dashidaira Dam alone, and flushing conducted in cooperation with Unazuki Dam downstream. We will describe each in detail below.

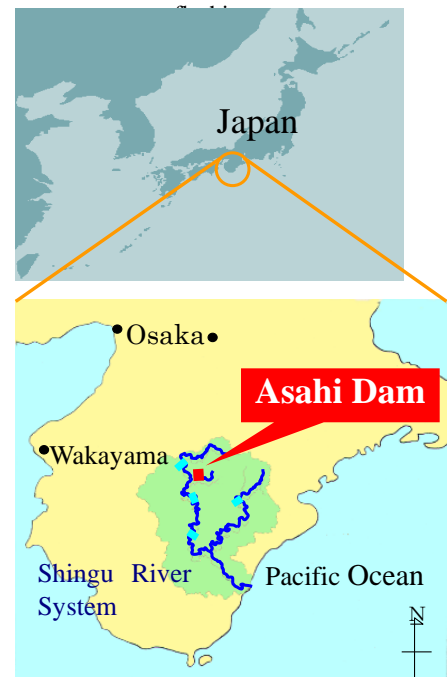
Fig. 2.6 Location of Asahi Dam

The KEPCO's Okuyoshino Power Station (Pumped-Storage) is located in the Shingu River, Nara Prefecture, which is home to national and quasi-national parks. Because of this, since the dam was originally constructed (completed in 1978), efforts have been made to preserve water quality by putting selective water intake facilities in place at the dam in order to give proper consideration to environmental issues. However, the river basin had become devastated around 10 years after the dam's completion. The occurrence of large-scale floods caused by typhoons in 1990 in particular caused a large quantity of suspended matter supplied from landslides upstream to flow into the reservoir. This in turn caused

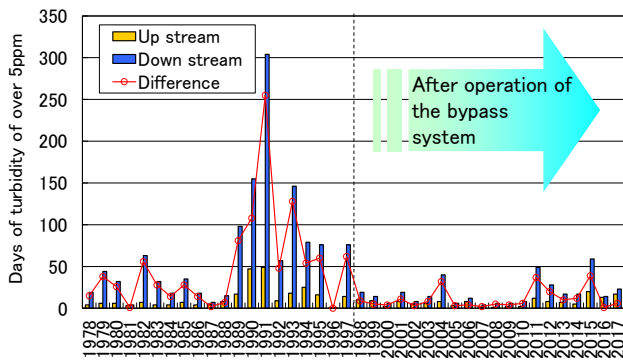
Fig. 2.8 Number of days with turbidity over 5ppm

Compared to the levels before the operation of the sediment bypass facilities, the number of days of prolonged turbidity has been greatly reduced since the start of operation in 1998 (Fig. 2.8). Based on these results, the bypass facilities were seen to be effective in mitigating prolonged turbidity. Fig. 2.9 shows changes in sedimentation volume before and after installation of the sediment bypass facilities. According to this, since the

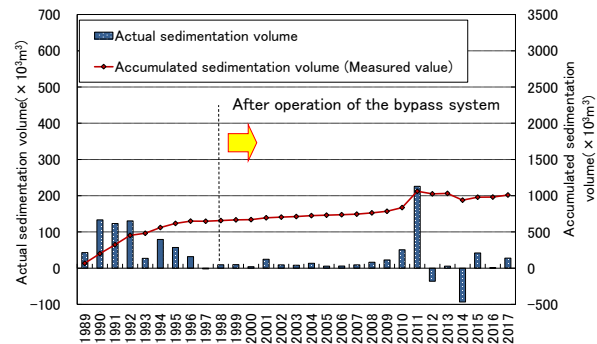
Fig. 2.9 Measured sedimentation volume in the Asahi Dam

sedimentation rate shows almost no upward trend after operation began, we see that the bypass is effective in mitigating sedimentation.

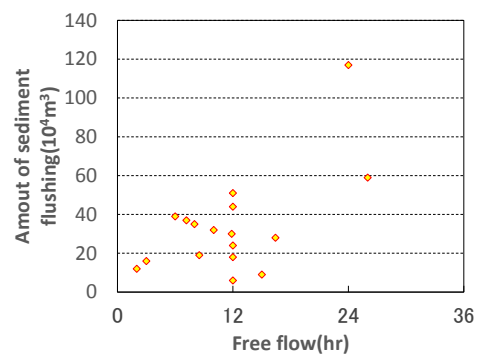
Fig. 2.10 The relationship between the amount of sediment flushing and the free flow time at Dashidaira Dam (Based on data after cooperative flushing began in 2001)

- Flushing be implemented at least once a year in order to prevent deterioration of deposited organic substances.
- Flushing time could be limited within 12 hours in most cases as shown in Fig.2.10.

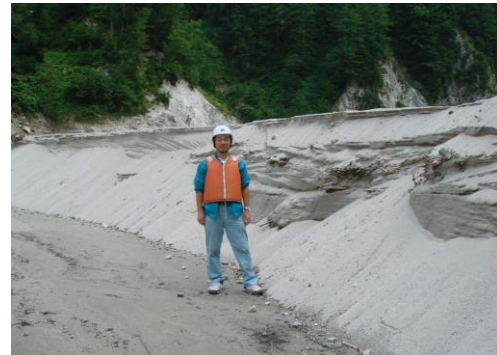
Photo.3.1 Dr. Sumi on the backsand of Kurobe Dam

The sedimentation volume for the Kurobe Dam already exceeded the design value of 100-year worth in 58 years after its completion. Since the difference of flow rates between flood and drought is extremely large in Japan, how to maintain the effective capacity of the reservoir furthest upstream on a major river is the most important issue for the durability of hydropower generation.
