# Impact of Flood Disasters on Taiwan in the Last Quarter Century

**Abstract.** The increasing natural disasters, especially floods during the last quarter century, are raising the economic losses in Taiwan. The most severe hazard in Taiwan is flooding induced by typhoons and storms in summer and autumn. By comparing the rivers around the world, the ones in Taiwan have the steepest slopes, the largest discharge per unit drainage area, and the shortest time of concentrations. Rapid urbanization without proper land uses managements usually worsen the flood problems. Consequently, flood hazards mitigation has become the most essential task for Taiwan to deal with. Although the government keeps improving flood defense structures, the flood damage grows continuously. In this article, possible flood mitigation strategies are identified for coping with complex environmental and social decisions with flood risk involved.

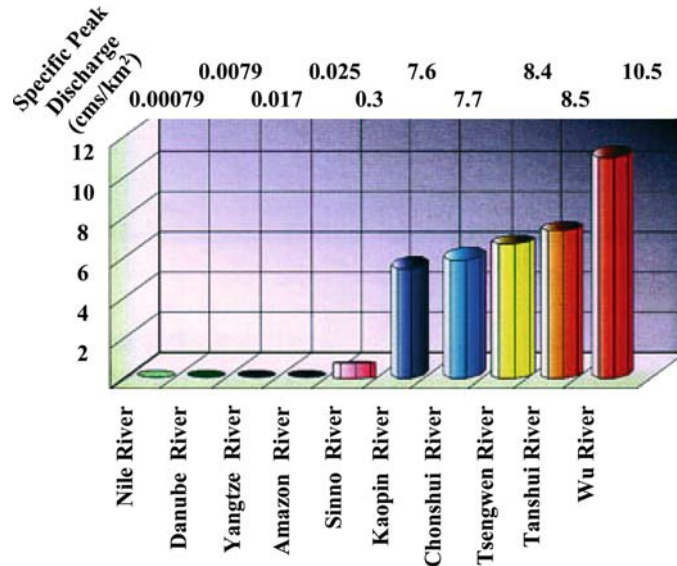
Figure 1. Comparison of specific peak discharges in rivers around the world (cms is  $7 \text{ m}^3/\text{s}$ ).

The annual rainfall in Taiwan reaches 2500 mm, which is 2.5 times the world average. However, 75% of the annual rainfall concentrates in the period from May through October. There were 350 typhoons, and over 1000 storms in Taiwan in the last century. The statistics show that losses due to natural disasters reached 365 million US dollars from 1983 to 1995. The amount is approximately 4.6 times fire damages in the same period. The peak discharge per unit drainage area in Taiwan is the largest in the world. For instance, the specific peak discharge of the Choshui River is 450 times that of the Yangtze River in China and 25 times that of the Sinno River in Japan. The comparison of specific peak discharges in the world is shown in Figure 1, and all of the rivers whose specific peak discharges are larger than the Sinno River's are in Taiwan.

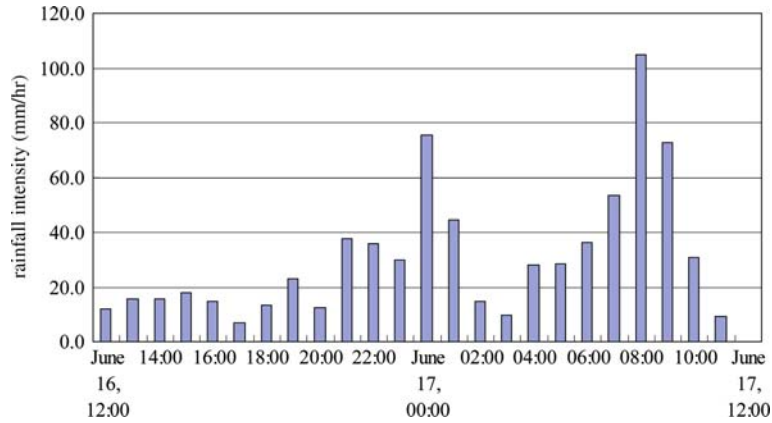
Figure 2. Historical rainfall records of Nan-Gun rain gage in Typhoon Nali.

On September 17th, 2001, the mountains in northeastern Taiwan suffered from a heavy rainfall brought by Typhoon Nari. According to the CWB's report, typhoon came through the Keelung River from the sea with threatening rain clouds that caused torrential rainfall. In the Nankang District of Taipei, the rainfall intensity increased from 4 a.m. (shown in Figure 2), the hourly rain amounted to 105 mm at 8 a.m. and 73 mm at 9 a.m., respectively. The 12-h rainfall from 4 a.m. to 4 p.m. amounted to 530 mm.

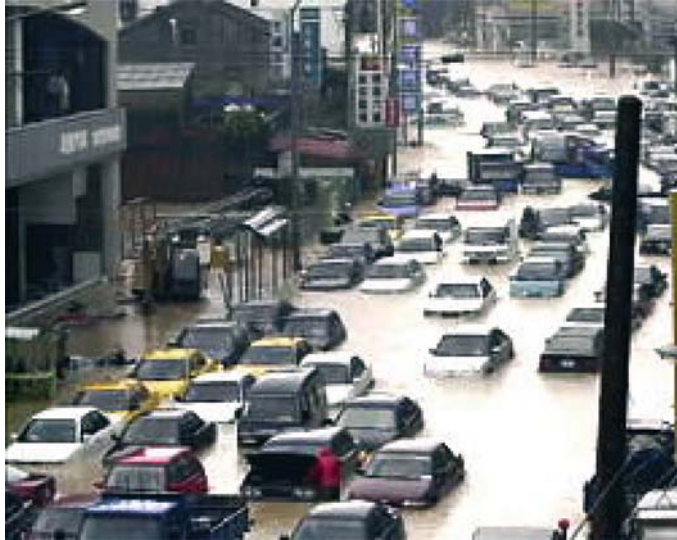
*Figure 3.* Numerous cars were submerged in Typhoon Nali.

This heavy rainfall and the consequent overflow from the Keelung River caused the inundation of a wide area of Taipei city, which is located in the northern part of Taiwan. The flood intruded into the substructure space, namely, the rapid transit system, the subway stations, and the basements in buildings and underground shopping malls, which caused heavy damages. There were 104 casualties or missing persons in this storm. The losses were so huge at the Taipei City government and most experts believed that the direct losses should be more than 20 million US dollars. Figure 3 shows numerous cars submerged in Typhoon Nali storm and people dealing with the enormous waste after the flood in Figure 4 (Taipei City Government, 2001).

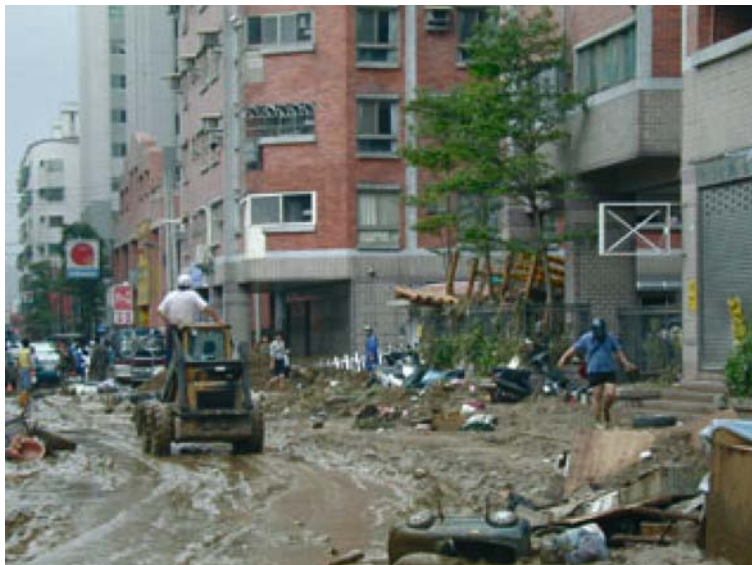
*Figure 4.* People deal with enormous waste after Typhoon Nali.

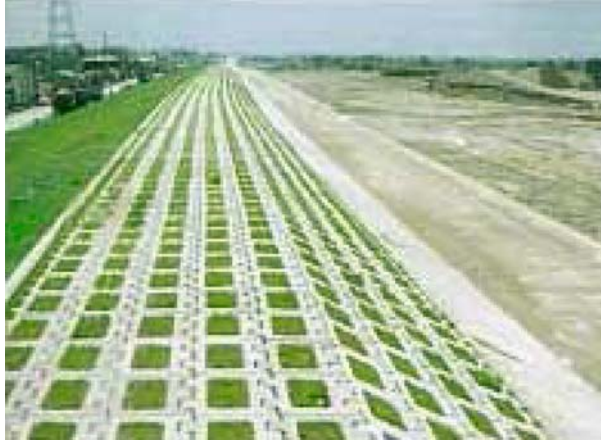
Figure 5. Dike construction employing ecology methods.

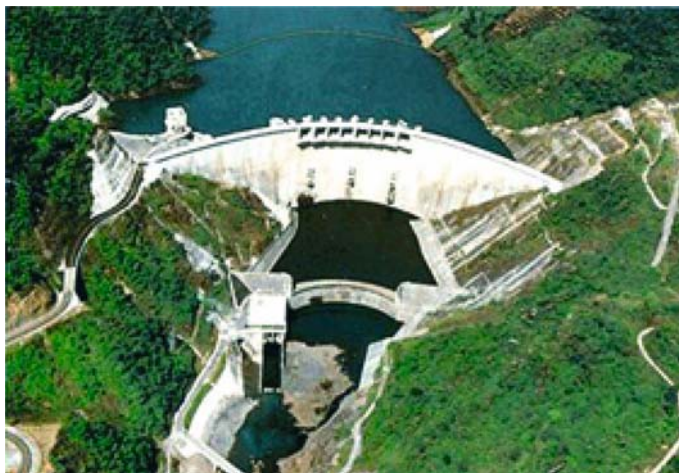
Figure 6. Overview of the Feidui reservoir in Taiwan.

During the period of Typhoon Herb, those 11 flood control reservoirs stored approximately 900 million cubic meters of flood flow; among them, the Feidui Reservoir (shown in Figure 6) stored 370 million cubic meter of flood flow.

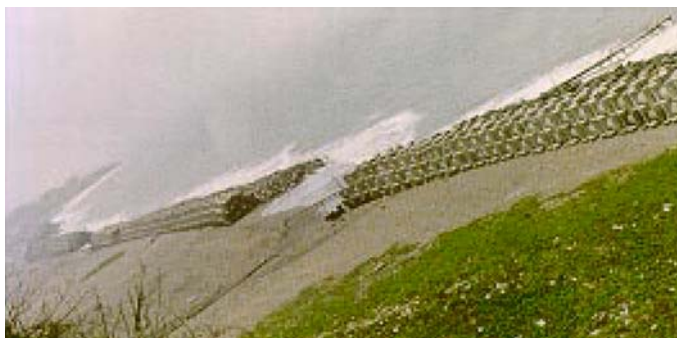
*Figure 7.* Coastal protection along Ginshan beach in Taipei County.

It is very important to protect the long coastline in Taiwan. In addition to installing tidal stations, coastal protection and coastal dikes are the two most commonly used protection facilities. Figure 7 shows the coastal protection along Ginshan beach in Taipei County. In order to improve scenery and sustainable use of coastal resources, improvements with a natural look should be actively pursued now around Taiwan.
