# Operation Results of the Koshiybu Dam Sediment Bypass Tunnel Completed in 2016

Katsushi Ishida, Toshiyuki Sakurai and Tetsuya Sumi

The Koshiybu Dam was constructed in 1969 and managed by the Ministry of Land, Infrastructure, Transport and Tourism, Japan. At the Koshiybu Dam, the sediment bypass tunnel (SBT) project was launched in 2000 with the aim of preventing sedimentation in the reservoir and ensuring the continuity of sediment transport at the river. The SBT was completed in September 2016.

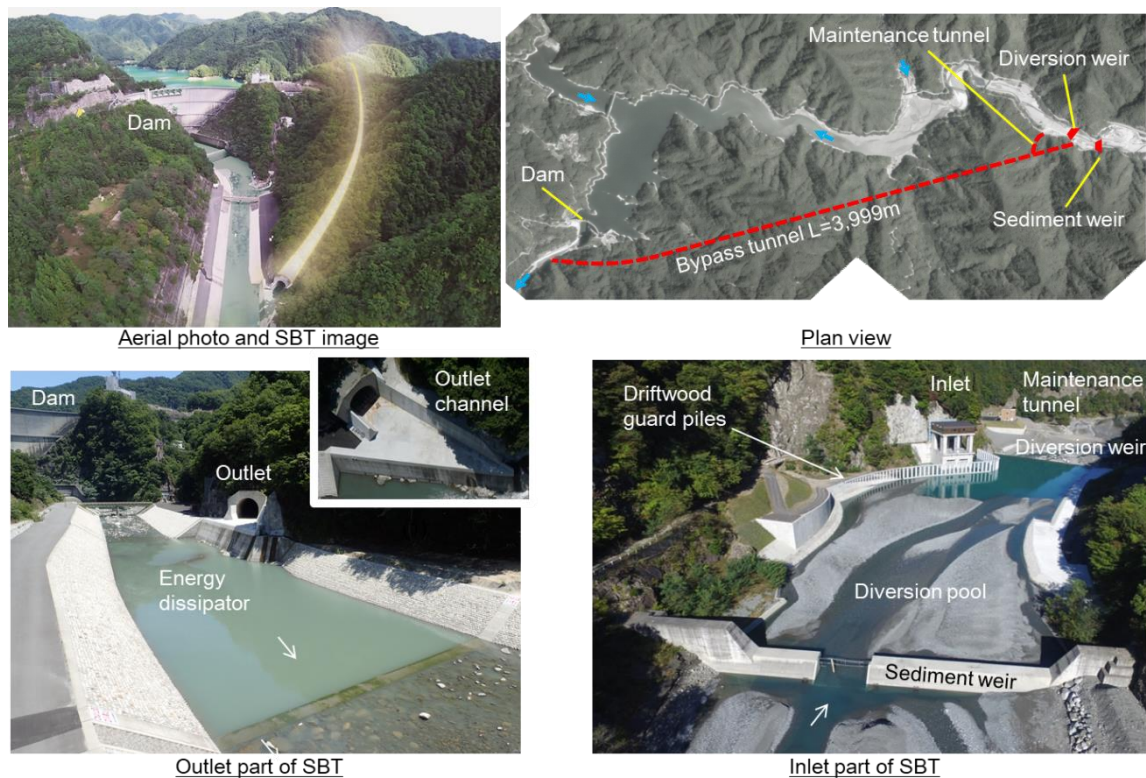
Figure 1: The outline of the Koshihbu dam and its SBT facilities

The Koshiybu Dam is an arch type concrete dam of 105 meters high for flood control, irrigation and power generation constructed in 1969. Figure 1 shows the outline of the Koshiybu dam and its SBT facilities. Regarding the background and history of the project, specifications and structure of the facilities of the Koshiybu Dam and its SBT, please refer to the past reports (Kashiwai, J., Kimura, S. (2015), Takeuchi et al. (2017), Sakurai et al. (2018)).

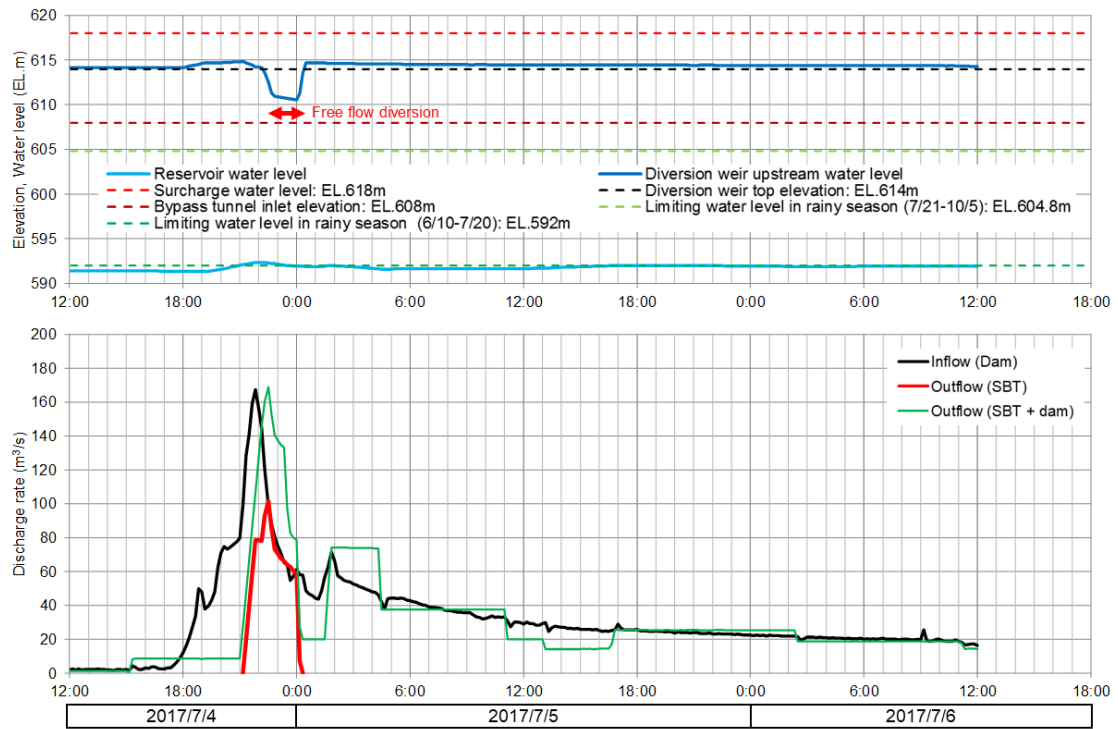
Figure 2: Hydrographs of the first trial operation in 2017

Hydrographs of three trial operations in 2017 are shown in Figure 2 to 4. And Figure 5 shows photographs of flow conditions in the inlet and outlet part of the SBT during the third trial operation.

In the first operation, the maximum discharge rate from the SBT was about 100 m³/s. At the time when the inflow discharge rate became 60 m³/s (SBT operation finish judgment reference discharge rate), the SBT discharge was terminated and it was a short-term discharge of about 3 hours.

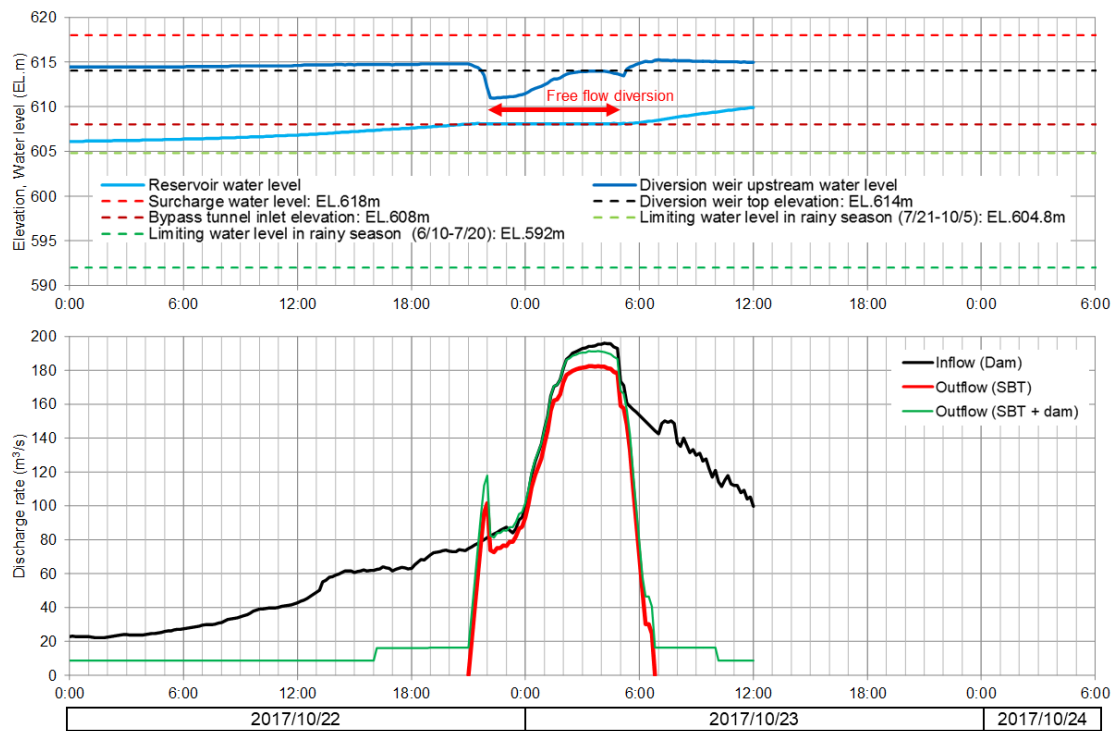
Figure 3: Hydrographs of the second trial operation in 2017

In the second operation, the largest past SBT discharge rate at the time 183 m³/s was discharged. The discharge time was about 10 hours, and after the peak of the inflow, the

inflow discharge rate was 60 m<sup>3</sup>/s or more, but the SBT discharge was terminated in order to recover the water use capacity.

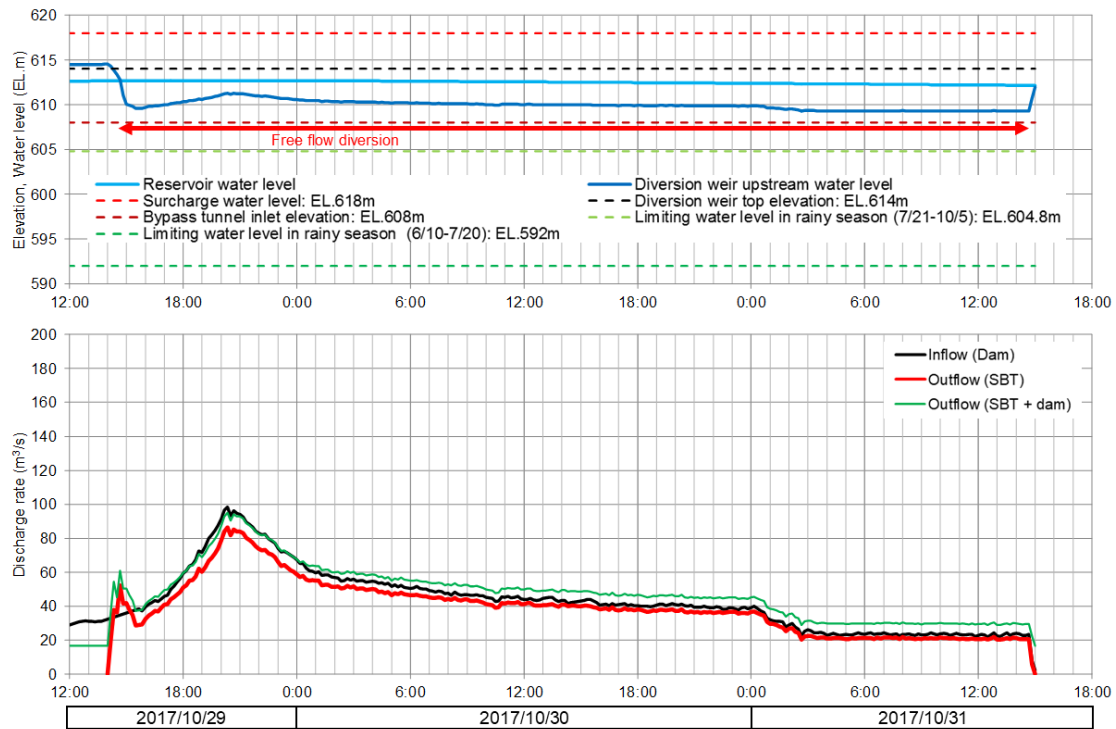
Figure 4: Hydrographs of the third trial operation in 2017

In the third operation, since the water use capacity was kept at the beginning of the flood, when the inflow amount was less than 60 m<sup>3</sup>/s, the SBT discharge was started earlier. Although the maximum SBT discharge rate was not so much as 86 m<sup>3</sup>/s, about 49 hours of discharge, which is the longest at the time, was carried out.

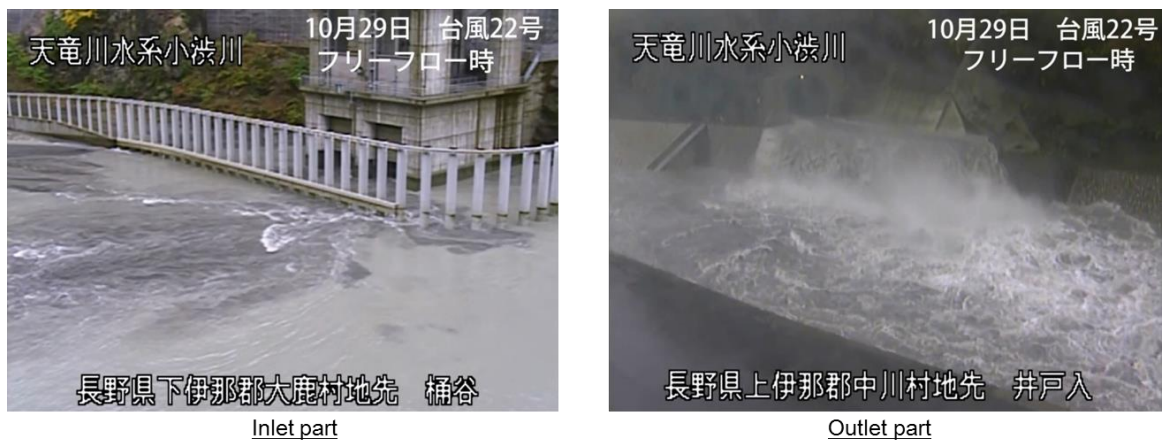
Figure 5: Flow conditions of the SBT inlet (left) and outlet (right) at third trial operation in 2017 (2017/10/29 17:00, SBT discharge rate: about 50 m³/s)

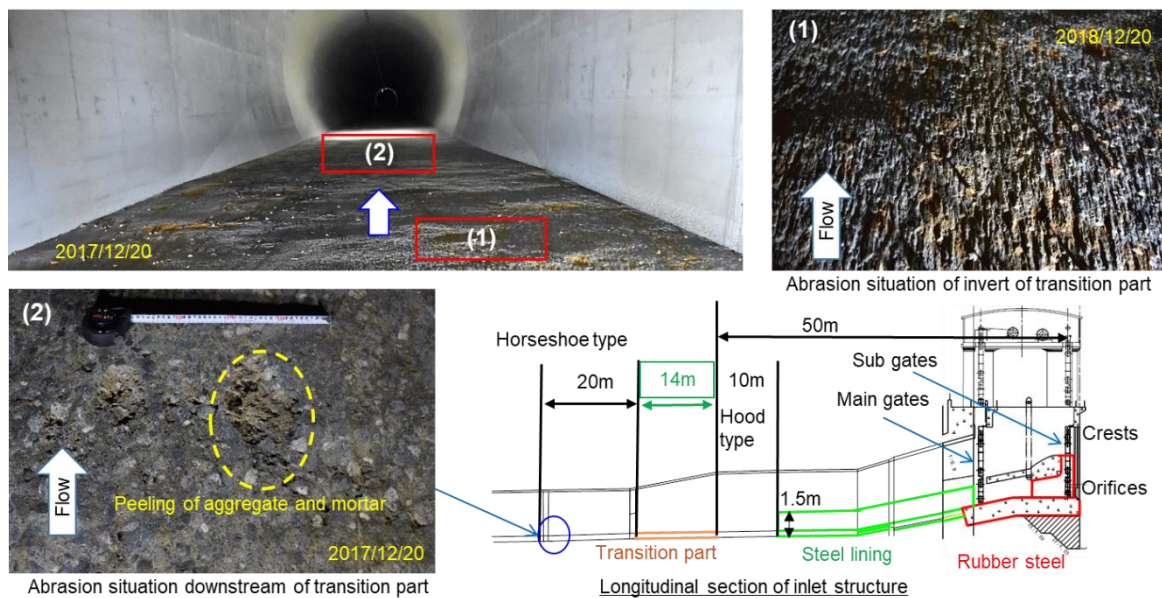
Figure 6: Abrasion damage situation of the tunnel invert after the trial operation in 2017

As a result of trial operation of SBT in 2017, regarding structural aspects, wear of the surface mortar part was observed over the entire bypass tunnel and aggregate exposure was confirmed at a part of invert concrete, but there was no serious damage (Figure 6). And there was no major damage to near the inlet part protected by the steel lining and rubber steel.

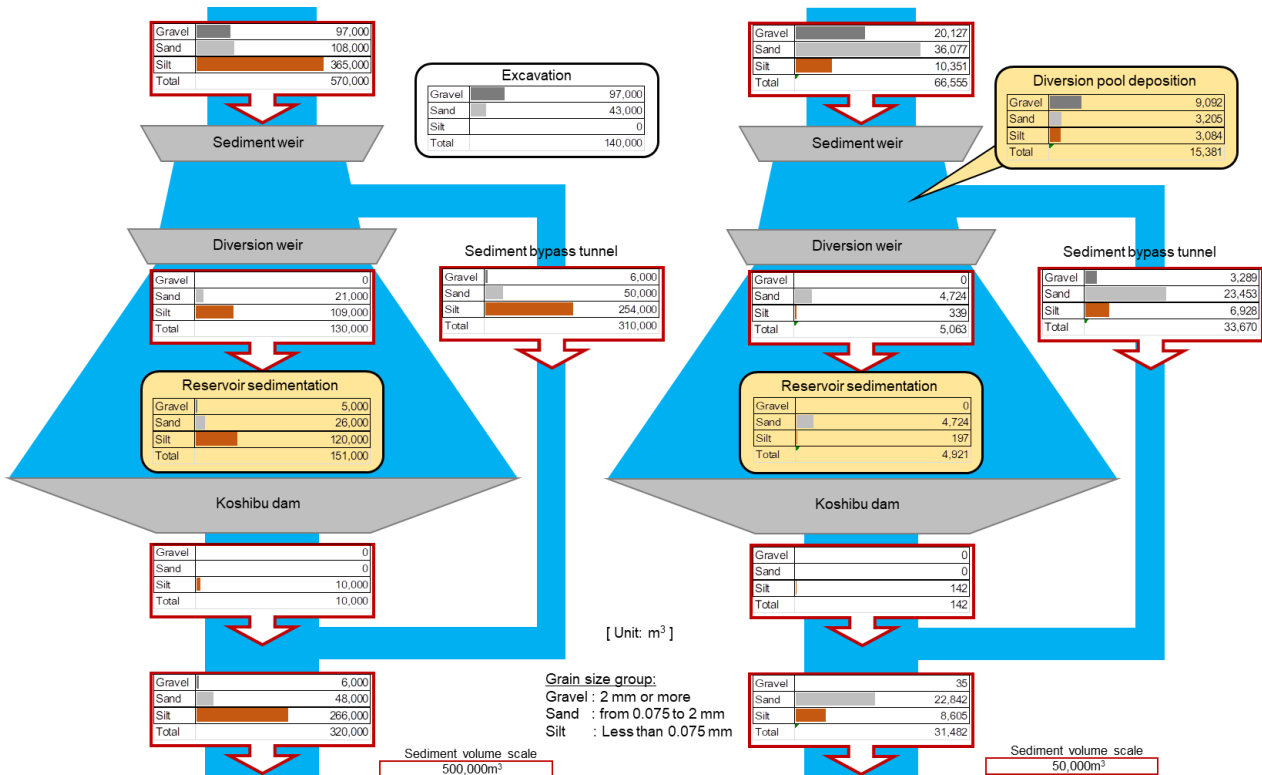
Figure 7: The sediment budget for each sediment grain size group (left: annual average sediment budget plan of the Koshibu dam SBT, right: sediment budget during the trial operations in 2017)

The sediment budget for each sediment grain size group is shown in Figure 7 together with annual average sediment budget plan of the Koshibu dam SBT. During the trial operations, about 67,000 m<sup>3</sup> of sediment flowed from the upstream, about 15,000 m<sup>3</sup> of sediment accumulated in the diversion pool and about 34,000 m<sup>3</sup> of sediment was bypassed. The proportion of sand in the bypassed sediment was as large as 70%. In addition, in the operations, the amount of reservoir sedimentation was suppressed to about 5,000 m<sup>3</sup>, and about 31,000 m<sup>3</sup> of sediment was supplied to the downstream river. Compared with the annual average sediment budget plan (the left in Figure 7), since the flood frequency was smaller than usual and the scale of flood events were small in 2017, the annual estimated inflow sediment volume about 150,000 m<sup>3</sup> was quantitatively small. Although the ratio of bypassed sediment and inflow sediment of trial operations in 2017 was about 50%, which was close to the planned ratio.
