Reconnaissance Report on the 31 March 2002 Earthquake on the East Coast of Taiwan

C. H. Loh,^{a)} M.EERI, K. C. Tsai,^{a)} M.EERI, L. L. Chung,^{b)} and C. H. Yeh^{b)}

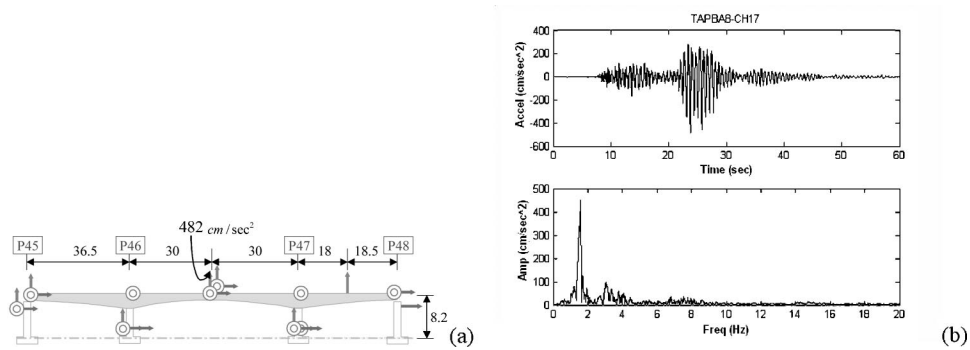
Strong motion data collected from viaducts in Taipei City were also analyzed, as shown in Figures 13 and 15. Figure 13b shows the recorded acceleration response at the center span of a viaduct (Cheng-Kuo South Expressway). The maximum acceleration at the center of the span is 482 cm/sec^2 in the vertical direction. The dominant period of that signal is 1.57 seconds. Damage of bearing in this highway viaduct was observed during this earthquake. A permanent horizontal displacement about 3 cm in the bearing had been observed, as shown in Figure 14.

Figure 13. (a) Side view of and instrumentation layout at the Chang-Kuo Viaduct (TAPBA8) in Taipei City. The recorded peak acceleration at mid-span of the viaduct in vertical direction is 482 cm/sec², and (b) recorded acceleration time history and the corresponding Fourier amplitude spectrum (in vertical direction) at the mid-span of the viaduct.

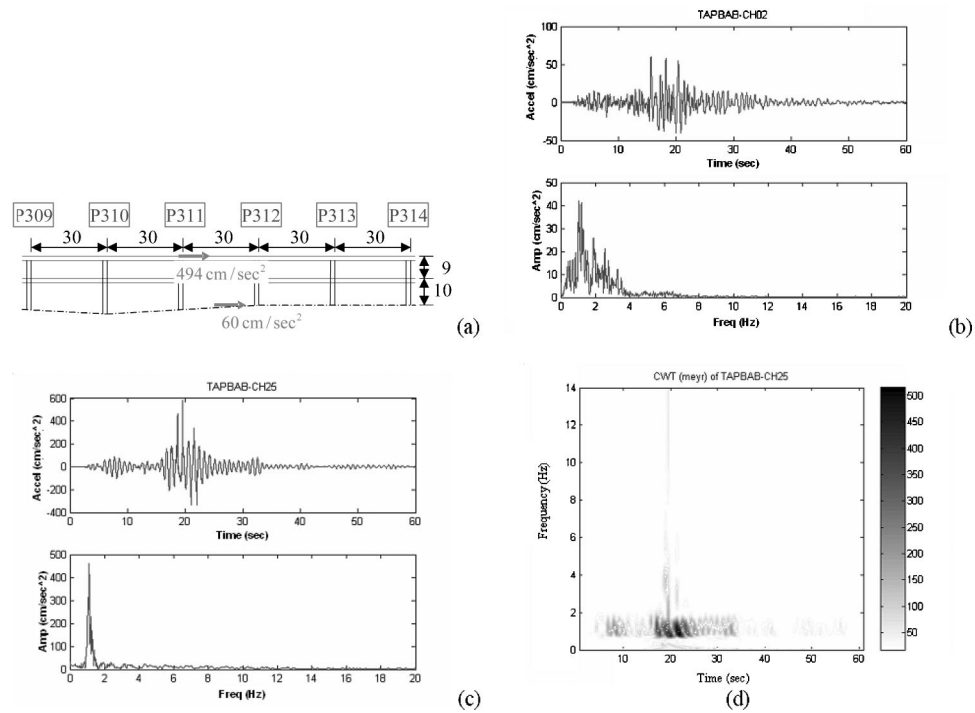
Acceleration response of another expressway viaduct (TAPBAB in Figure 10) was shown in Figures 15a–d. The recorded horizontal acceleration at the base was 60 cm/sec^2 ; and that at the top deck of the viaduct was 494 cm/sec^2 (the accelerometer at the top deck was located near the expansion joint where minor impact phenomenon

was observed). The amplification on peak acceleration was significant. Wavelet analysis was used to study the response data. Figure 15d shows the amplitude-frequency-time spectrum of the recorded bridge response at the deck of the viaduct. From Figure 15d it is found that high-frequency signals (10~12 Hz) exist in the response data. Detailed study is required on the high-frequency signal in the response data with respect to damage feature.

Figure 15. (a) Side view of and the recorded maximum acceleration of TAPBAB, which is one of the viaducts in Taipei City; (b) and (c) recorded acceleration time histories and the corresponding Fourier amplitude spectra at the ground and the top deck of the viaduct shown in part (a); and (d) continuous wavelet analysis from data collected at the top deck of the viaduct.

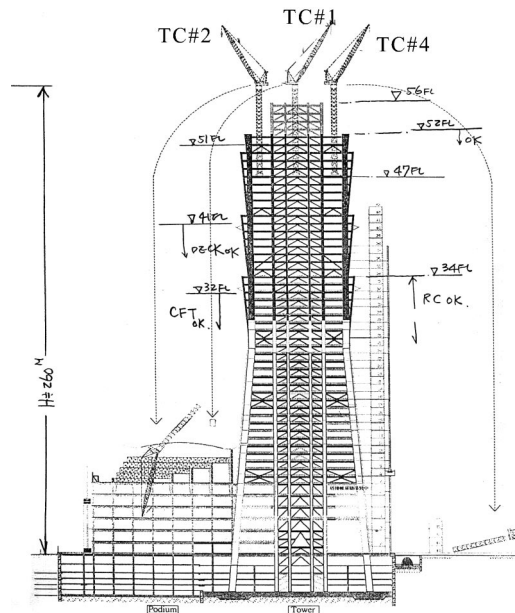
among four tower cranes, two collapsed and one was severely damaged with crane counterweights falling off one end of the boom, as shown in Figure 22. The incident killed two corresponding crane operators, two steel workers near the 53rd floor and one part-time student worker on the ground. This article reports on the damages of the TFC structure observed following the 31 March earthquake and discusses the ground accelerations recorded at two nearby free-field strong-motion stations.

Figure 22. Elevation view of the frame and tower cranes of TFC construction site. The locations of two fallen cranes are also indicated in this figure.

the falling of the column being erected by TC#1. In addition, the strong shaking together with the sudden release of the lifted column weight seem to be responsible for all the counterweights (15 pieces, 75 kN each) of TC#1 falling from the rack and dropping from a height of about 260 m (Figure 22). Some of these counterweights hit the ground and caused substantial damage to construction equipment and material. Two pieces of the counterweights hit and damaged a significant part of the construction site office (Figure 28b). Some of the falling counterweights penetrated the metal deck, severely damaging several steel beam members before stopping at the 34th concrete floor slab. The falling boom of TC#2 hit and penetrated the roof structure of the podium, and the collapsed TC#4 landed on the adjacent street. Due to the severe vibrations and the impacts caused by the falling counterweights, various construction material and equipment, including some welding machines, high-tension bolt containers, and damaged steel members fell from high floors. Some of the falling pieces knocked off some edges of the concrete slab and damaged the perimeter curtain walls near the lower floors before landing on the ground.

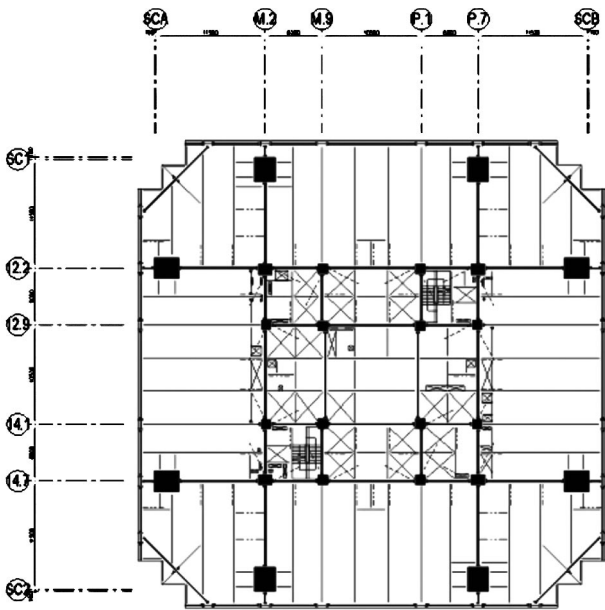
Figure 23. Plan view of the frame system on the 47th floor of the TFC construction site.

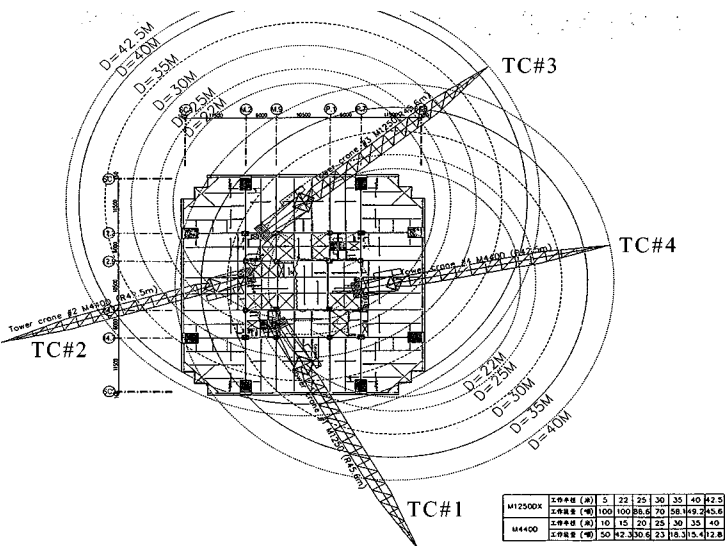
A total of four tower cranes (TC#1 through TC#4), as shown in Figure 24, had reached a height of about 260 meters on 31 March 2002 for lifting the material or equipment for the construction of 53rd to 56th floors. These four cranes were designed based on the New Zealand Seismic Standards. The tower cranes TC#1 and TC#3, located near

Figure 24. Plan view of the locations of the four tower cranes at the TFC construction site.

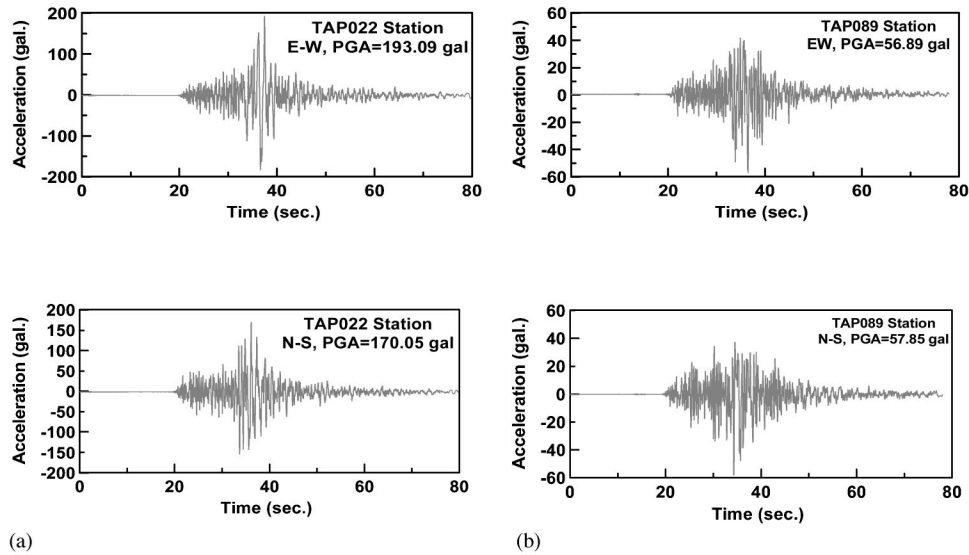
Figure 25. Acceleration time histories of stations (a) TAP022, and (b) TAP089.

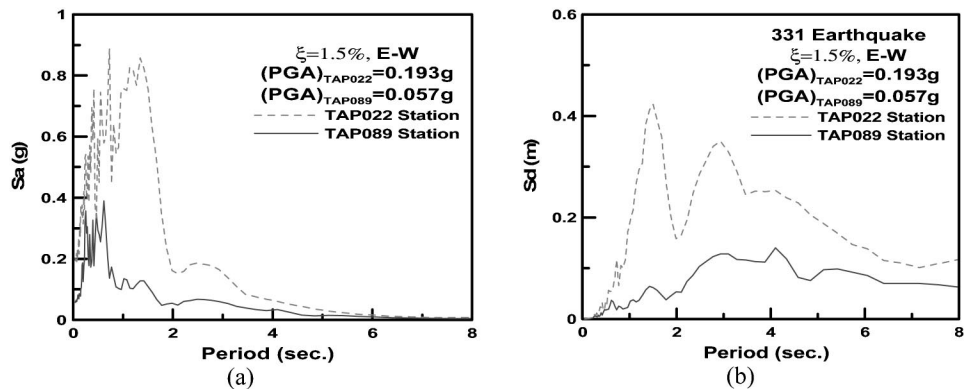
Figure 26. Acceleration (a), and the displacement (b) response spectra, with 1.5% damping at stations TAP022 and TAP089, in the 31 March earthquake.

The site of the TFC building is located at the southeast side of Taipei Basin where a deep alluvium deposit has been identified. Ground accelerations recorded in the main shock of the 31 March earthquake in the TAP022 and TAP089 stations may be useful in assessing the seismic demand imposed on the structures in the region. As shown in Figure 10, the TAP089 site is about 2 km toward the southeast of the TFC and near the foothill of Taipei Basin, while TAP022 is only about 300 m south of the TFC. The variations of ground motion intensity are evident (Figures 25a and 25b) as the PGA in the east-west direction is 0.193 g in station TAP022 and only 0.057 g in TAP089. The elastic acceleration response spectra are given in Figure 26 for a damping ratio of 1.5%. It should be noted that it is estimated from detailed analysis that the fundamental periods of the four tower cranes are about the same as 2.2 and 2.7 seconds for TC#1 and TC#2, respectively, while that of the superstructure of the TFC at the time of the incident is about 2.2 seconds (Tsai et al. 2002a).
