Polyethylene Failure of the Patellar Component in New Jersey Low-Contact Stress Total Knee Arthroplasties

Chun-Hsiung Huang, MD,*† Jiann-Jong Liao, PhD,† Fang-Yuan Ho, MS,‡
Chia-Yin Lin, BS,‡ Tai-Horng Young, PhD,§ and Cheng-Kung Cheng, PhD†

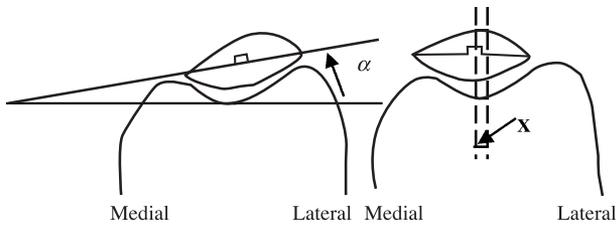
Fig. 1. Gomes/Bindelglass modified roentgenographic measurements of patellar tilt angle (α) and displacement from the center of the trochlear groove (x).

proposed by Gomes et al [5], with modifications suggested by Bindelglass et al [6], in which the reference line was drawn tangentially to the floor of the trochlear groove rather than between the high points of the asymmetric flanges (Fig. 1). This method was used to quantify the condition of the patellar tracking in the center of the trochlear groove. A “good” tracking condition was defined when the lateral-medial tilt was less than 5° , and the subluxation displacement was less than 5 mm at the same time. The surfaces or cross sections of the failed polyethylene were examined by scanning electron microscopy (S-3500N, Hitachi, Japan) to investigate the failure mechanism.
