Investigation of the photo-catalytic coating on AZ91 alloy

A TiO₂ thin film was deposited on AZ91 alloy to enhance the corrosion-resistance and photo-catalytic properties. Experimental results showed that the TiO₂-coated AZ91 exhibited hydrophilicity. The corrosion potential of TiO₂-deposited AZ91 was higher than that of the uncoated AZ91, suggesting an increase in the intrinsic corrosion resistance. Compared with the uncoated samples, the corrosion resistance of TiO₂-deposited samples, on the other hand, deteriorated. FE-SEM observation showed polycrystalline characteristics as well as the presence of pinholes on the film. EDS analysis revealed the pinholes to be locales of incomplete deposition, where accelerated corrosion occurred.

Keywords: AZ91 alloy; Magnetron sputtering; Contact angle; Corrosion resistance; Photo-catalytic

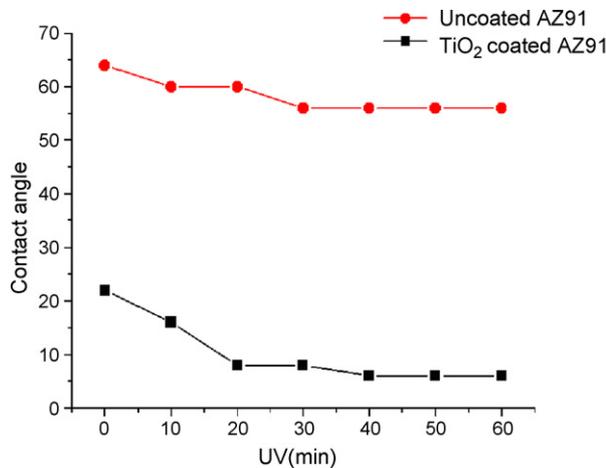
Fig. 2. Contact angle of uncoated and TiO₂-coated AZ91 alloys as a function of UV exposure time.

When a photo-catalytic TiO₂ is exposed to UV light, it forms a hydrophilic surface [17]. Fig. 2 shows the contact angle vari-

ations as a function of UV exposure time for uncoated AZ91 substrates and AZ91 substrates deposited with a thin film of TiO₂. Since the contact angle variations observed in this study are significant, the effect of surface roughness on the contact angles may be neglected. Uncoated AZ91 substrates exhibited very high contact angles, as high as 60°, even after UV exposure. On the other hand, the contact angles of TiO₂-coated substrates dropped to less than 10° after UV light exposure for more than 10 min, indicating a distinct hydrophilicity of TiO₂-coated AZ91 samples.

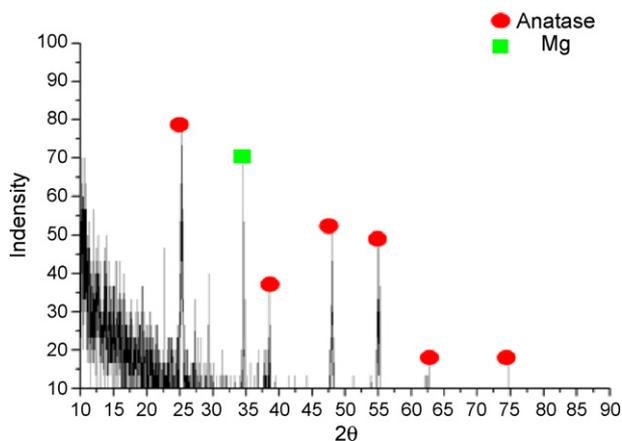
Fig. 1. X-ray diffraction spectrum for the deposited film.

Of the three possible crystal morphologies of TiO₂—rutile, anatase, and brookite-anatase shows the strongest photo-catalytic properties [16]. Fig. 1 shows the low angle XRD spectrum for the deposited film. The distinct crystalline Anatase phase with photo-catalytic characteristics can be identified from the spectrum. Also present in the spectrum are Mg-peaks, which appeared because of X-ray penetration of the thin film into the substrate, exciting diffraction peaks from AZ91 Mg-substrate.

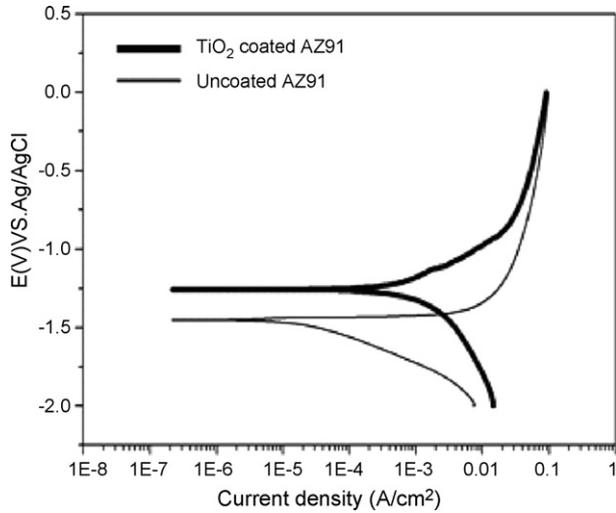
Fig. 3. Potentiodynamic polarization curves of uncoated and TiO₂-coated AZ91 alloys.

Fig. 3 shows the potentiodynamic polarization curves of uncoated AZ91 sample and AZ91 sample deposited with photo-catalytic thin films. The curves showed a corrosion potential of -1.45 V for uncoated AZ91 substrates and -1.26 V for the TiO₂-deposited samples. Since higher corrosion potential means better corrosion resistance, the corrosion resistance of TiO₂-deposited substrate is therefore better than that of uncoated AZ91 alloy. The corrosion current density of uncoated AZ91 alloy, however, was as low as 20.7 mA/cm², in contrast to the much higher 720 mA/cm² for TiO₂-deposited AZ91 alloy. Moreover, observation of the surface structure after corrosion test showed that TiO₂-deposited samples had corroded much more severely than did uncoated AZ91 alloy, as seen in Fig. 4. FE-SEM analysis on the surfaces of these samples revealed many pinholes on the TiO₂-deposited substrates, exposing the AZ91-substrates beneath the thin film. The deposited film of TiO₂ and pinhole areas of magnesium substrate formed a Galvanic cell effect [19], causing accelerated corrosion.

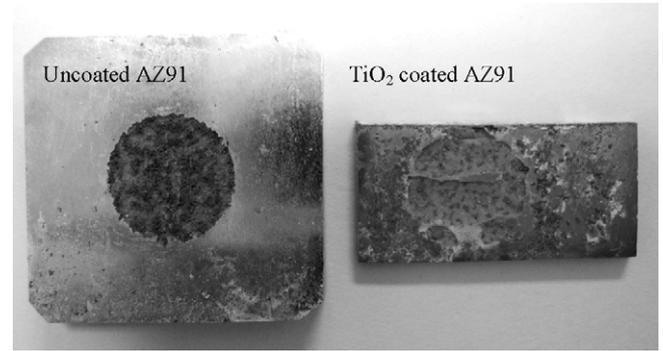
Fig. 4. Surface morphologies of uncoated and TiO₂-coated AZ91 alloy after corrosion test.

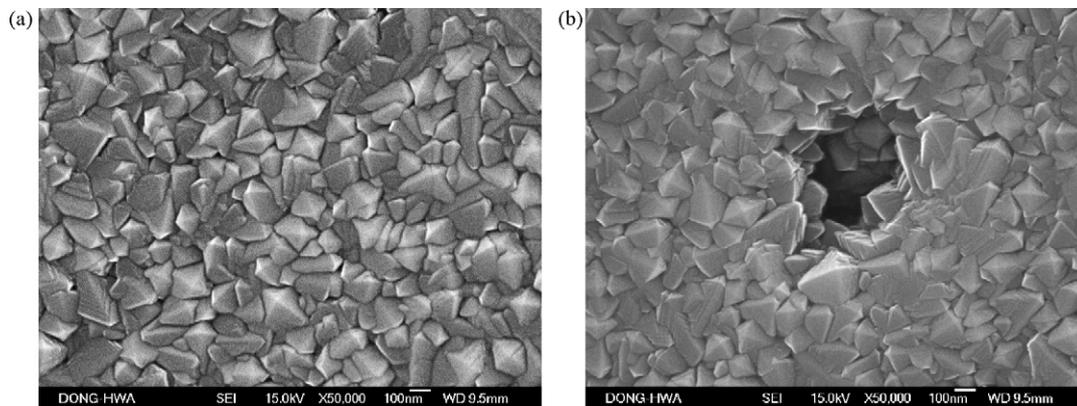
Fig. 5. FE-SEM surface images of TiO₂-coated AZ91 alloy: (a) perfect coating region and (b) pinhole formation region.

The microstructure of TiO₂ photo-catalytic thin film shows many pinholes on the surface. From the quantitative image analysis, the pinholes present are approximately 10% of the coated area. Fig. 5 shows the high magnification FE-SEM microstructures. Clear images of the polygon-shaped anatase-structure can

be identified in the pinhole-free region. The exposed parts of AZ91 substrate were visible inside the pinhole. Fig. 6 shows the presence of only Ti- and O-peaks on TiO₂ films. In contrast, pronounced Mg-peaks, in addition to Ti- and O-peaks, were also found in the pinholes. It is speculated that the formation of pinhole was caused by the residual contaminants that remained on the surface because of insufficient cleaning of the AZ91 alloy substrate. Fig. 7 shows the FE-SEM microstructure of the cross-section of TiO₂ films, about 1 μm in thickness. The interface between the deposited film and the substrate was defect-free, indicating a good bonding between TiO₂ films and AZ91 substrate. The EDS analysis of AZ91 substrate and TiO₂ thin film

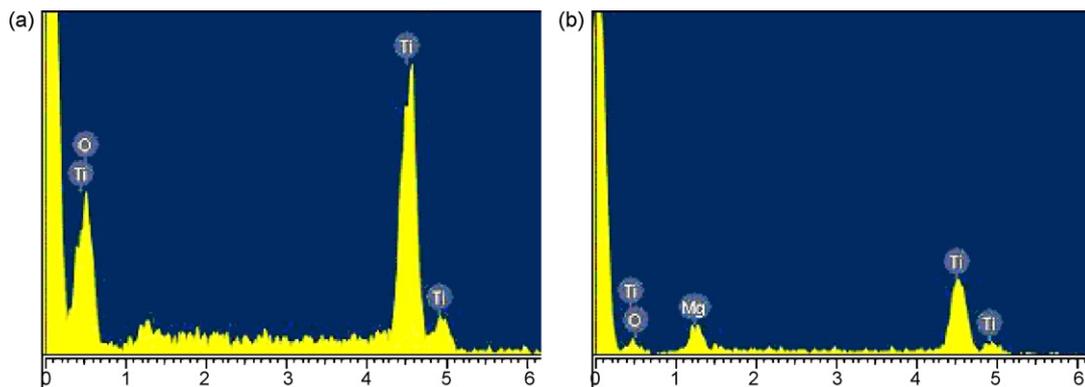
Fig. 6. EDS results of: (a) perfect coating region and (b) pinhole formation region.

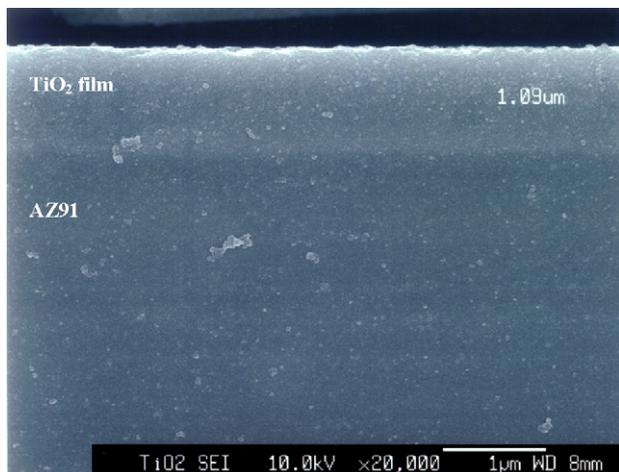
Fig. 7. FE-SEM cross section morphology of TiO₂ coating.

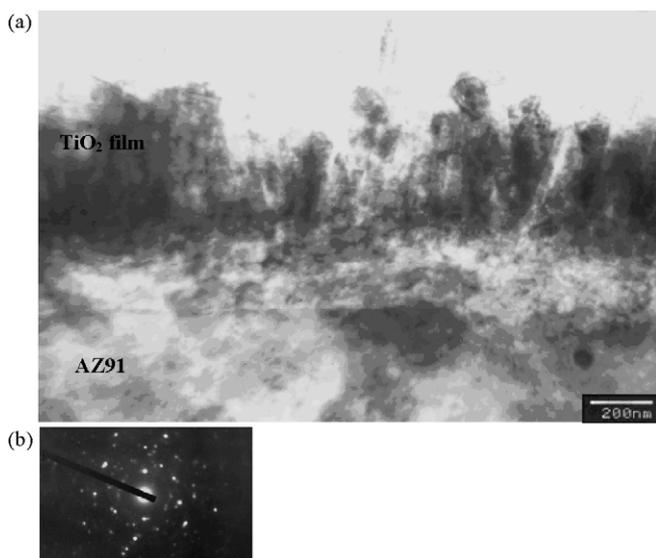
Fig. 8. (a) TEM cross section image of the TiO₂ coating, and (b) SADP taken from the TiO₂ film.

clearly shows the film composition to be TiO₂. Fig. 8(a) shows the TEM image of the cross-section of TiO₂ film. The difference in thickness observed between TEM and SEM images is a result of sample preparation method since, for TEM specimens, part of the thin film was ion milled away. The columnar-like structure of the TiO₂ film indicated the crystallinity, as identified by SADP (selected area diffraction pattern) and shown in Fig. 8(b). The above image also showed that the deposited TiO₂ thin film was not fully dense, with many pinholes on the surface. Under corrosive environments, oxygen molecules penetrated into AZ91 substrate and caused the accelerated corrosion. Prevention of pinhole formation is crucial in ensuring the protective function of TiO₂ films.
