# Non-Destructive Quarantine Technique- Potential Application of Using X-ray Images to Detect Early Infestations Caused by Oriental Fruit Fly (*Bactrocera dorsalis*) (Diptera: Tephritidae) in Fruit

**Key words:** X-ray, non-destructive inspection, image analysis, fruit, Oriental fruit fly

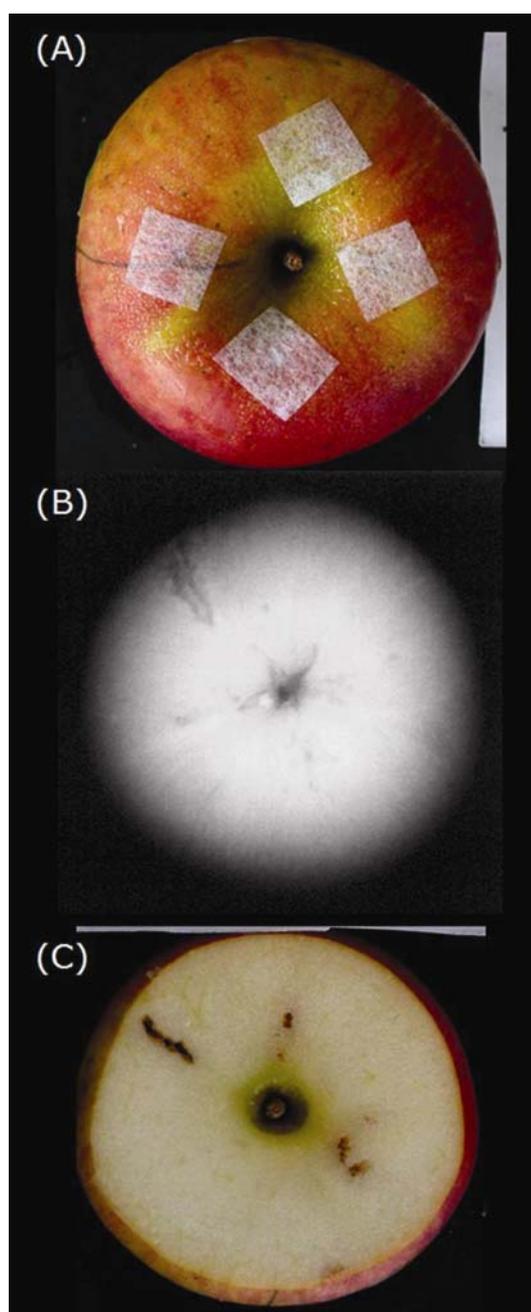
Fig. 1. Seven days after Oriental fruit fly eggs were implanted, an apple showed no outer damage (A) while an X-ray image (B) revealed signs of tunnels which closely matched the internal injuries (C). The four white patches in (A) are surgical tapes used to cover the pin-holes after egg implantation.

The internal structure of pomes and drupes are not complex, and the internal density of both fruits is evenly distributed except for the area near the core. Therefore, any internal injuries of these fruit could be clearly revealed by X-ray imaging. Figure 1 is an X-ray image of an apple into which Oriental fruit fly eggs had been implanted for 7 days, and this is the earliest time the internal injury of the apple could be detected by either X-ray image or dissection. No surface injury was observed (Fig. 1A). A tunnel created by the fly larva was detected by X-ray imaging (Fig. 1B), and it exactly matched the internal injury found when the apple was subsequently dissected (Fig. 1C). Figure 2 shows two pears which were infested by Oriental fruit fly larvae; one had eggs implanted for 3 days (Fig. 2A, C, E) and the other for 6 days (Fig. 2B, D, F). The X-ray images revealed internal injuries as early as 3 days after egg implantation into the

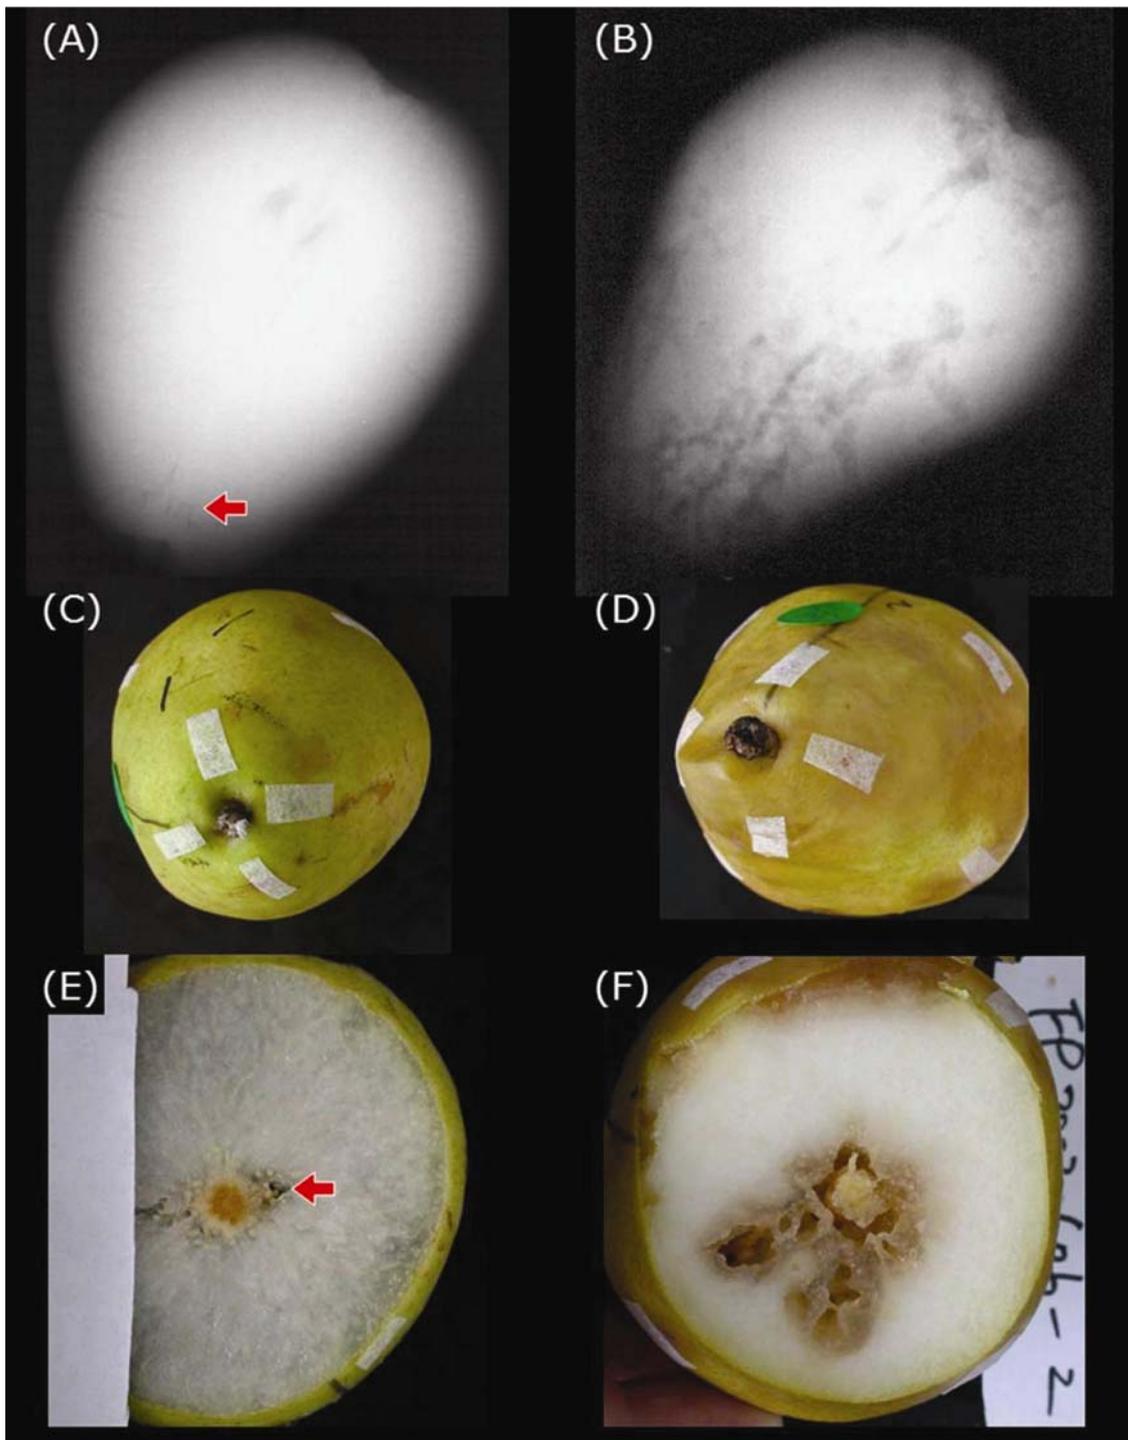
Fig. 2. Images of pears at different times of infestation. Three days after eggs were implanted, X-ray images (A) successfully revealed subtle signs of injury (red arrow) which were not detectable from the surface (C) and which closely matched the internal injuries (E). More-obvious signs of injury shown as tunnels in the X-ray image (B) were found 6 days after egg implantation, and serious internal injuries could be seen (F), while no obvious outer damage was revealed (D).

pears. The red arrows in Fig. 2A, E indicate slight injury detected by the X-ray image, and the contour analysis of the density changes showed uneven contour lines in this area (Fig. 3A & C) while those of the healthy part were smooth. In

the pear infested for 6 days, the internal injuries were more serious than those of the pear infested for 3 days, and many tunnels were easily detected on the X-ray image (Fig. 2B). The contour lines of the serious internal injuries are not continuous

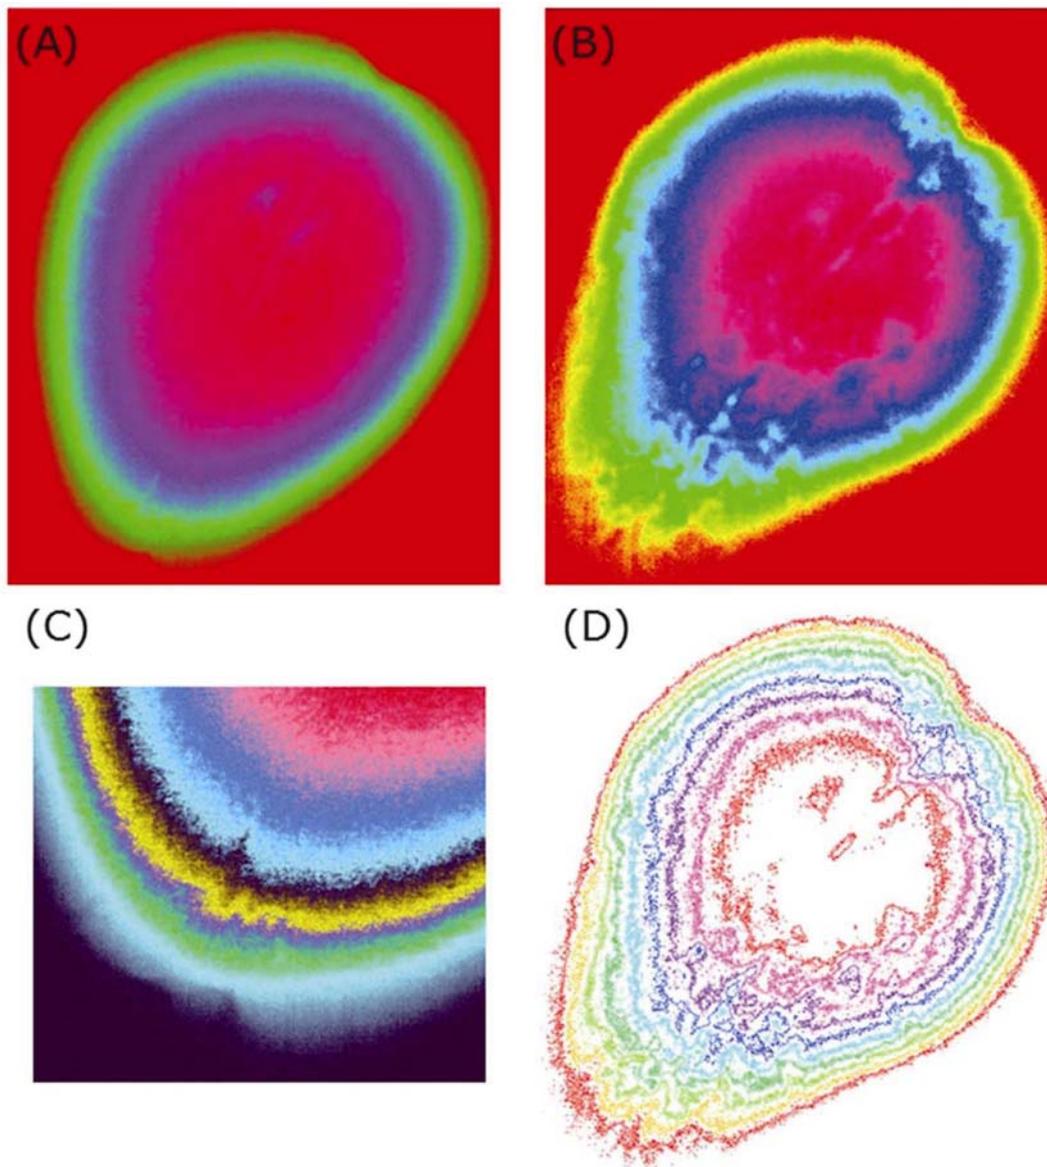
Fig. 3. X-ray images in Fig. 2 after image analysis for density changes. Picture (A) is the image analyzed from Fig. 2A, and (C) showed enlargement of the infested area. Pictures (B) and (D) were derived from Fig. 2B, and density changes are expressed as pseudo-colors and contour lines, respectively. The infested area revealed obvious distortion compared to the smooth contour curves of uninfested area.

(Fig. 3B, D), which greatly differs from the smoother lines shown in Fig. 3A, C. The best intensity condition for X-ray photography of the apple and pear was 45 kVp.

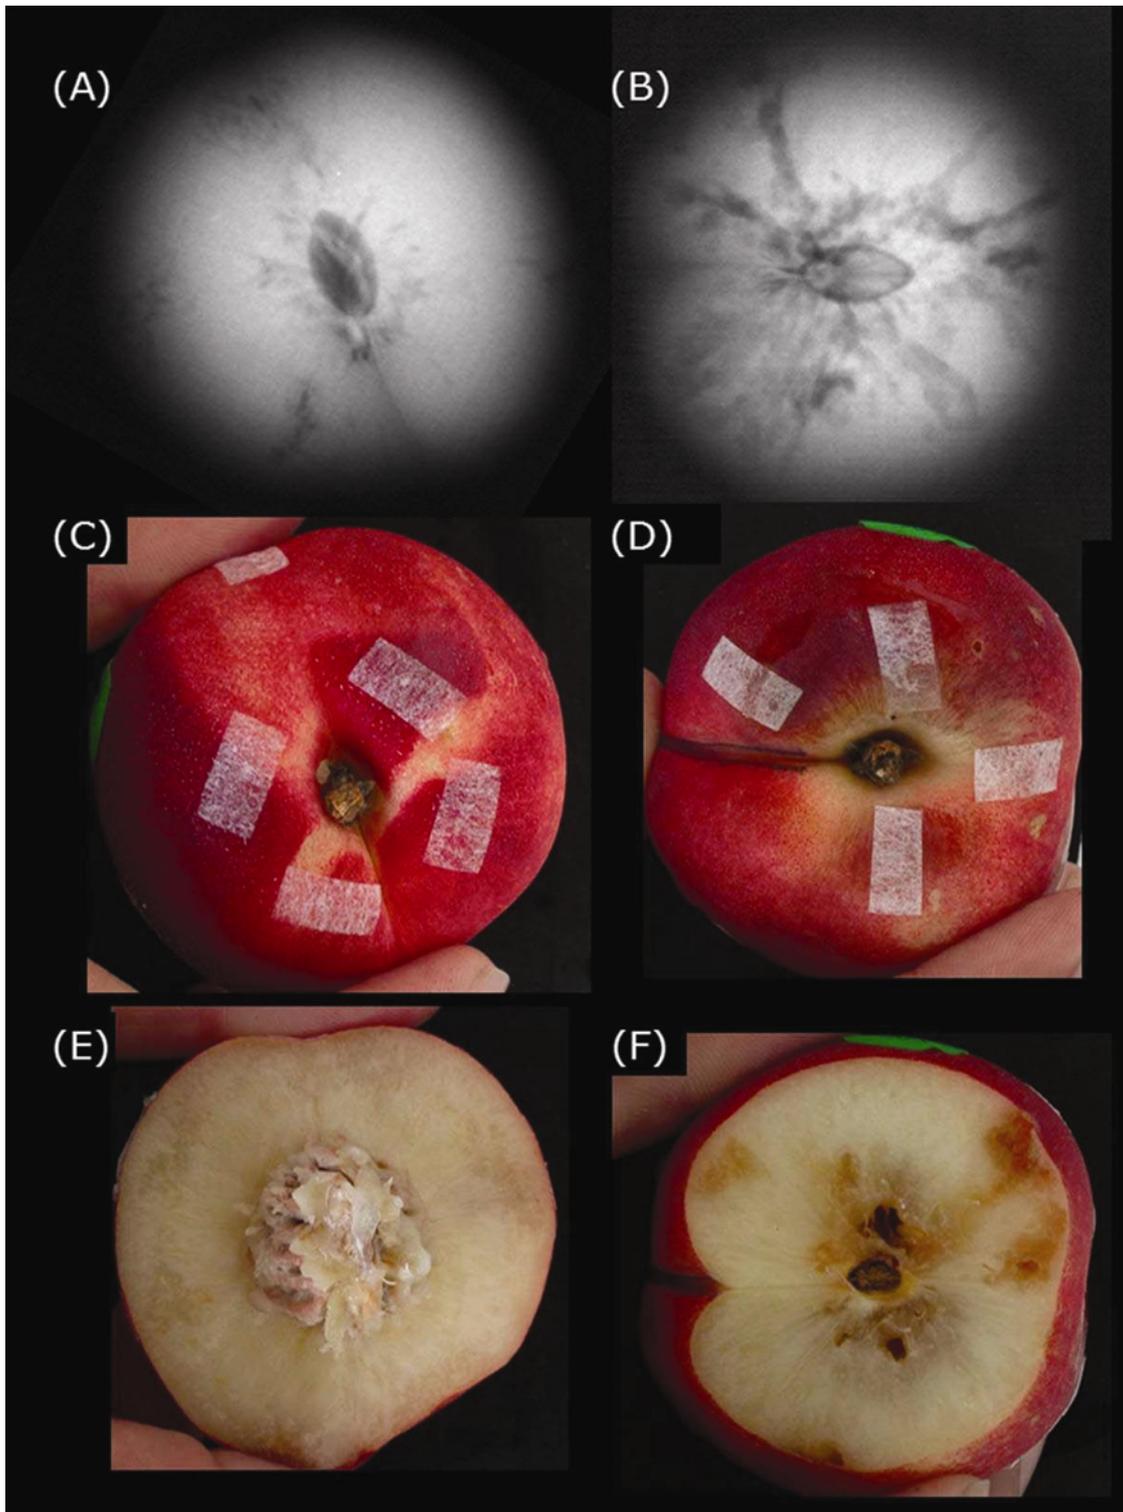
Fig. 4. Photos of peaches 4 (A, C, and E) and 6 (B, D, and F) days after egg implantation. (A) and (B), X-ray images showing signs of injury; (C) and (D), outer surface revealing no abnormalities; (E) and (F), internal injuries revealed after cutting open the peach.

Similar to the pome, the best intensity for X-ray photography for peaches was 45 kVp. Figure 4 shows two peaches which

had been infested by Oriental fruit fly larvae. One had eggs implanted for 4 days (Fig. 4A, C, E) and the other for 6 days (Fig. 4B, D, F). The X-ray images revealed internal injuries at as early as 4 days after egg implantation into the peaches. In the peach infested for 6 days, the internal injuries were more serious than those of the peach infested for 4

days, and many tunnels were easily detected on the X-ray image (Fig. 4B). Similar to the pears shown in Fig. 2, no surface injury was observed on either of the peaches shown in Fig. 4. The contour lines were not smooth, and a V-shaped pattern was evident in the parts where the internal injuries were found (Fig. 5).

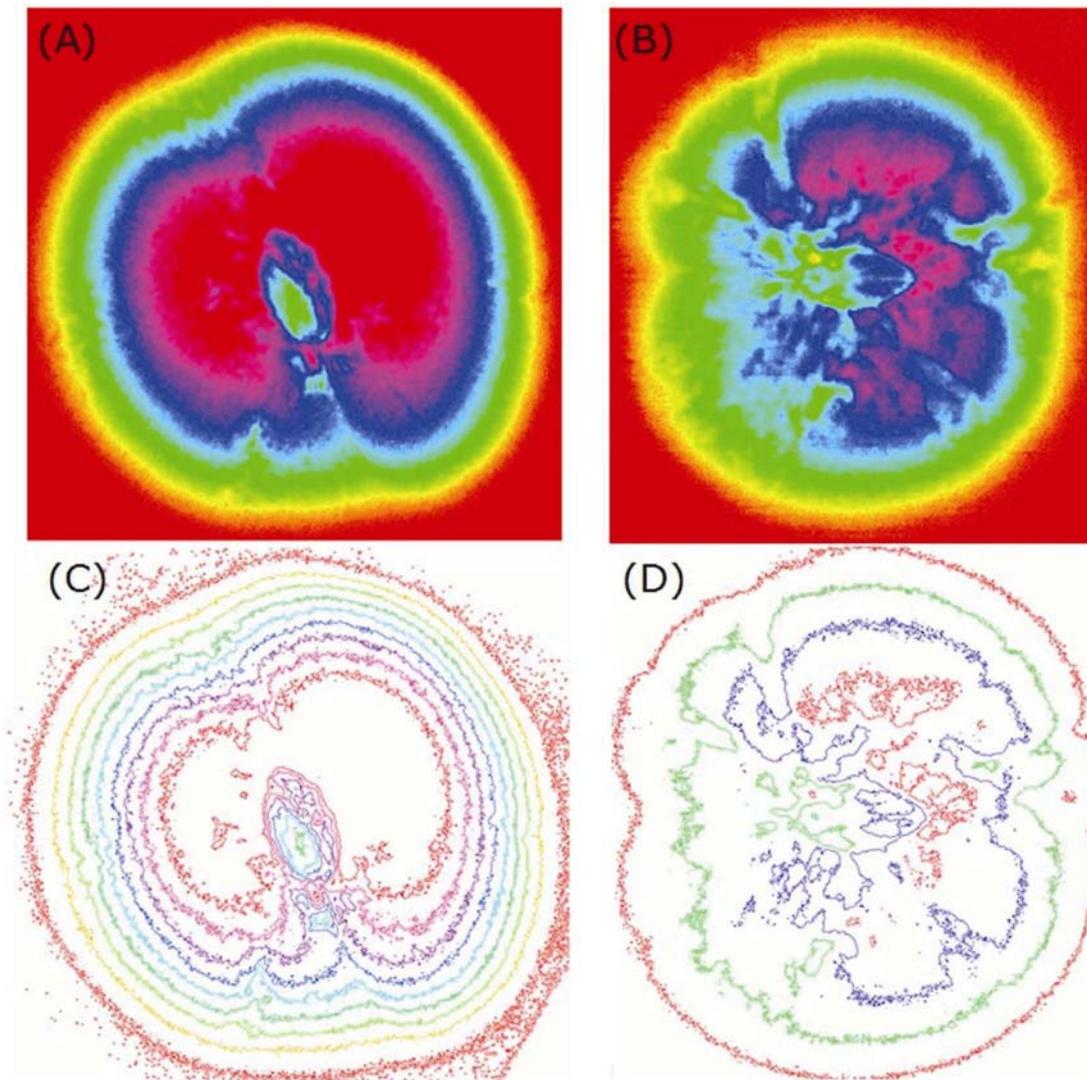
Fig. 5. After image analysis, X-ray images of peaches in Fig. 4A are shown in (A) and (C) with density changes expressed as pseudo-colors and contour lines, respectively. Similarly, (B) and (D) were derived from Fig. 4B, and show obvious injury symptoms.

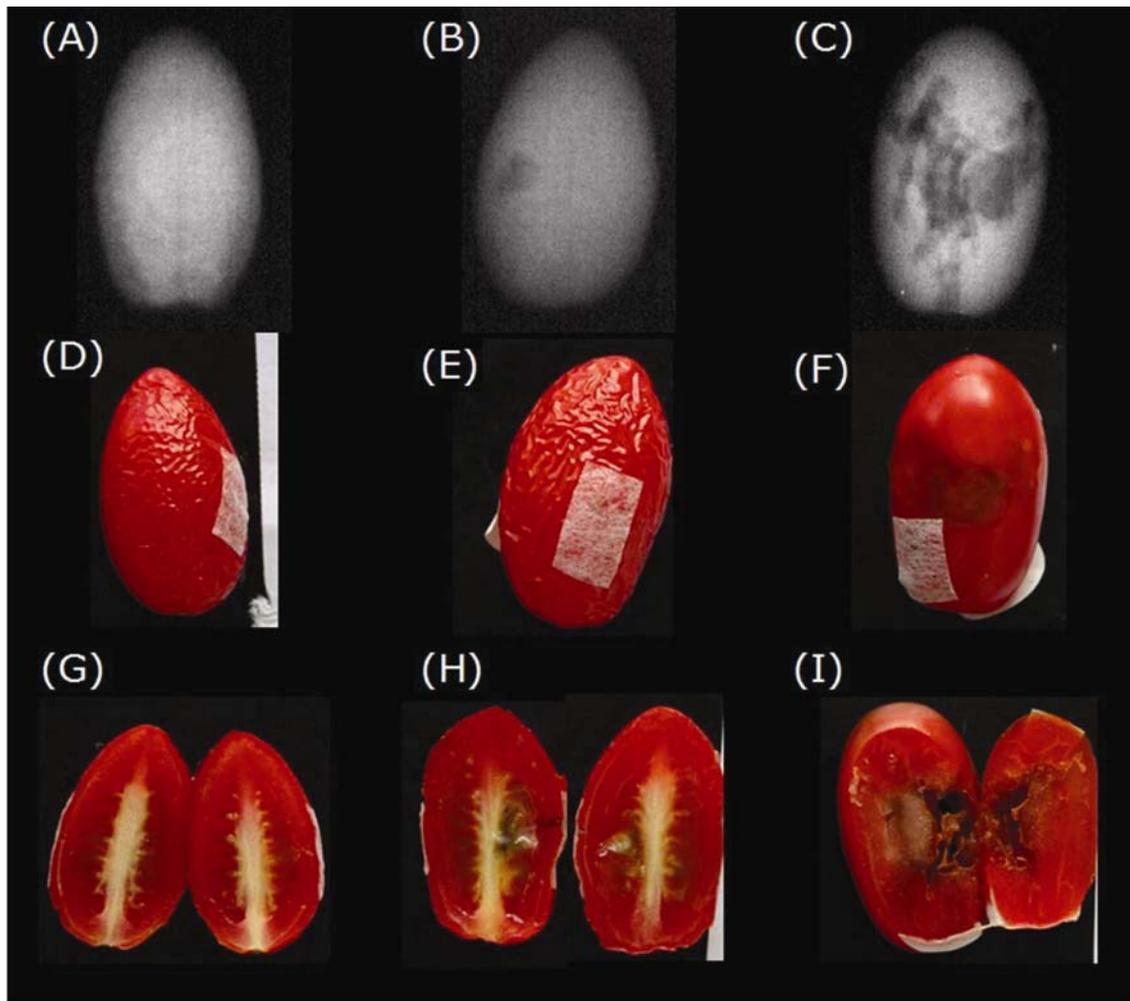
Fig. 6. Pictures of cherry tomatoes 6 and 17 days after egg implantation shown in the middle (B, E, and H) and right (C, F, and I) columns, respectively. The tomato with no eggs implanted for 6 days which served as the control is shown in the left column (A, D, and G). (A)-(C), X-ray images; (D)-(F), pictures showing the fruit surface in visible light; (G)-(I), internal injuries after cutting the tomato in half. Signs of internal injuries were obviously enhanced on the X-ray images over time.

With the same exposure time (0.1 s), we found that the best conditions for X-ray photography of cherry tomatoes required stronger power and therefore the voltage was increased to 50 kVp (Fig. 6). Internal injuries to the tomatoes were detected by X-ray images and dissection on the 6th day after egg implantation (Fig. 6B), even though the surface of the fruit appeared intact. A spot on the X-ray

image indicated the injured part caused by fly larvae, and this did not show up on the X-ray image of the control (Fig. 6A). More-serious internal injuries and more-extensive tunnels were observed on the X-ray image on the 17th day after egg implantation (Fig. 6C). The injuries could be observed by closely examining the tomatoes without X-ray, but still no remarkable surface injuries could be observed (Fig. 6F). The contours and pseudo-colors of the density changes inside the infested tomatoes revealed uneven lines (Fig. 7B, D), as described previously for the pome and the drupe.

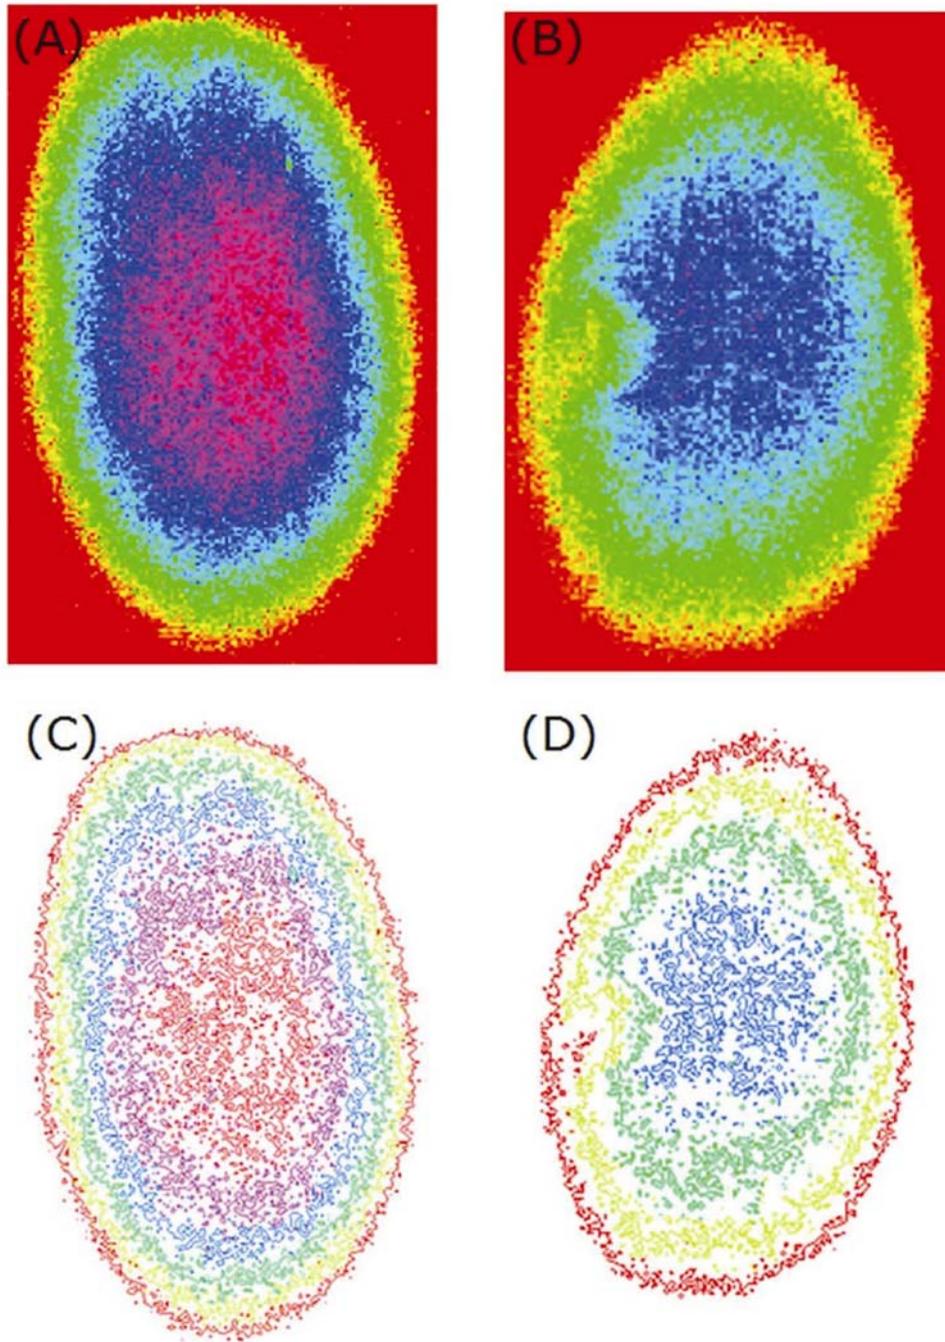
Fig. 7. After image analysis, X-ray images of cherry tomatoes in Fig. 6A are shown in (A) and (C) with density changes expressed using pseudo-colors and contour lines, respectively. Similarly, (B) and (D) were derived from Fig. 6B and show obvious injury symptoms.

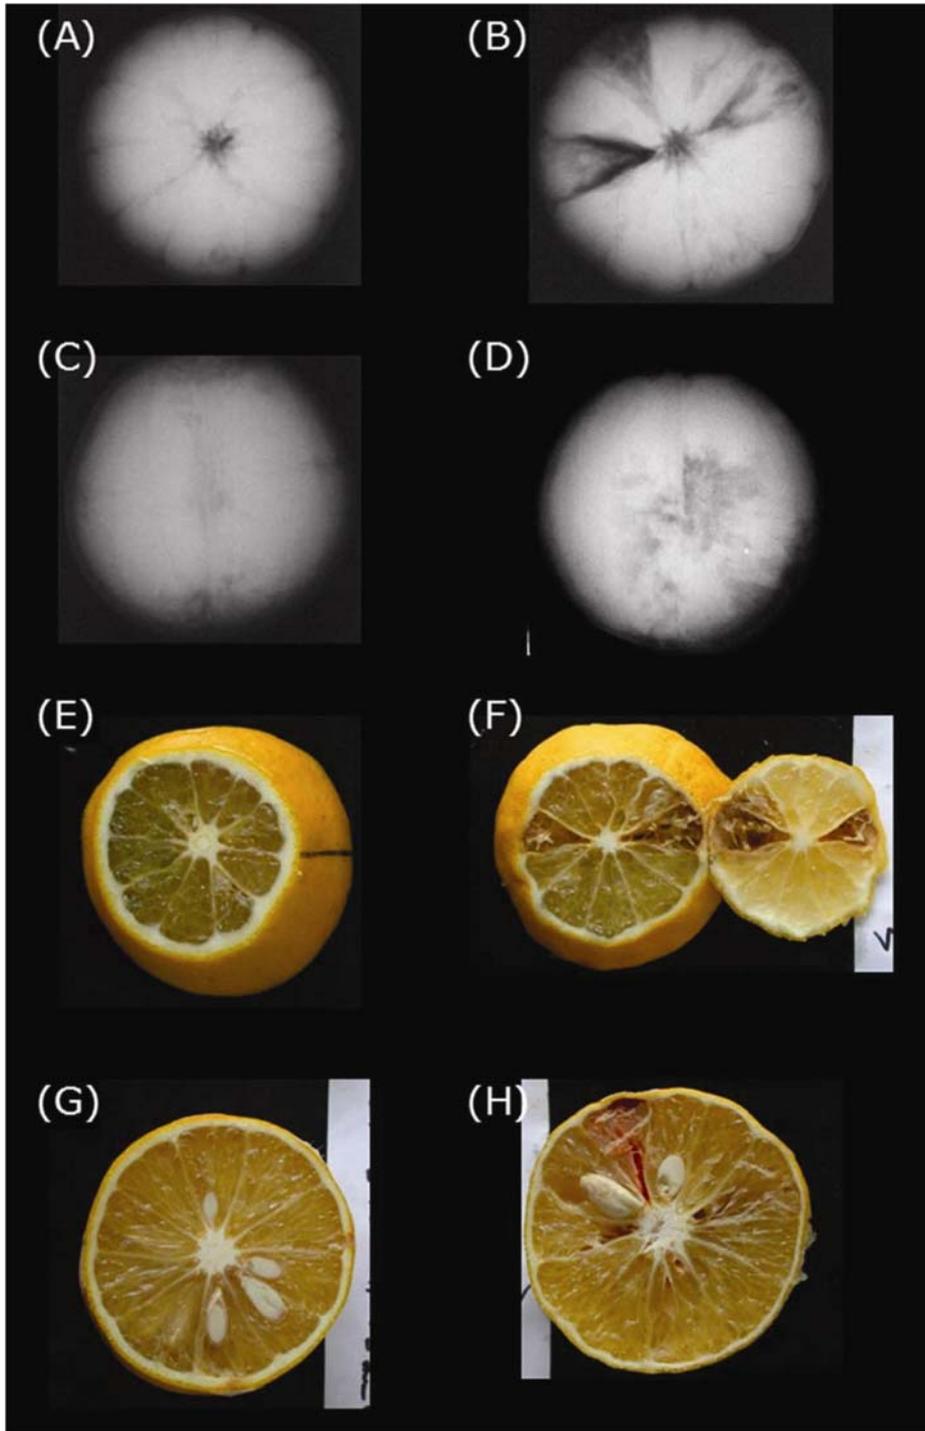
Fig. 8. Photographs of oranges 6 (A, C, E, and G) and 17 (B, D, F, and H) days after egg implantation. (A) and (B), X-ray images from the top view; (C) and (D), X-ray images from the side view; (E)-(H), fruit cut in different areas showing the internal injuries.

The best intensity for X-ray photography of oranges was the same as for tomatoes, i.e., 50 kVp (Fig. 8). Because the inside of an orange is divided into segments, the initial internal injuries caused by the fly larvae were confined by the segments. Fly larvae were first detected by X-ray images of an orange into which eggs had been implanted for 6 days. Since the internal structures are more complicated than those of the fruits described above, and the segments provide a strong contrast on X-ray images, a top view of the X-ray image did not provide reliable clues for locating the internal injuries (Fig. 8A). In contrast, a side-view X-ray image gave a clear indication of the location of the injury (Fig. 8C). The contour lines and pseudo-colors of the density changes on the side-view X-ray image also clearly showed the location of the injuries, but the top view was unsuitable for determining the location of the injuries (Fig. 9A & C). When slicing on orange, it was not easy to determine either the extent of internal injuries or the presence of larvae due to the juicy contents (Fig. 8E, G). For those oranges which had eggs implanted for 17 days, the internal injuries were serious and were easily diagnosed by locating brown tissue (Fig. 8F, H). Both the X-ray

images and examination of slices of seriously infested oranges showed that the injuries were not confined by the segments (Fig. 8B, D, F, H). The contour of density changes derived from the top-view X-ray image of the orange (with eggs implanted for 17 days) showed broken, uneven lines (Fig. 9B, D), indicating that the fruit had been seriously infested by fly larvae.

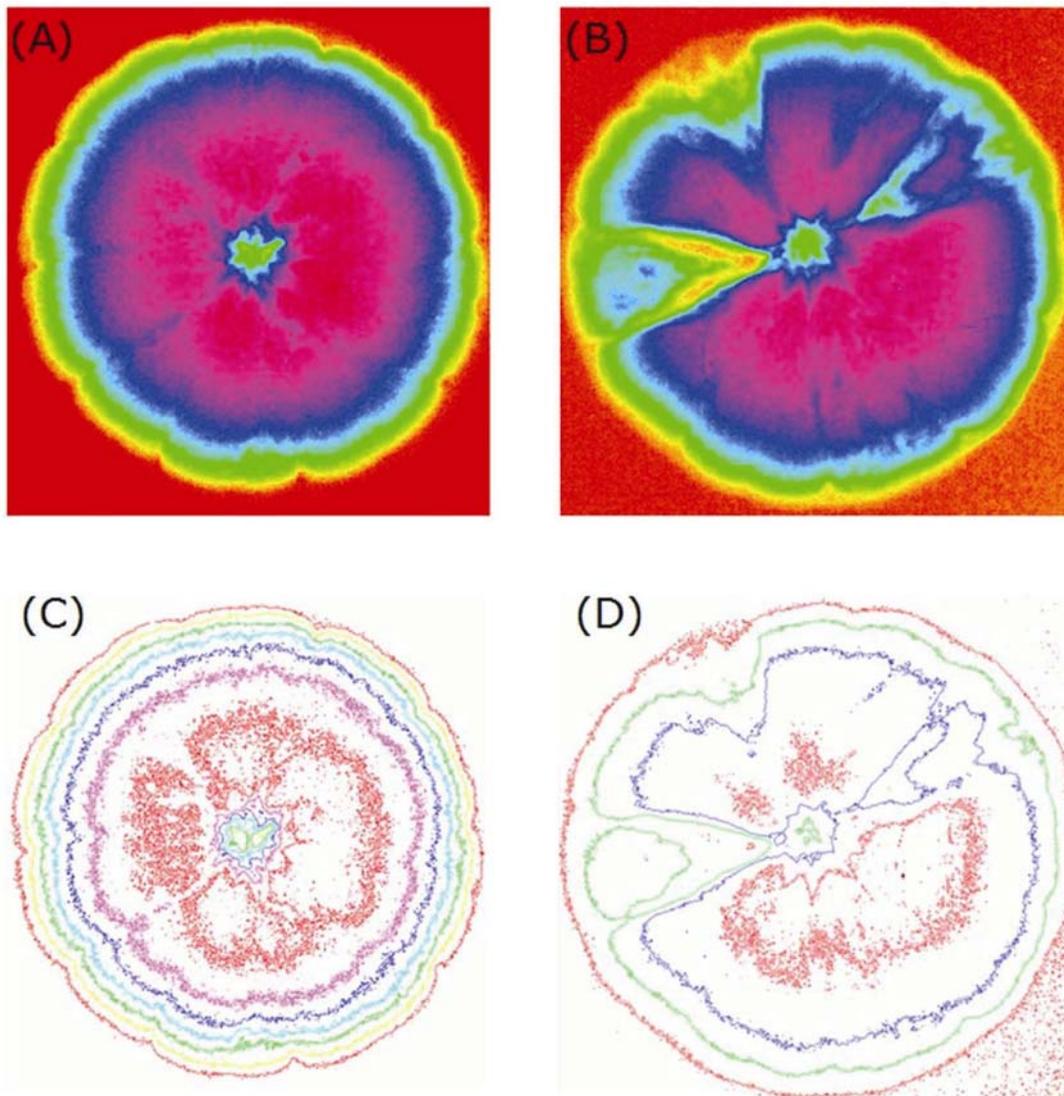
Fig. 9. After image analysis, X-ray images of the orange in Fig. 8A are shown in (A) and (C) with density changes expressed using pseudo-colors (A) and contour lines (C), respectively. Similarly, (B) and (D) were derived from Fig. 8B and show obvious injury symptoms.
